**DUNOLLIE CASTLE,  
ARGYLL**

**Standing Building Survey and Excavation  
Data Structure Report**  
August 2017  
Roderick Regan

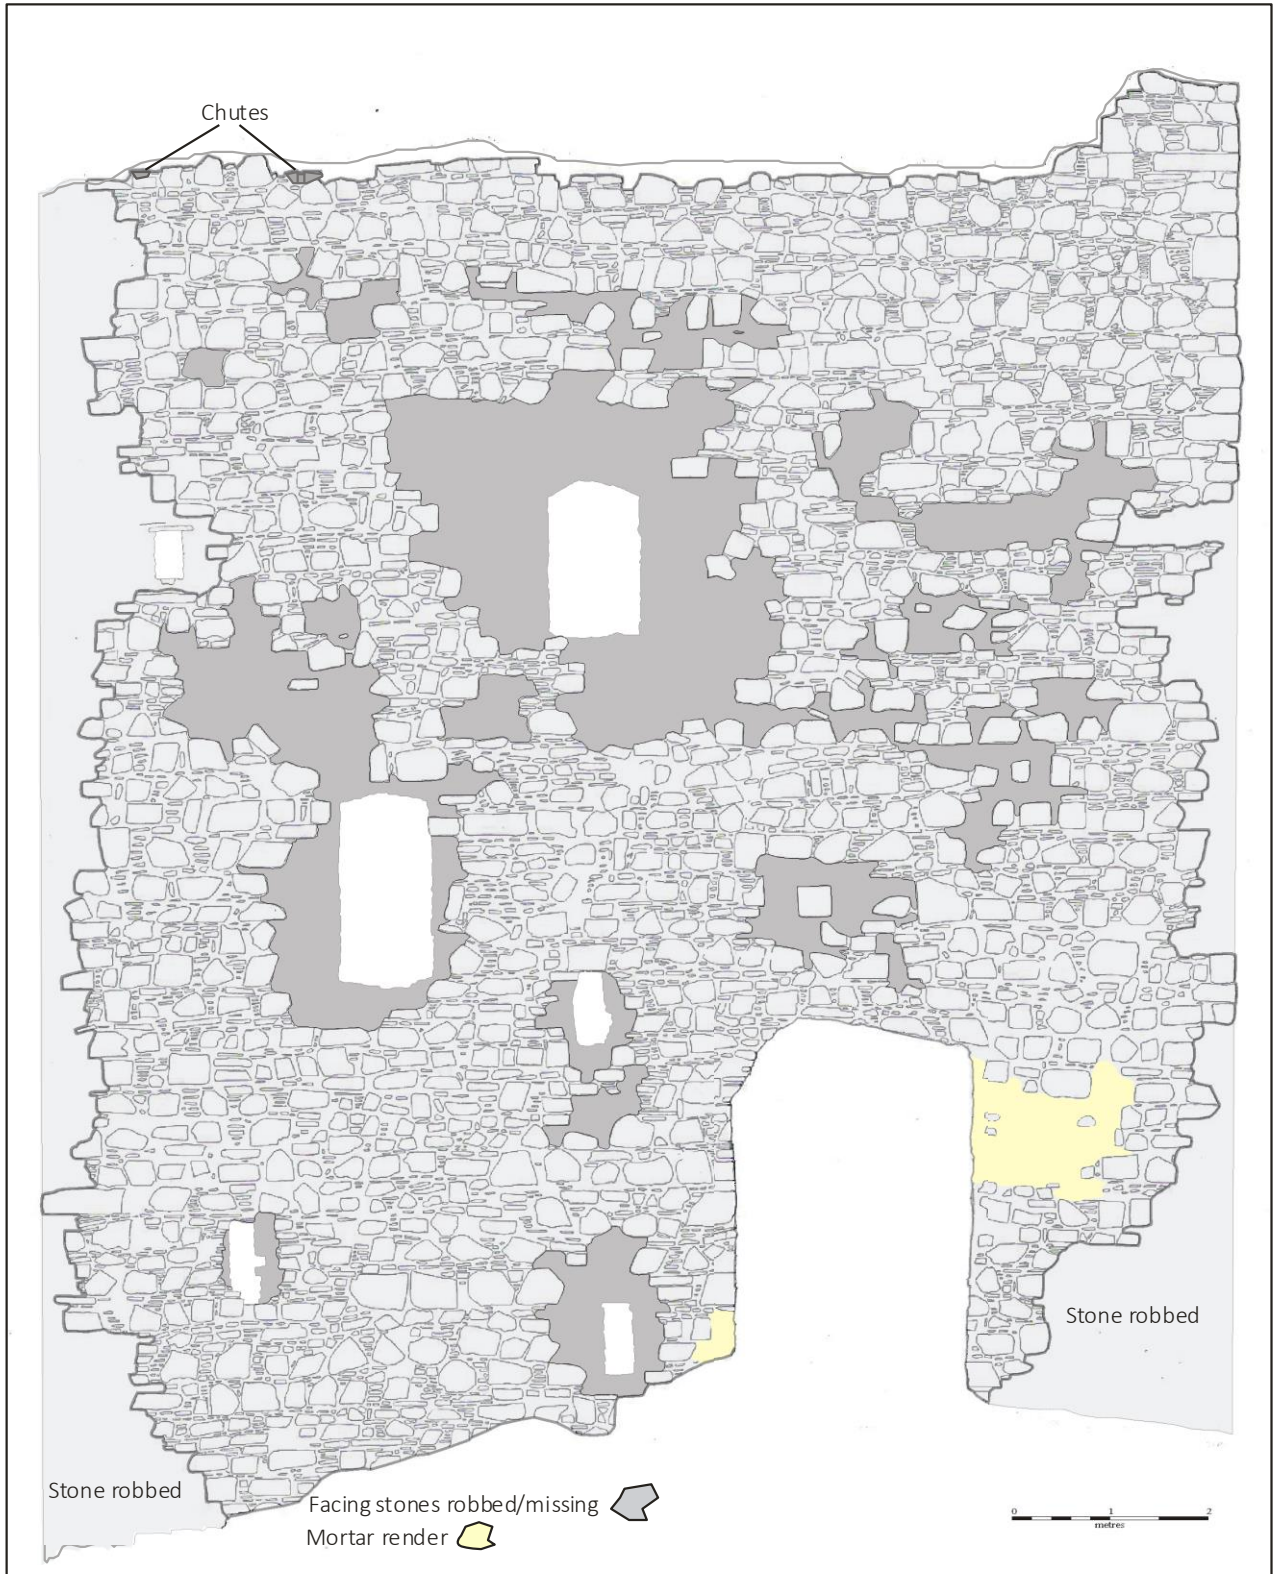
Figure 3: SE elevation of the tower

As mentioned above previous repair work was most extensive on the south west face of the tower, particularly around the windows and doors. On the south east side of the tower there is more evidence of extensive robbing around the doors and windows and it seems likely the extent of stone robbing was similar on the south west face prior to any repair work.

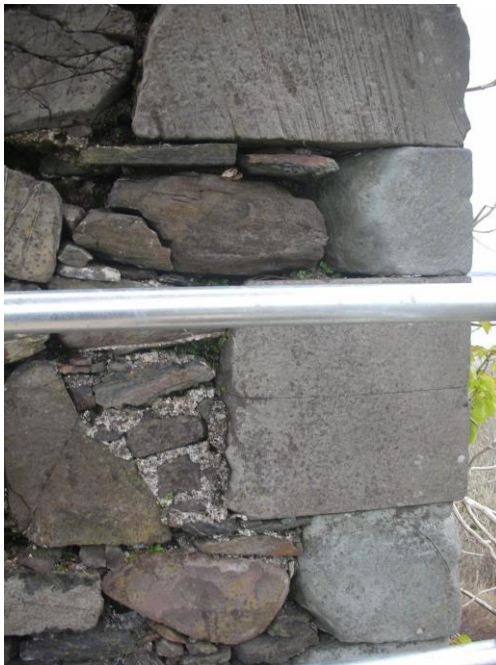
Surviving quoins on SE corner of tower

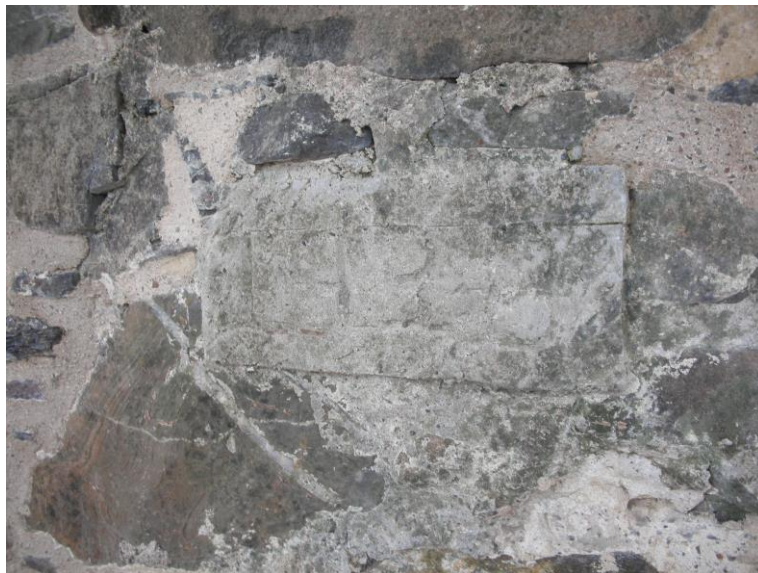
Render plaque dated 1939

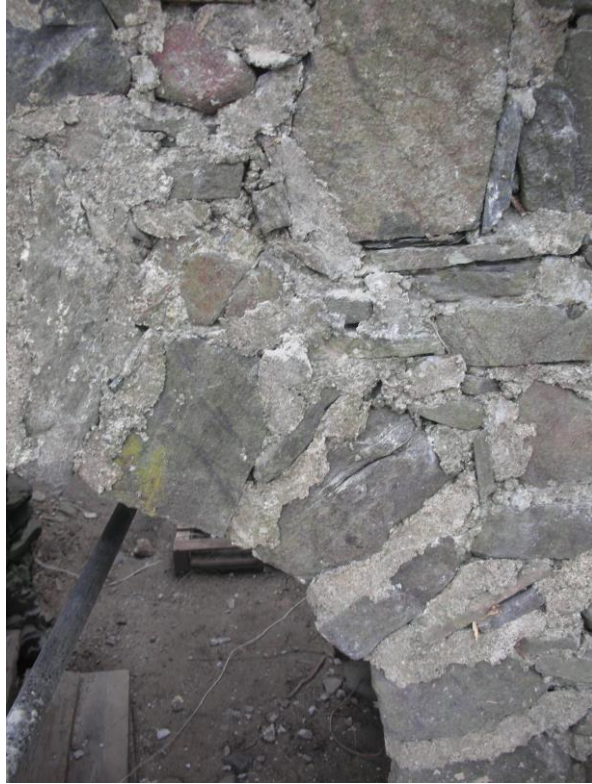
Repair around second floor window in SW tower wall

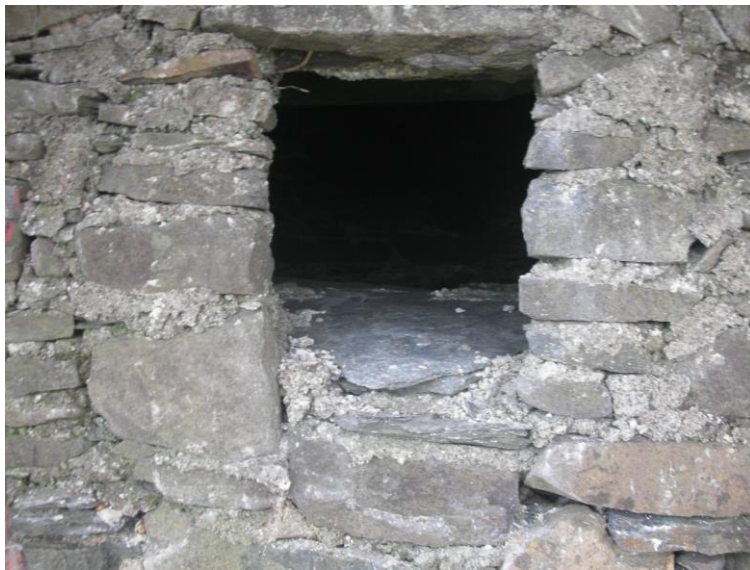
Render repair on upper stair window in SW tower wall

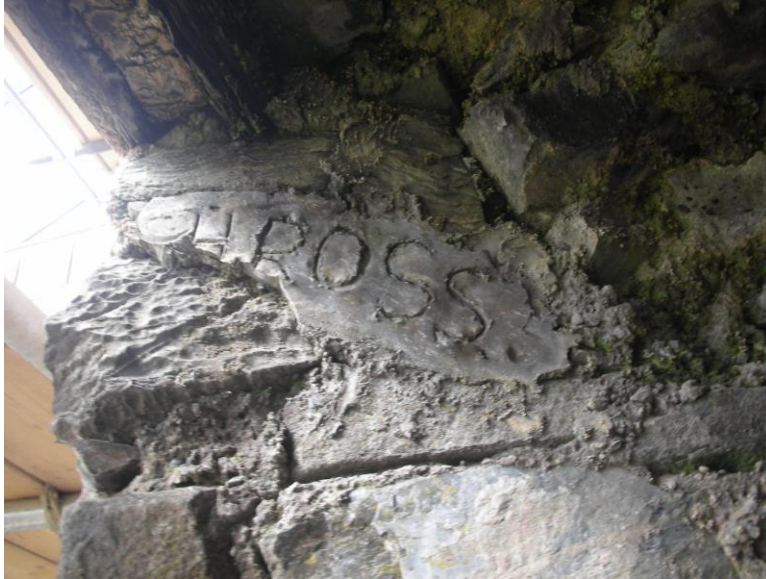
Personalised repair on the first floor entrance

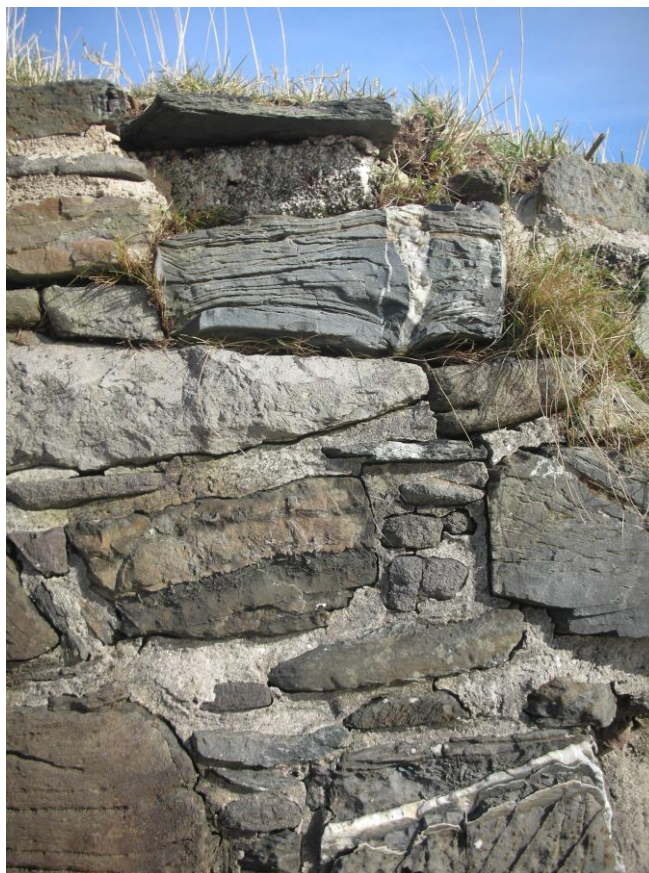
Re-pointing below drainage chute on SW tower wall

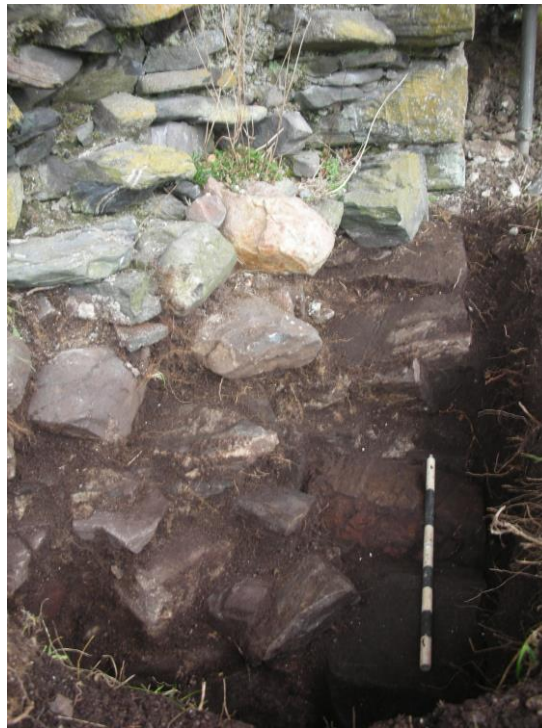
The cleared stonework prior to underpinning

The masonry lay under up to 0.35m of what was mainly a dark brown sandy silt or loam that contained some small rubble fragments along with some small fragments of mortar. This appeared to be an accumulation of vegetation debris (i.e. degraded ivy leaves) with some weathered building material, overlying the original robbed stonework. No artefacts were recovered.
