**CASTLE DOUNIE,
NORTH KNAPDALE FOREST
ARGYLL**

**An Archaeological Evaluation
Data Structure Report**

June 2011

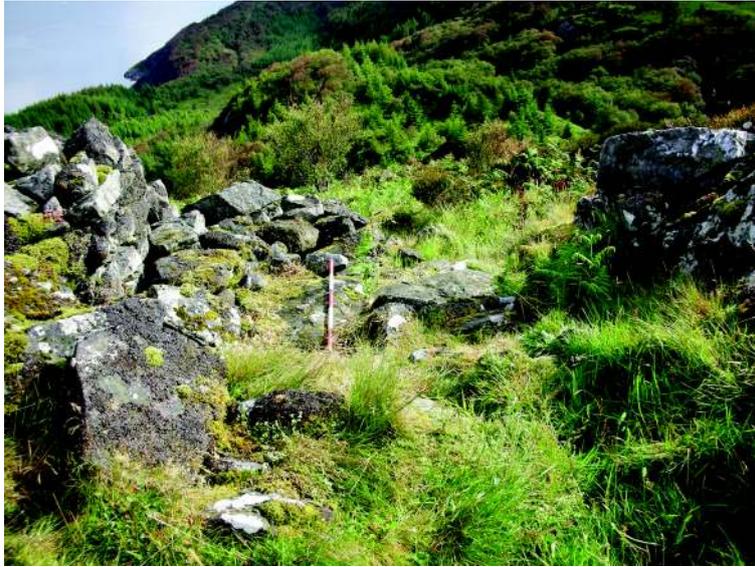
Entranceway prior to rubble removal

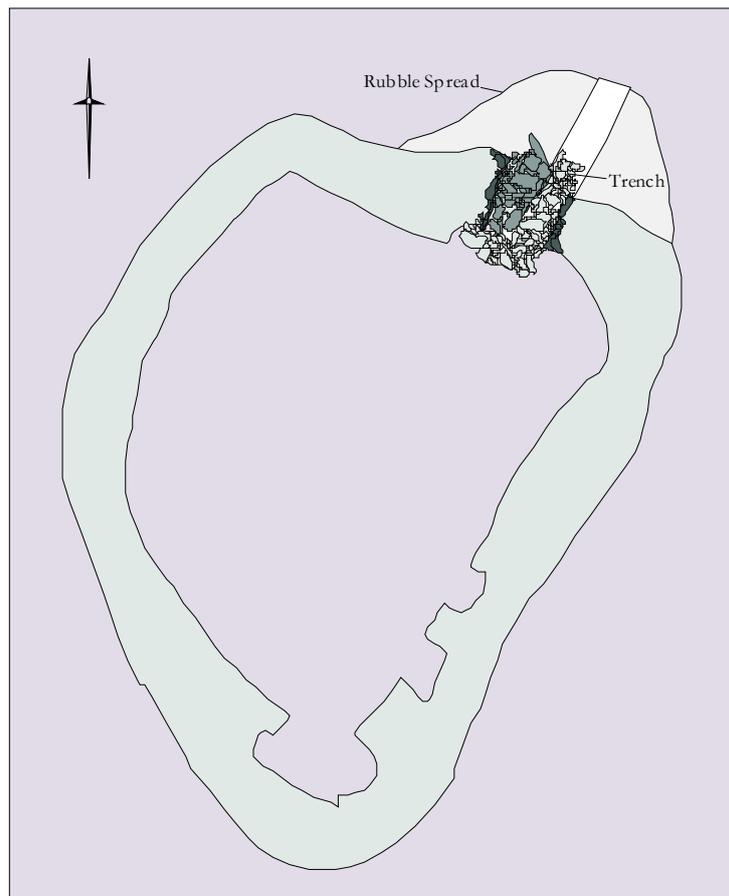
Figure 2: Dun and location of Trench (after RCHAMS)

The dun has previously been described by the Royal Commission and a summary of the dun and their description of the entrance is reproduced here. The dun has an irregular plan and measures 18m by 14m. The internal area of the dun is essentially featureless but several chambers appear to have been incorporated within the wall construction on the E and S sides. *‘The well preserved entrance lies on the NNE; originally it measured 2.1m across, unusually broad for an entrance passage, but was subsequently reduced to a width of 1m by a stretch of inferior walling attached to the W side of the passage.’* (RCHAMS 1988). The dun is one of 21 forts and duns that are currently recorded in North Knapdale and form one of the densest concentrations of these types of monument in Scotland.

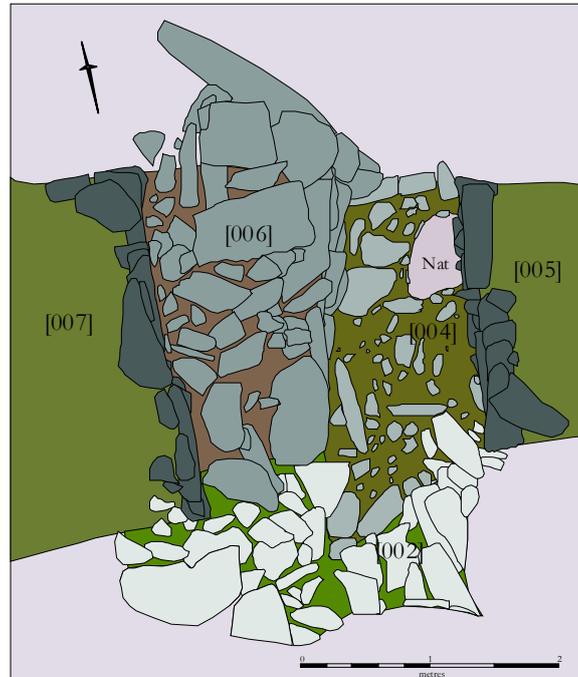
Figure 4: Surface [004] in Entrance Passage

Natural bedrock was encountered at the NE of the entrance passage and along the base of the E passage wall. The E wall [005] appeared to have been directly constructed on bedrock, at least in the parts where this relationship could be observed. The surface within the rest of the passage comprised of a mixture of schist blocks and smaller schist fragments which at the N levelled up natural dips in the bedrock. Some blocks were lain E/W across the entrance passage and these may have been crude steps, effectively revetting surface material on their higher (S) sides.

[004] Surface. Entrance surface, comprising of schist slabs and rubble levelling over natural bedrock. Several stones appear to lie E/W across entrance passage and may be intended as crude steps, largest stone 0.35m x 0.15m x 80mm.

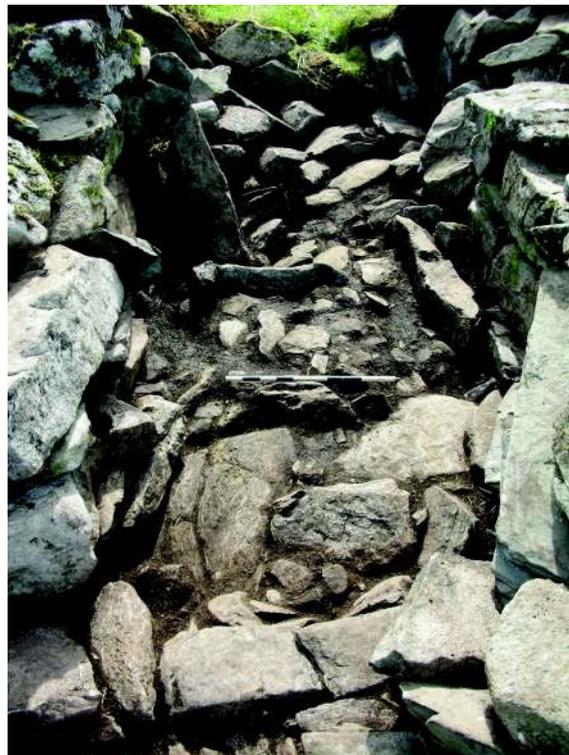
Entrance Passage from S

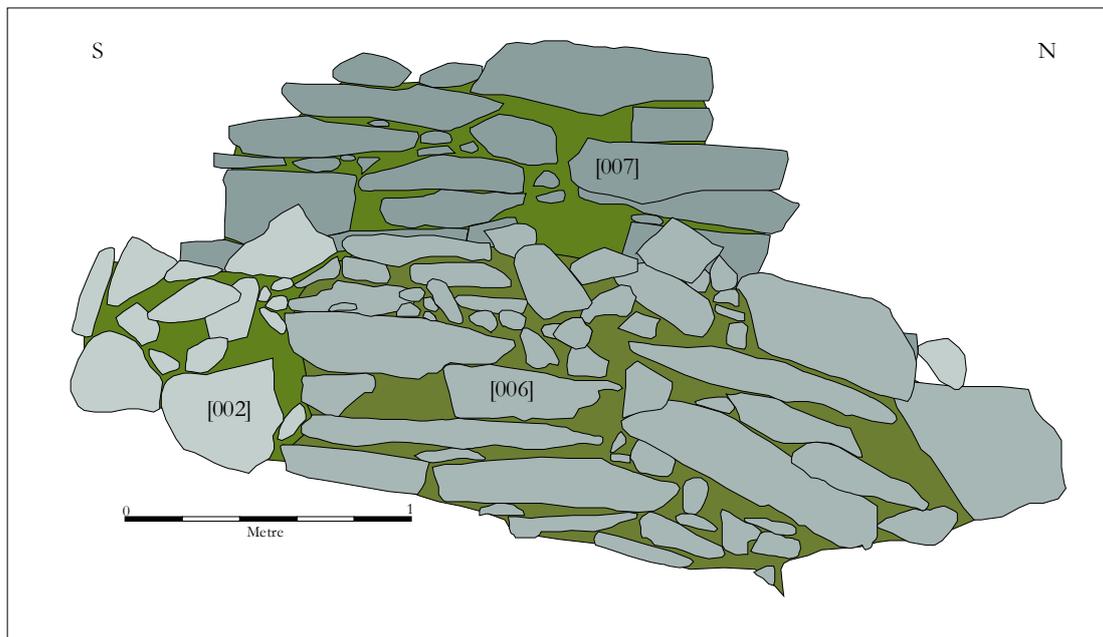
Figure 5: Western side of Entrance Passage

As noticed previously, the W side of the entrance passage is formed by a later modification or narrowing seen with wall [006]. Part of the surface revetting at the N of the entrance appeared to run under this later passage wall, although it is possible the collapse of this wall at its N end may mask the true relationship.

If this part of the surface does indeed run under the wall then it is possible that it relates to the earlier passage alignment as represented by wall [007]. While the N and E edge of passage wall [007] could be traced with ease, its S edge was less clear. It may be that this edge has collapsed in antiquity, although seen through the collected rubble at the S side was what appeared to be a hollow within the stone-work and it may be there is a more complicated arrangement on this side. Lying between and over some of the stones forming the passage surface was dark organic deposit [003] that contained charcoal and burnt bone. Two flints along with a possible iron pin

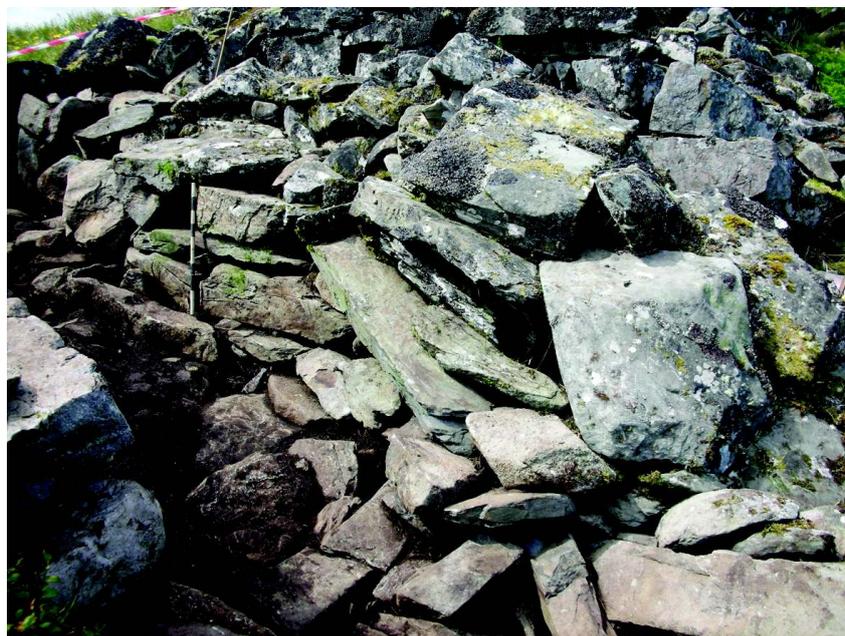
Collapsed Wall [006] from NE

[006] Wall. Western wall forming later entrance blocking/narrowing. Constructed from angular schist blocks the wall measured 2.70m long but this was distorted by the collapse of the N end of the wall material, the original length likely between 1.80m-2.0m. The remaining wall stands up to 0.75m high in 5 rough courses (largest block measured 0.95m x 0.27m x 0.20m).

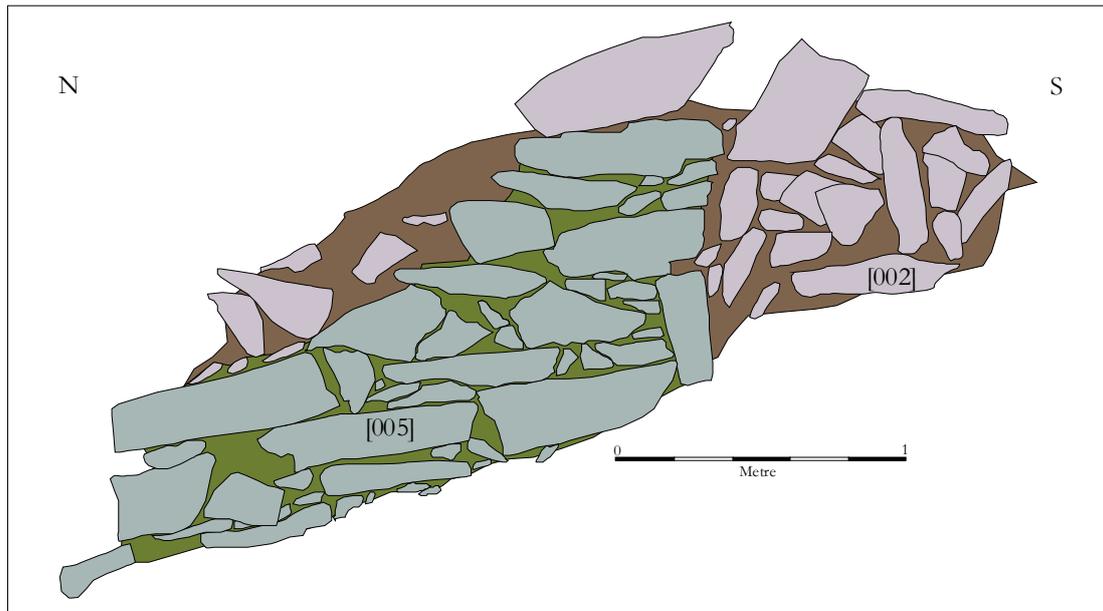
Figure 6: Eastern wall of Entrance Passage

[005] Wall. Eastern wall of entranceway, measuring 2.00m wide and standing up to 1.05m in 7 undisturbed rough courses. Constructed using mainly large angular schist blocks with smaller fragments used as levelling/hearthing material. (largest block measured 0.80m x 0.36m x 0.20m)

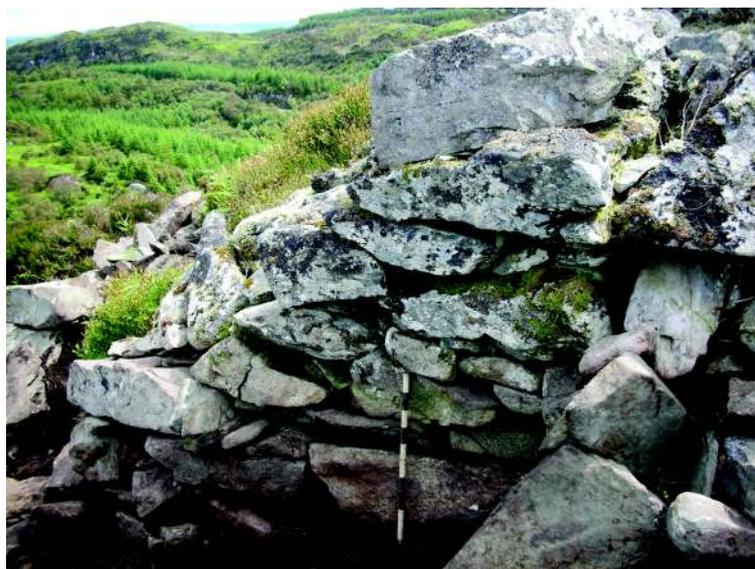
East Wall [005] from SW

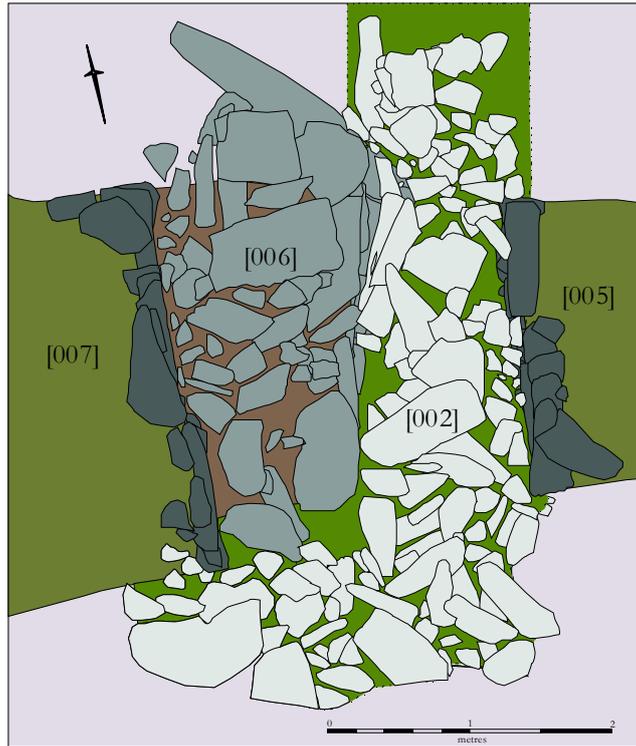
Figure 7: Rubble collapse [002] in Entrance Passage

Embedded into this deposit was the lowest wall collapse or tumble [002] that filled the entranceway. Within the entrance passage the collapse was up to 0.50m in depth, and this collapse was traced for at least 5m beyond the entrance to the N. The area to the N was cleared during the evaluation as the ground dropped away in what appeared to be regular ridges which might have represented outer wall or step lines. This however, proved not to be the case and the removal of the vegetation cover revealed a mass of tumbled rubble.

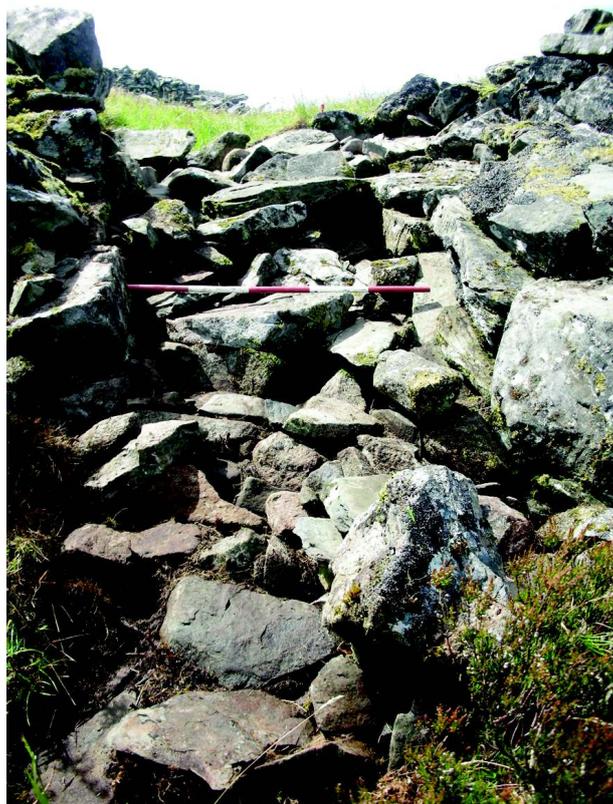
Rubble [002] in Entrance

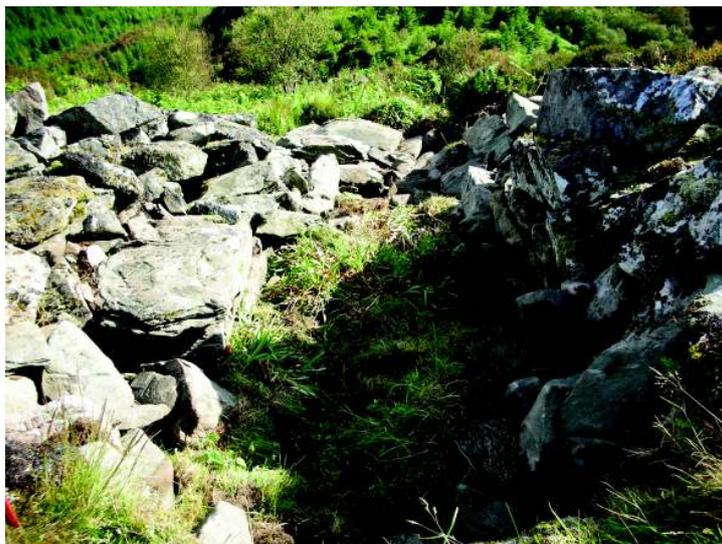
Consolidated Trench

The walls of the dun appear to be generally robust but some consolidation might be deemed necessary, if, as proposed, this becomes the public entrance onto the site. The mass of rubble seen to the N of the entrance passage also was partially uncovered during this phase of work and while this was not excavated it is still possible it still masks earlier built features.

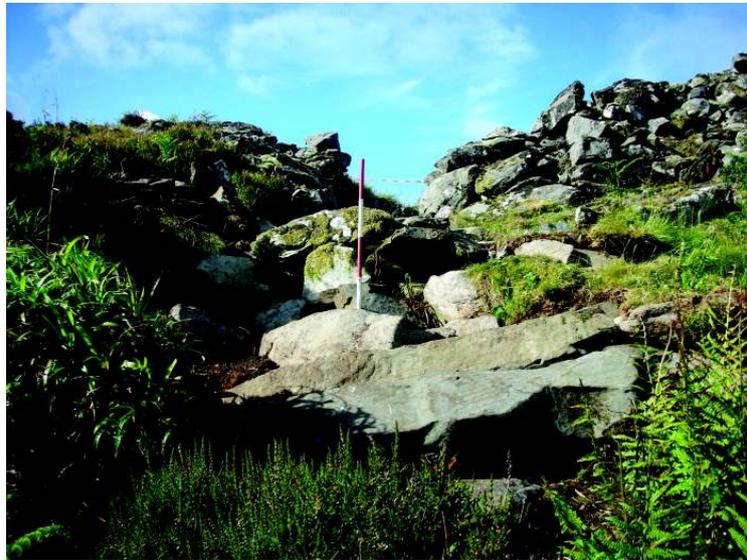
[002] Layer. Collapse/demolition, mainly consisting of epidiorite blocks tumbled into entranceway and to the north of the entrance. The largest block measured 1.60m x 0.50m x 0.20m.

Rubble at N of Entrance

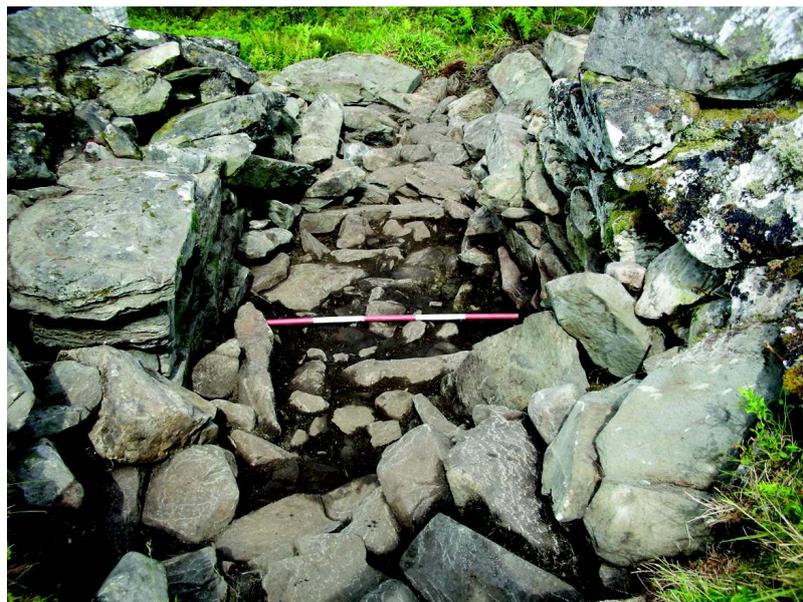
Cleared Entrance from S

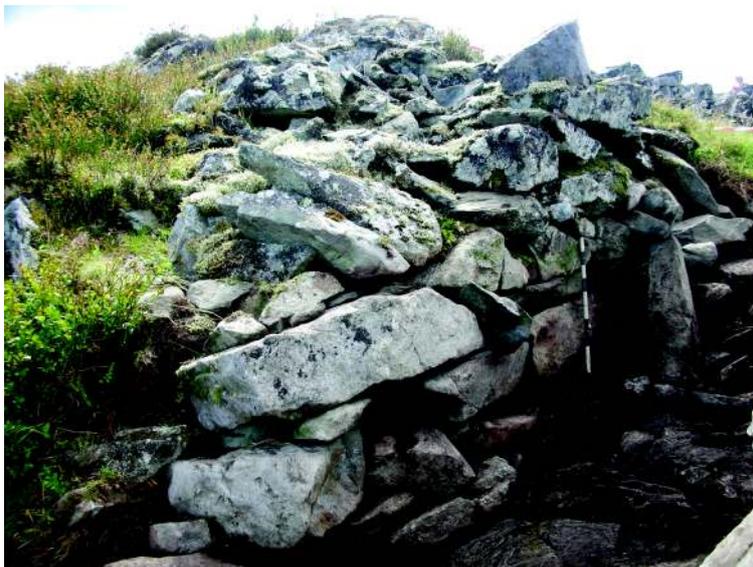
East side of Entrance Passage [005] from SW

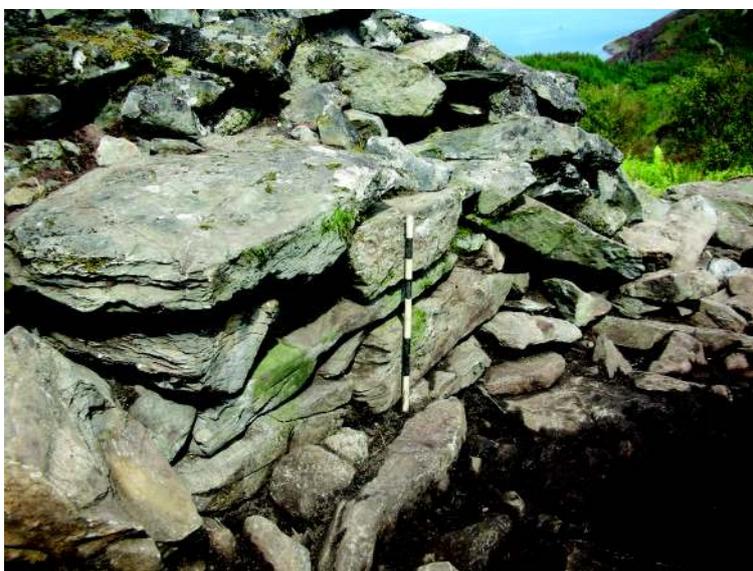
Later West side of Entrance Passage [006] from SE

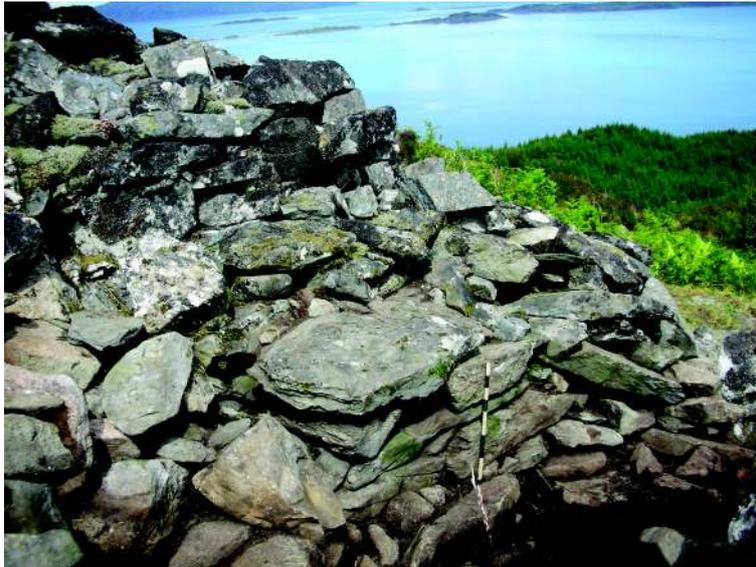
[007] Wall. Original W side of entrance and constructed from angular schist blocks the wall measured 2.0m long and stands up to 1.60m high in 10 rough courses (largest block measured 0.87m x 0.30m x 0.23m).

West side of Entrance Passage [006] in front of [007] from SE
