**DUN FHINN  
KILDALTON, ISLAY  
AN ARCHAEOLOGICAL SURVEY**

**DATA STRUCTURE REPORT  
May 2017  
Roderick Regan**

## 1. Introduction

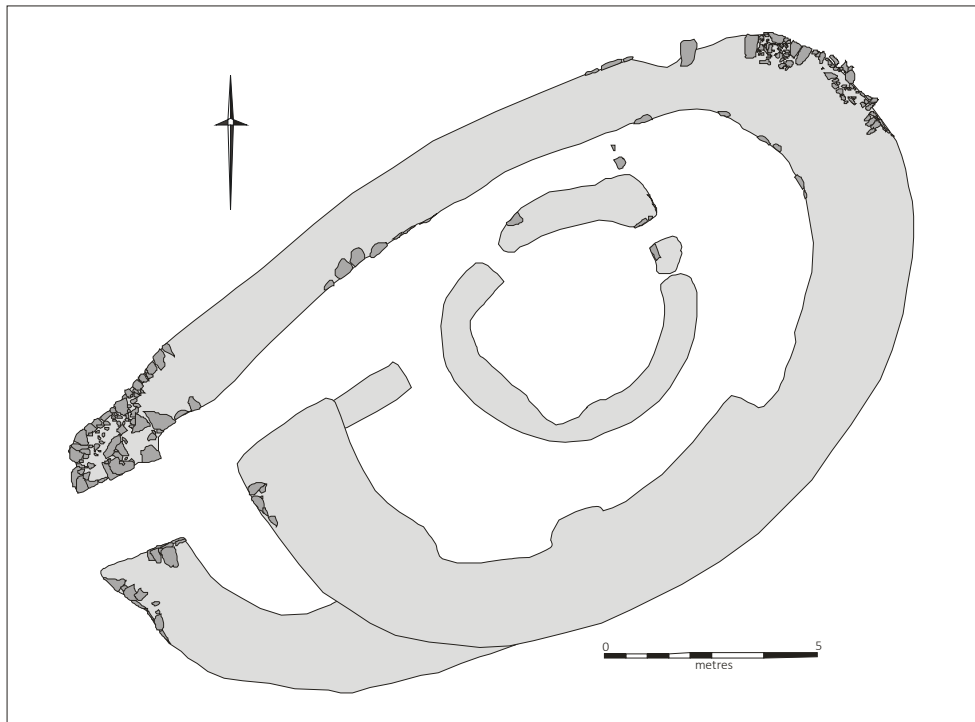
Figure 4: Plan of Dun Fhinn

debris covers the SE flank of the knoll in a scree-like spread. At the SW end there is a particularly heavy spread of jumbled stones, and while without excavation it is not possible to be sure, it seems most likely that, as indicated on the plan, the wall split into two sections; the inner section followed the margin of the summit to complete the dun wall, while the outer section branched down towards the foot of the knoll, through a drop of about 3m, to form a curving outwork. The entrance through the outwork is 2.7m in average width, and a short length of each of the side-walls of the passage is exposed. The entrance through the inner wall is obscured by debris. Within the interior there is a later intrusive enclosure formed by a wall 1m thick with an entrance facing NE' (RCAHMS 1984).

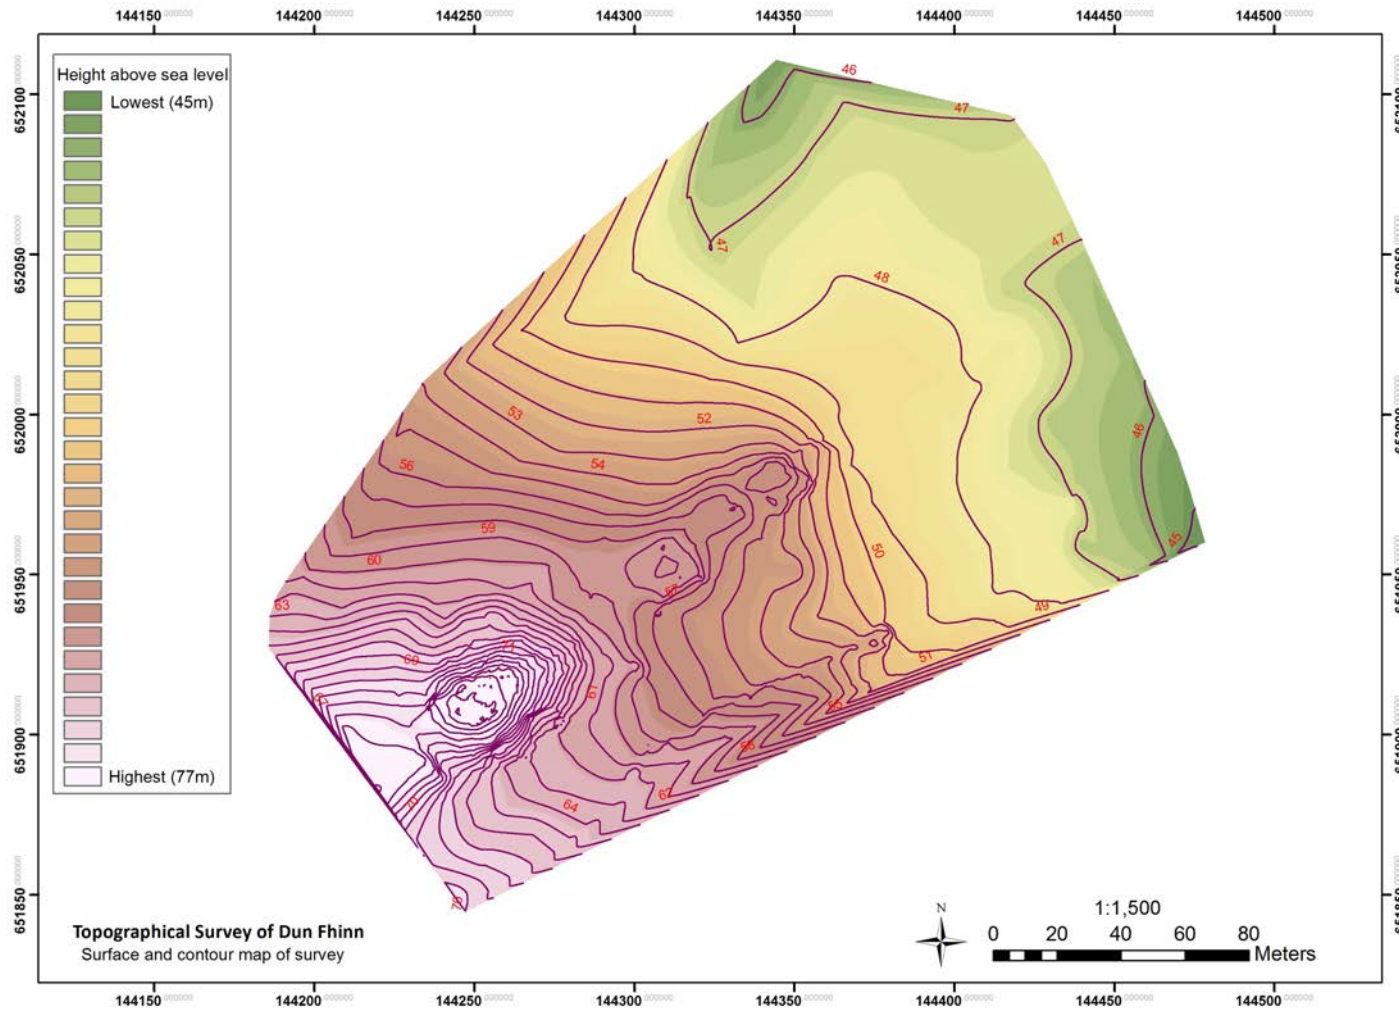
Figure 5: Topographical survey of Dun Fhinn and surrounding area

The topographic survey of Dun Fhinn was conducted using a Leica GS09/CS09 GNSS SmartNet system, which is able to record X, Y, and height (Z) location data to within 2cm accuracy. The system collects satellite data which is corrected in real-time, from a known base station on the mainland via an internet link. The survey took three days, over which 3000 data points were collected within the local landscape of the Dun. This included the survey of the Dun itself, and the surrounding landscape in which it sits. Over and close to the mound of the Dun itself, the spatial resolution of the survey is approximately 2m. The broader landscape survey was surveyed to approximately 10m resolution (Figure 5). A micro-topographical survey across the plateau of the Dun was also undertaken (Figures 6 & 7), with a survey resolution of approximately 0.5m, so that finer detail of the topography and upstanding archaeology within this area could be further understood. The data are downloaded into a GIS package where the data points were converted into surface layers (via a Natural Neighbour interpolation algorithm) and height contours. The data can also be imported and manipulated into a 3D workspace for further analysis and visualisation

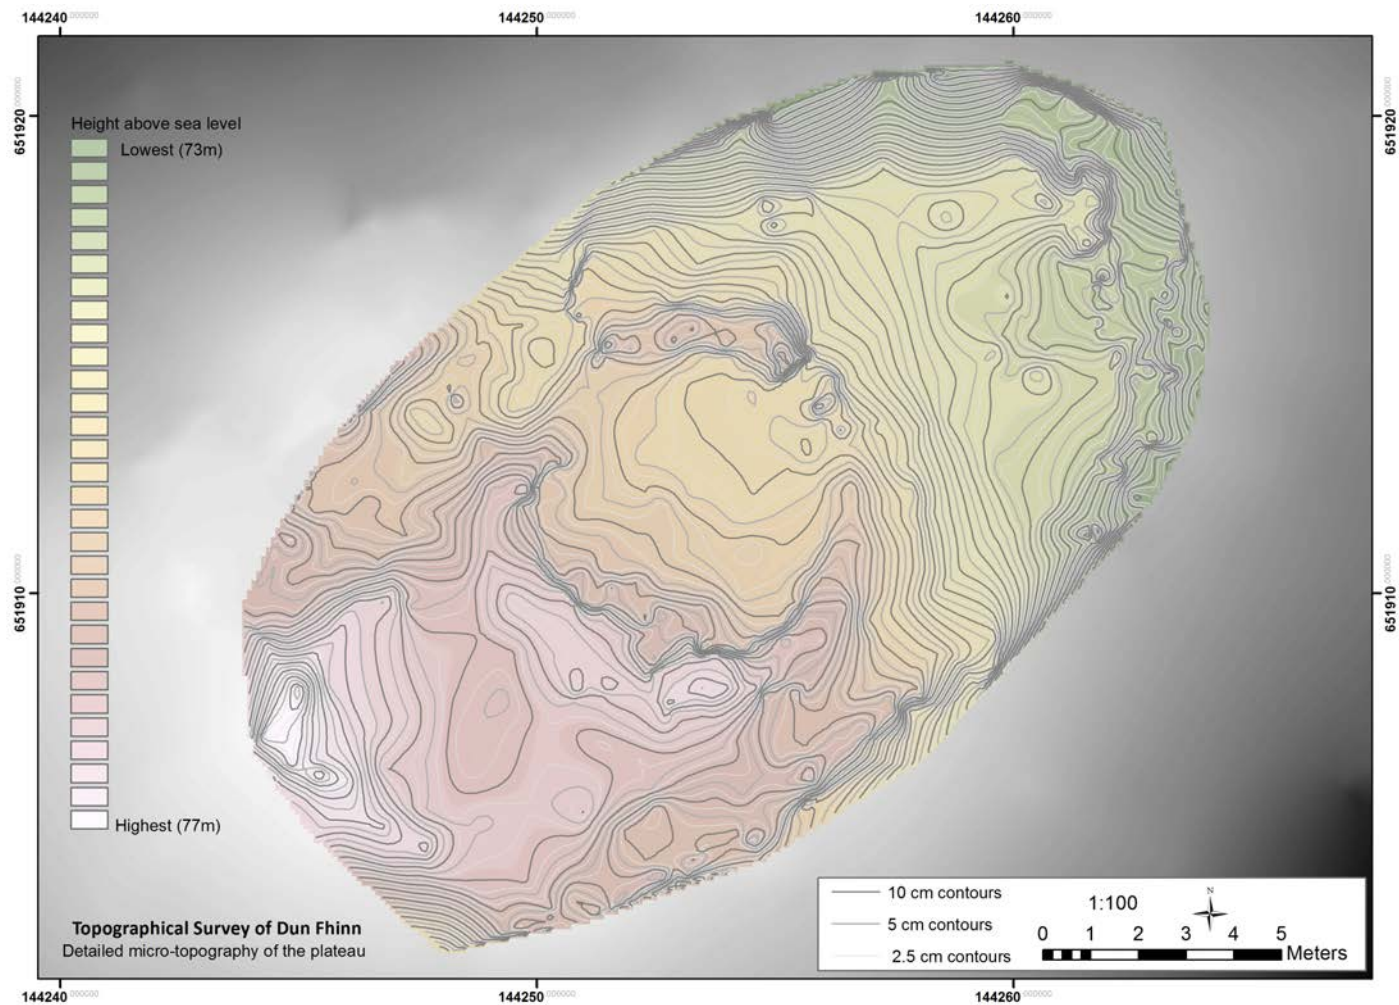
Figure 7: Micro-topography of the Dun plateau

The RCAHMS description still holds although there is possibly evidence of another wall or structure lying to the south of the enclosure and the inner dun wall. As postulated above the wall does indeed bifurcate forming an outwork at the entrance and some sections of facing can be traced of the upper dun wall although this has been much distorted by subsidence/collapse. The outer wall facing is most exposed on the SW and N/NW sides of the dun where it stands up to between 1.10m and 1.80m in height.

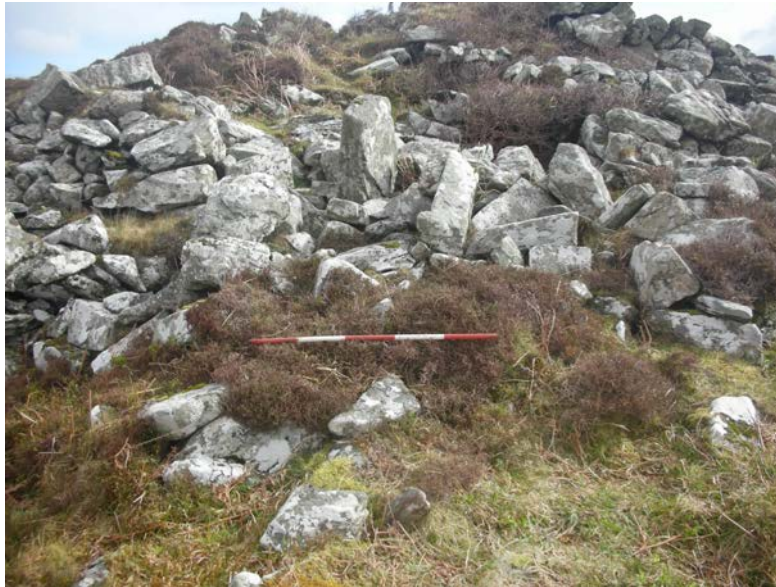
The rubble filled lower entrance through the dun outwork

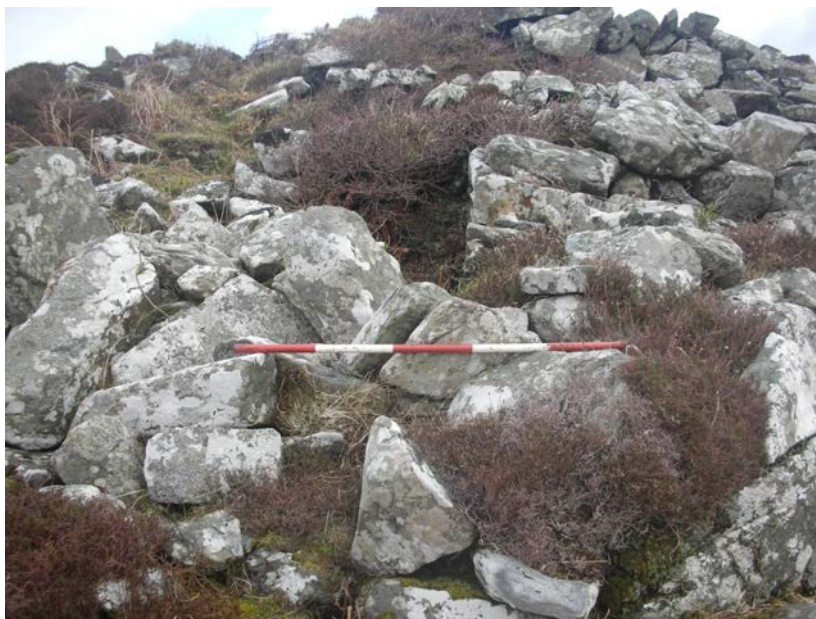
The eastern side of the entrance

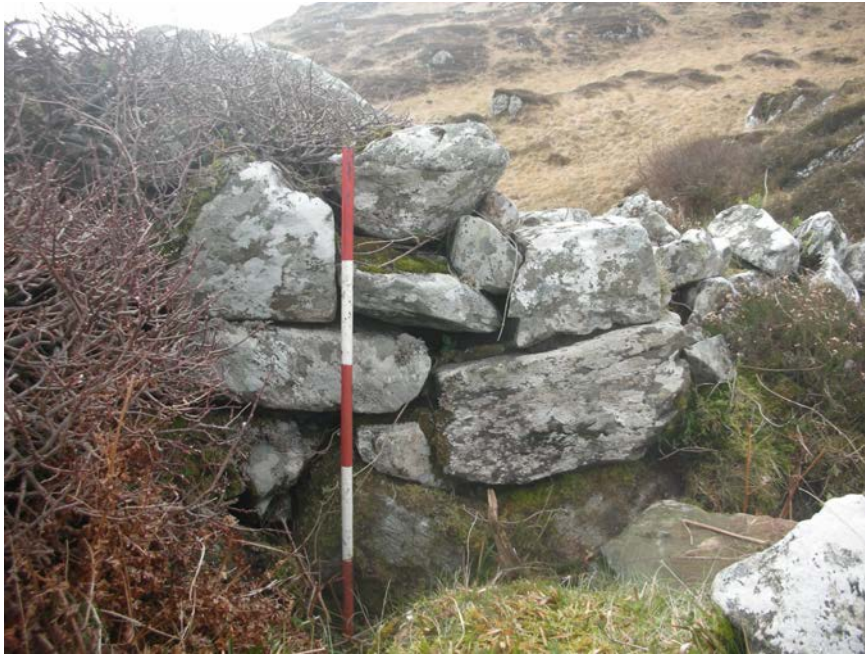
Facing stones of the eastern side of the entrance

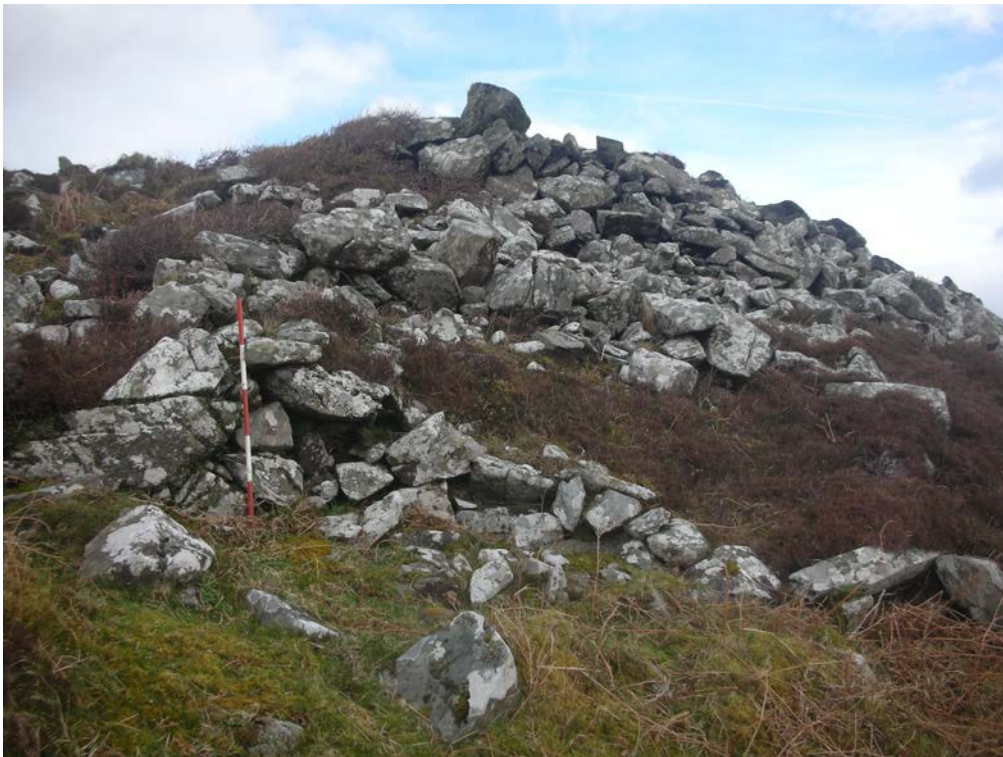
The lower out-work facing stones with the distorted facing stones of the dun wall above

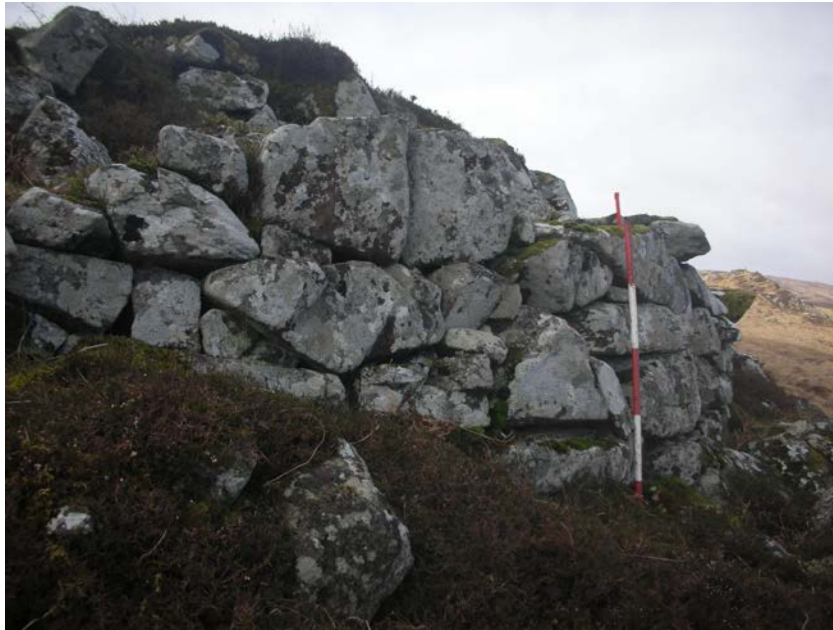
The facing stones on the NW side of the dun

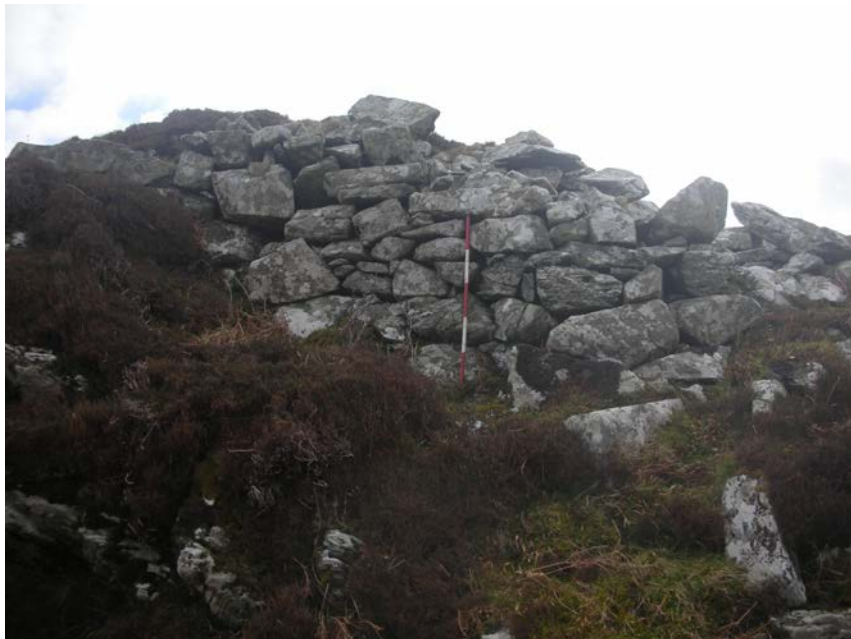
The facing stones on the SW side of the dun

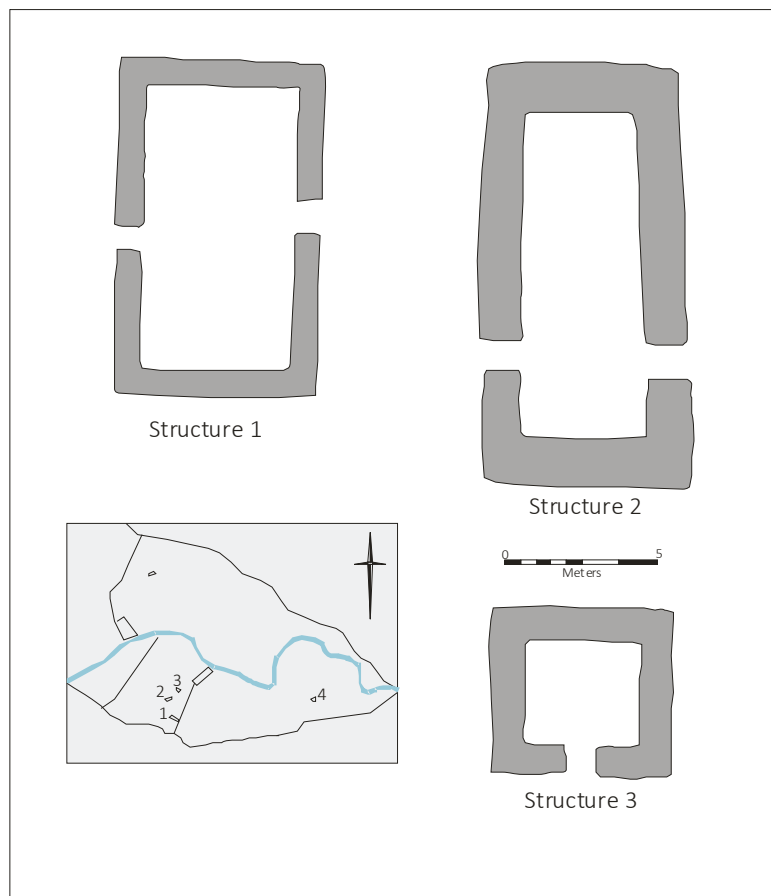
Figure 11: Staoin Structures

The area south of the river was bounded by a turf and earthen dyke with some internal divisions. Most of the ear enclosed within the surrounding dyke shows signs of extensive rig and furrow cultivation. The remains of 5 structures were recorded (Structures 1-5) along with three rectilinear enclosures.

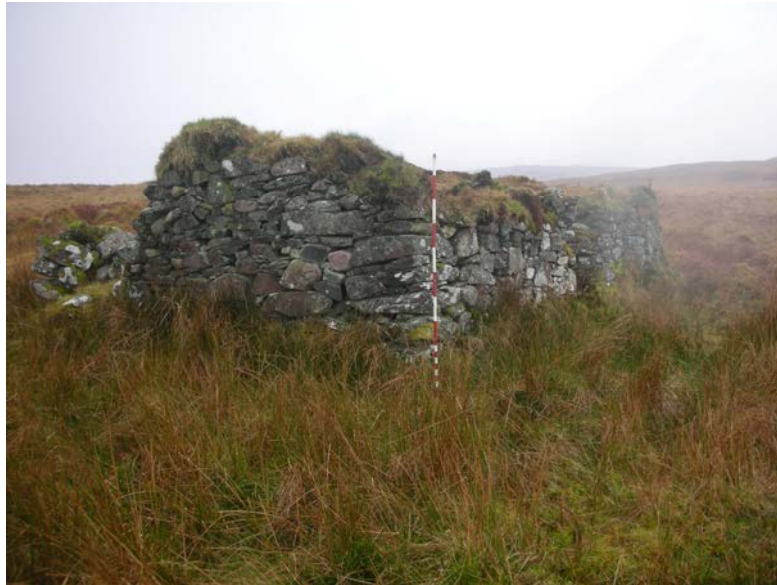
Staoin, Structure 1

Rectangular rubble built structure oriented NS and measuring 10.80m long and 6.6m wide externally. The walls in part stand to probable full height up to 2.1m. The building has two opposed entrances although the one on the side has been blocked. There is evidence of clay and sand mortar/packing within the walls.

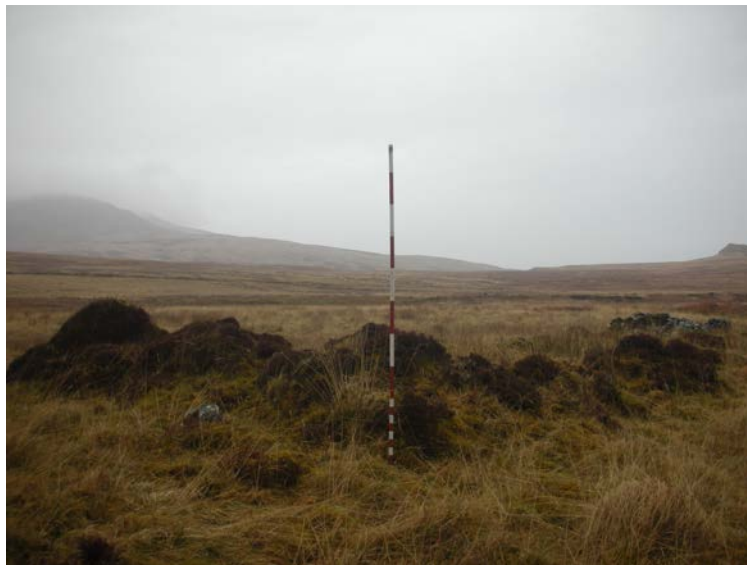
Staoin, Structure 2

Rectangular rubble built structure oriented EW and measuring 13.8m long and 7m wide externally. The denuded/robbed walls stand up to 0.60m in height. The building has two opposing entrances within the W end of the structure.

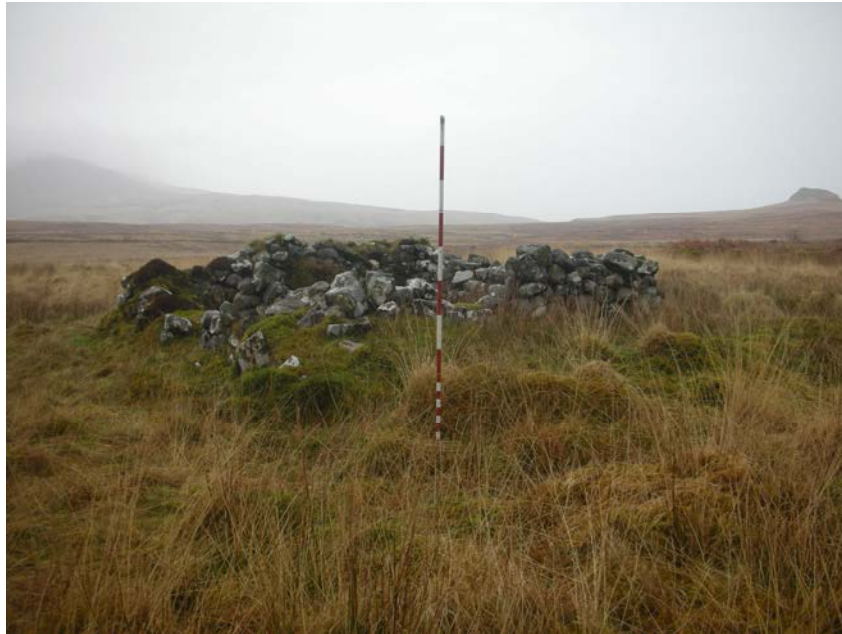
Stain, Structure 3

Rectangular rubble built structure oriented NW/SE measuring 6.0m long and 5.40m wide externally. The walls stand up to 1.50m in height. The building has an entrance on the SE side. The building appears to have been shortened as footings of what may be an earlier version of the building extend 2m to the NW.

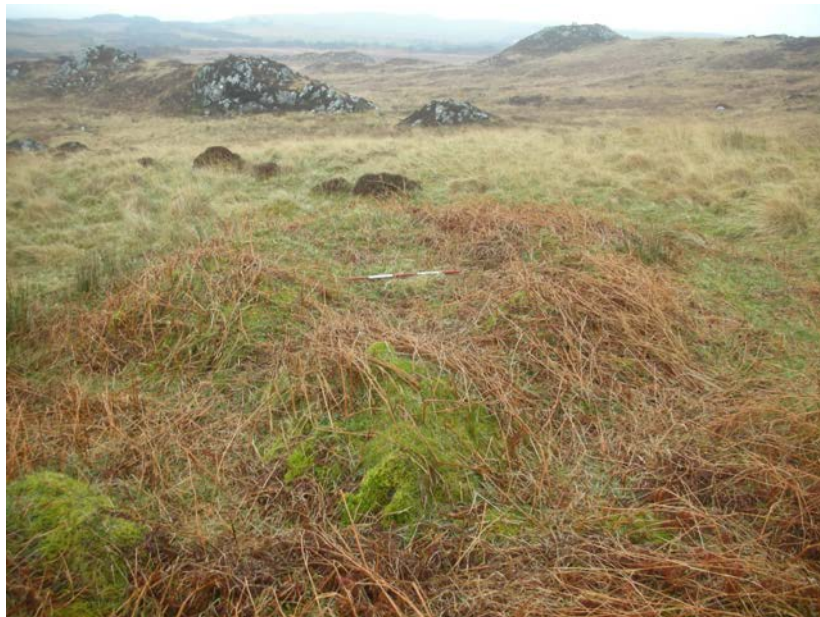
Stain, Structure 4

Spread of rubble representing remains of oval? structure oriented NW/SE measuring c8.30m by 6.10m.

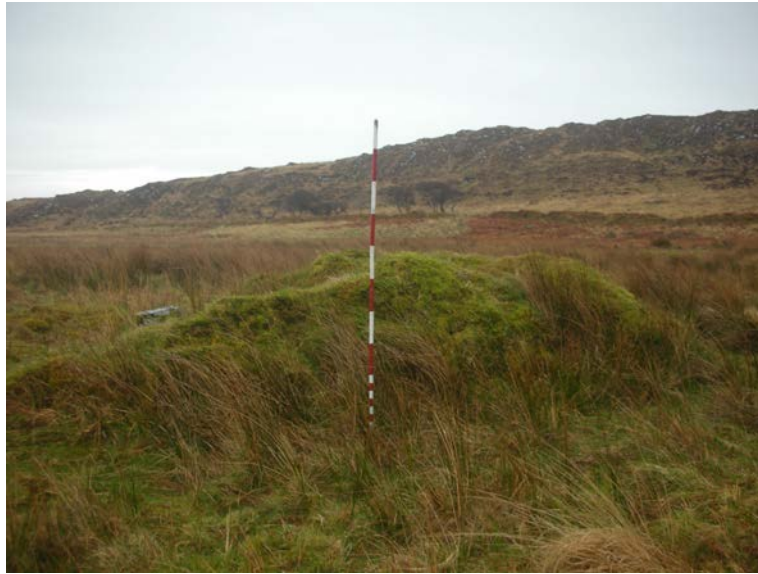
Staoin, Kiln

Overall the structure measures 7m by 5m but the main oval kiln measures 5m by 4m standing up to 1.30m in height with a flue entrance on the E side. Footings of a sub-square structure or earlier kiln extend to the W and contain a smaller sub square arrangement of stones.

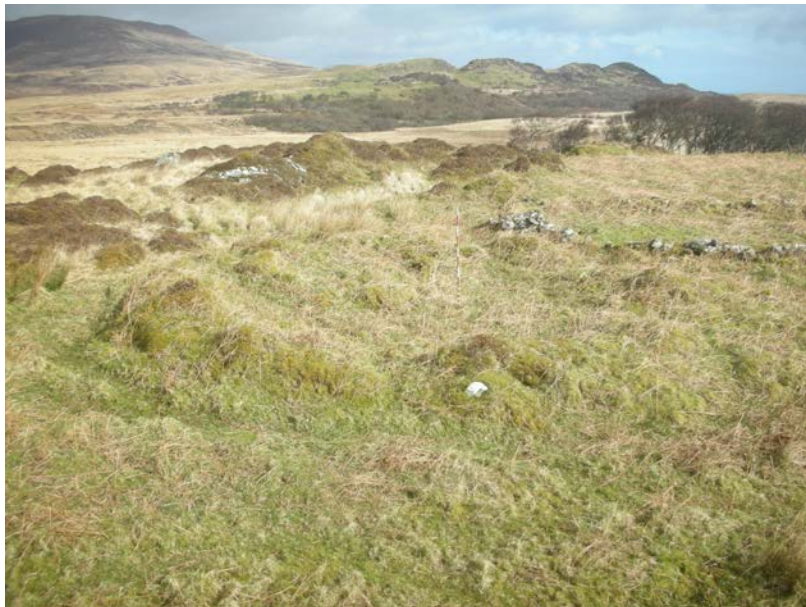
Site 14, Structure 1

Sub circular enclosure or structure measuring 12m by 11m externally with turf covered walls standing up to 0.6m high. The walls appear eroded and vary in width although 1.0m appears to be the most consistent. A gap on the SE east side suggests an entrance.

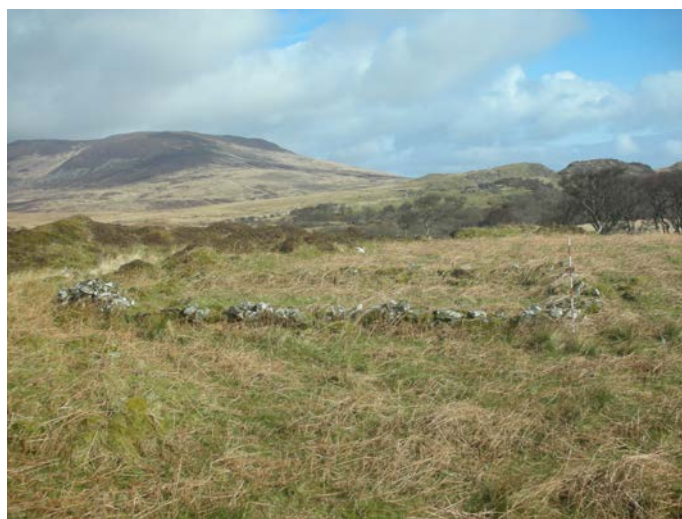
Site 14, Structure 2

Sub rectangular enclosure measuring 13m by 8.4m externally with walls generally 0.8m wide and standing up to 0.9m high with an entrance gap on its W side, although this may be due to robbing to construct a small twinning pen at the SW.

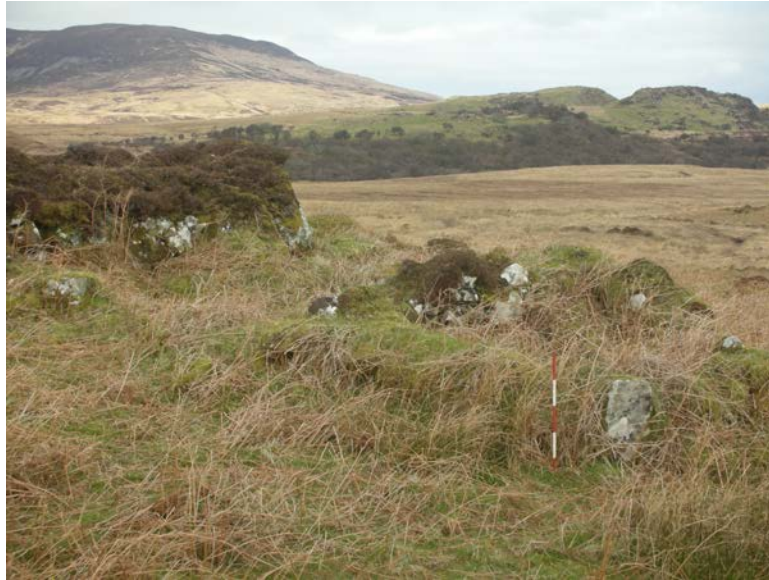
Site 14, Structure 3

Rectangular building constructed against a natural scarp which forms its NW side. The structure measures 9.8m by 4m externally with walls up to 1.2m wide and standing up to 1.8m. The building is divided into two parts by a cross wall with entrance gaps in the SW and SE sides.

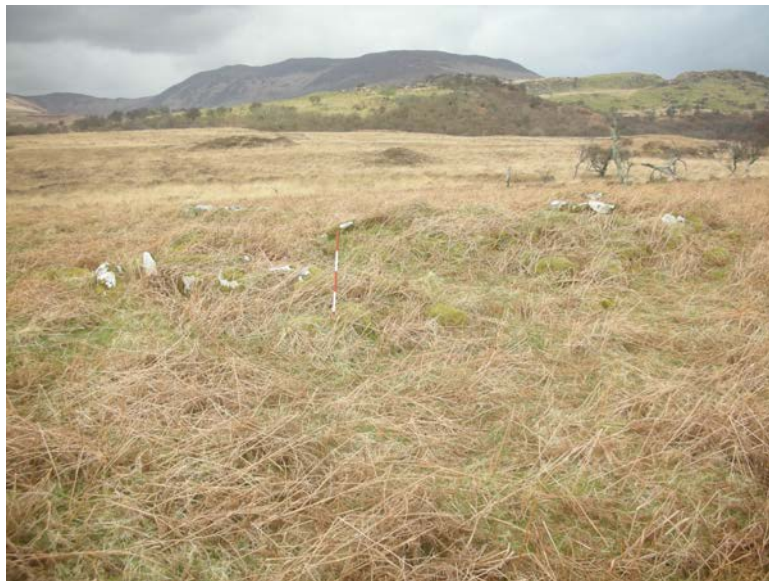
Site 15, Structure 1

Lying to the north east of Site 13 and on the same geological ridge was another small settlement, which has previously been described in Canmore (Appendix 2, Site 29) and consisted of two structures and what is likely an associated well structure these all lying within an enclosed area.

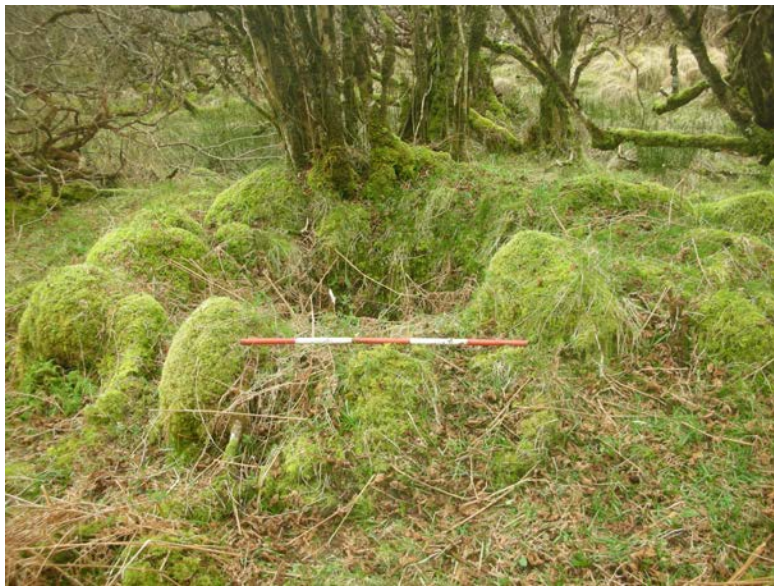
Site 15, Well

Circular stone lined well structure measuring 2m by 2m externally with walls standing up to 1.60m.

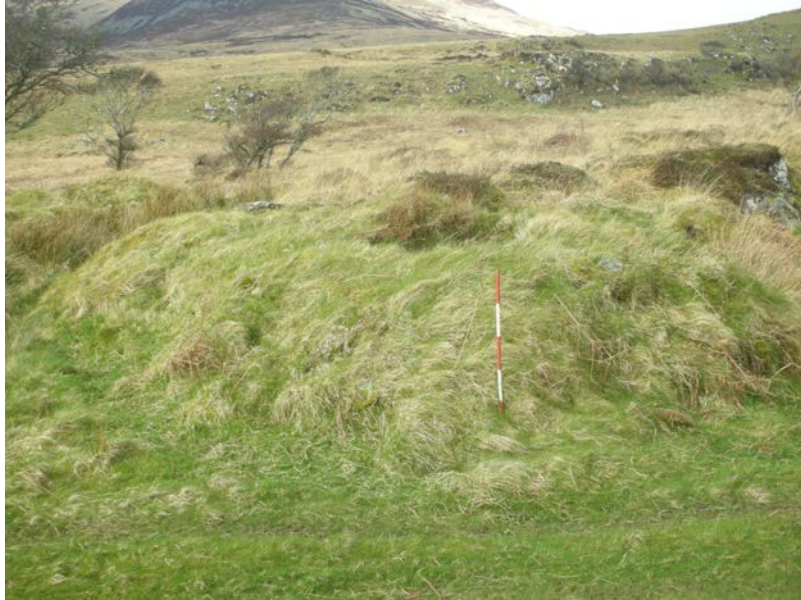
Site 16, Structure 1

Possible recessed platform or small enclosure with turf and stone walls sides. Measures 7m by 6m internally with walls standing up to 0.4m in height.

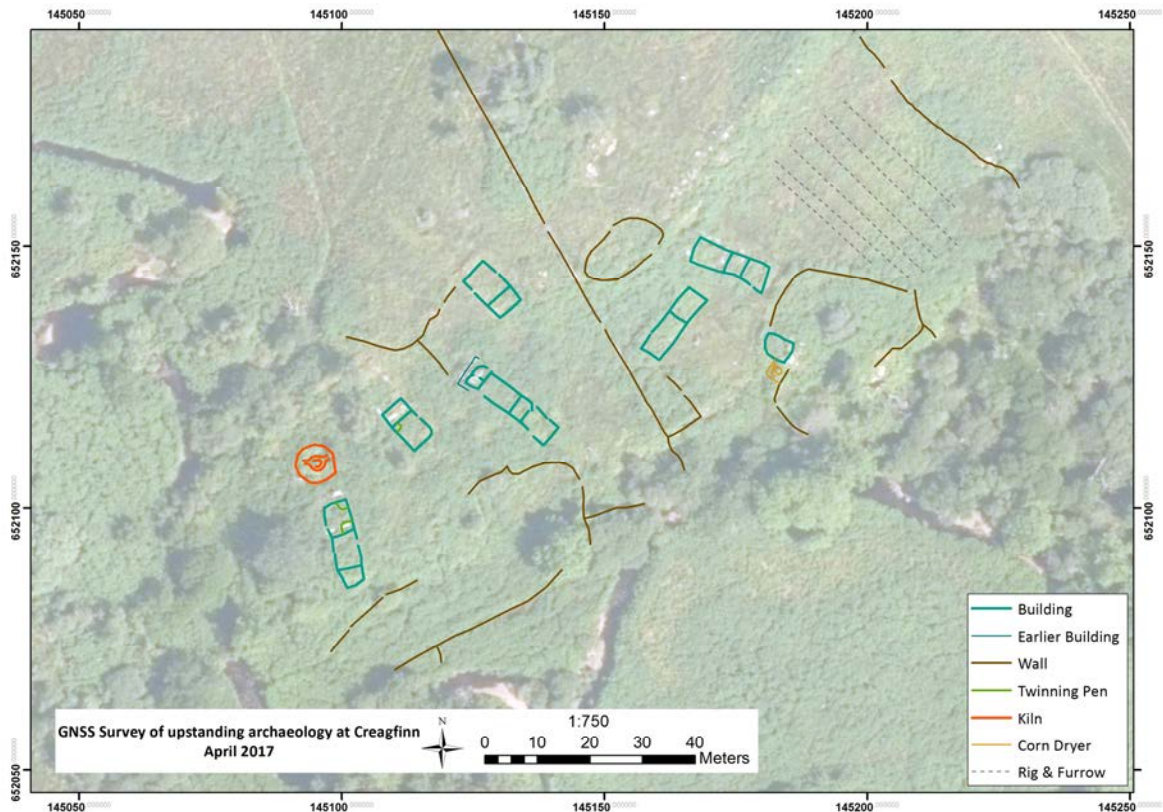
Figure 15: Survey of upstanding structures at Craighinn

A GNSS survey of the upstanding archaeology at Craighinn was undertaken over a single day (Figure 15). This was conducted using a Leica GS09/CS09 GNSS SmartNet system, which is able to record X, Y, and height (Z) location data to within 2cm accuracy. Where archaeological remains were identified, they were logged within the GNSS system and subsequently plotted within a GIS system to complement the hand-drawn archaeological record of this site.

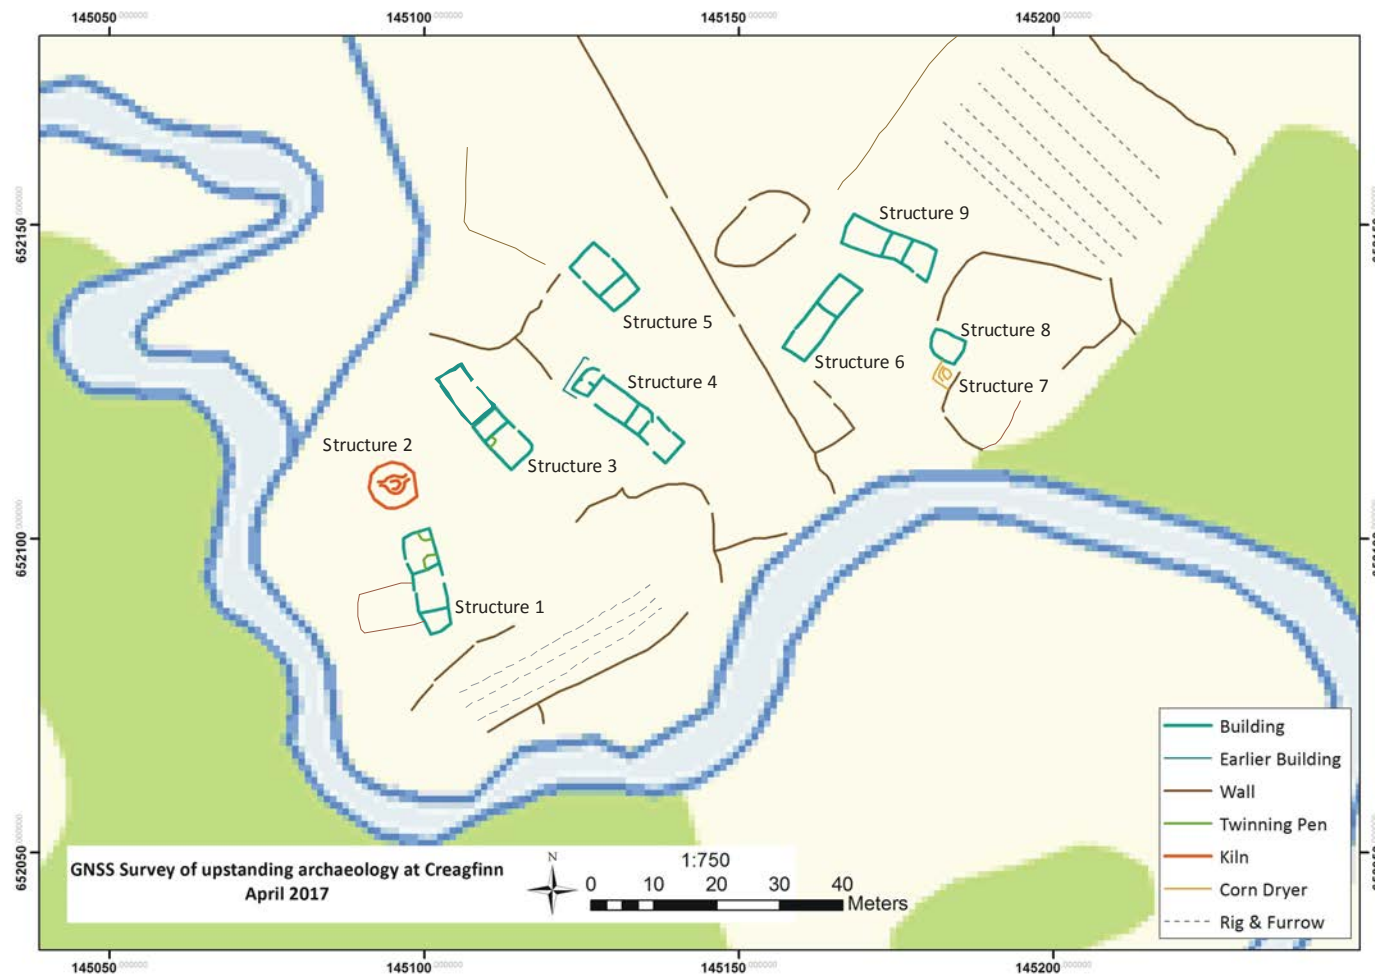
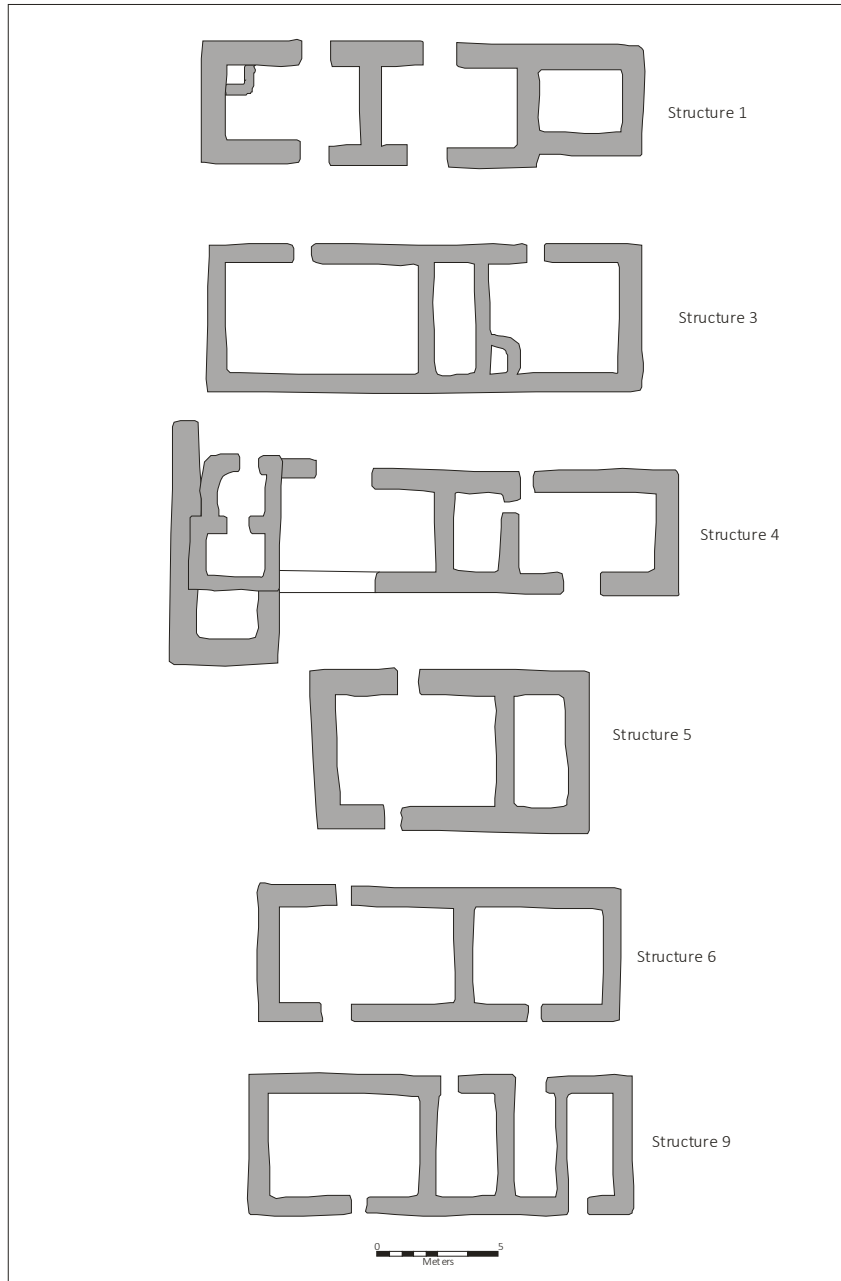
Figure 16: Creagfinn

The settlement consists of 6 rectangular buildings (Figures 16 and 17, Structures 1, 3, 4, 5 and 9) and a seventh irregular building (Structure 8) along with two kilns (Structures 2 and 7). These are situated on a bend in the Kintour River and surrounded by a series of enclosures some of which contain evidence of rig and furrow cultivation. Structure 9 is depicted as roofed on the 1<sup>st</sup> Edition Ordnance Survey map suggesting this was the last occupied structure in the settlement.

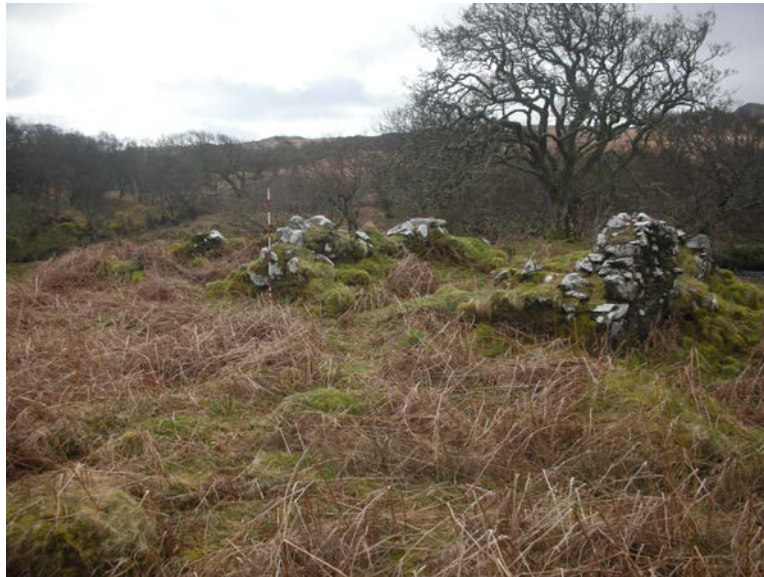
Creagfinn, Structure 1

Rectangular NW/SE oriented rubble built structure and measures 18m long and 6m wide externally with walls 0.60m wide and standing up to 1.7m in height. The building is divided into three parts with opposing entrances in the two northern most divisions. Traces of an attached enclosed area 10m wide lies on the western side of the structure. Two twinning pens have been constructed within the northern room. The northern wall is best preserved and suggests a gable ended building.

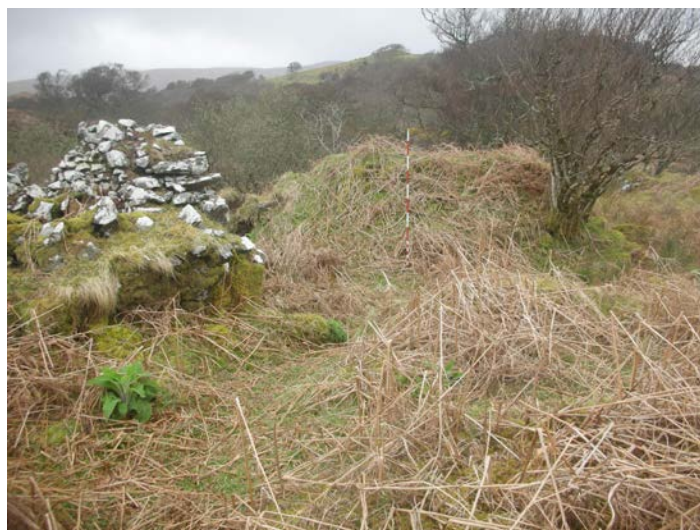
Creagfinn, Structure 2, Kiln lying NE of Structure 1

This kiln structure is sub circular in shape measuring 5.5 by 5m and stands to a height up to 2.40m above present ground level. The walls measured up to 1.40m thick around a central chamber, which was likely accessed on the SW side.

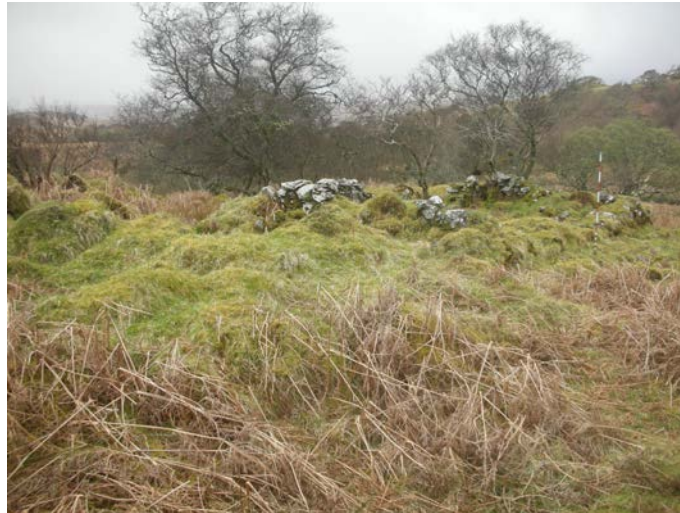
Creagfinn, Structure 3

Rectangular NW/SE oriented rubble built structure measuring long 17.7m in length by and 6m wide externally with walls 0.70m wide standing in 0.70m in height. The building is divide into three parts with two entrances on the NE side. A twinning pen has been constructed in the corner of the southern room.

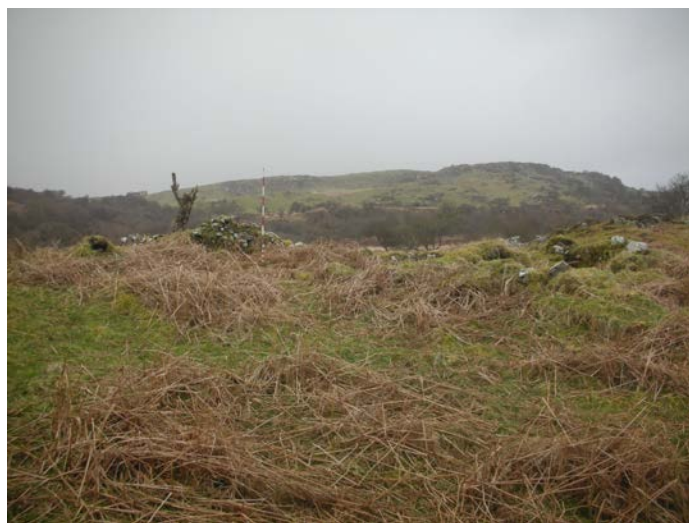
Creagfinn, Structure 4

This building in its original form may have been T shaped. At the W end are the footings of a SW/NE oriented rectangular building measuring 9.8m by 5.20m externally with walls standing 0.50m high. Over this has been built a smaller structure measuring 5.4m by 3.30m externally with walls up to 1.50m in height. This smaller structure is divided two parts or rooms the northern most with a distinctly curving N wall. To the SE of these is what was likely an attached rectangular range which is oriented NW/SE measuring 16m long by 6.1m wide externally and divided into three parts.

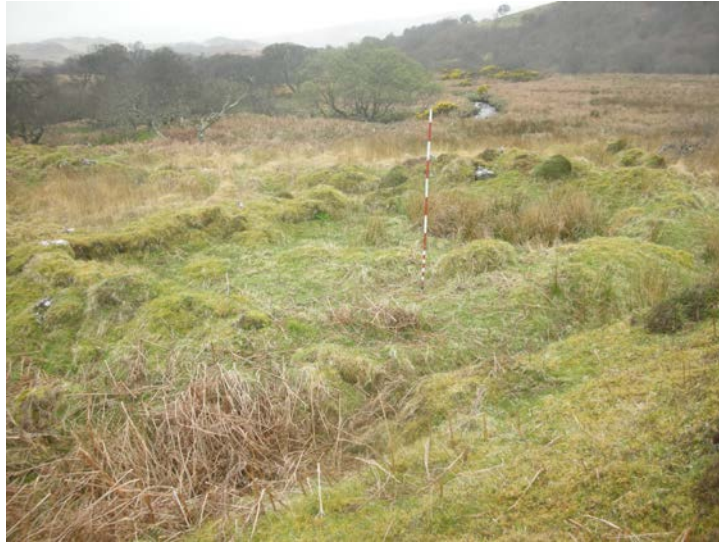
Creagfinn, Structure 5

Rectangular NW/SE oriented rubble built structure measuring long 11.30 long by 6.50m wide with walls 0.70m wide and standing up to 0.80m in height. The building is divided into two parts with opposed entrances in the northern room.

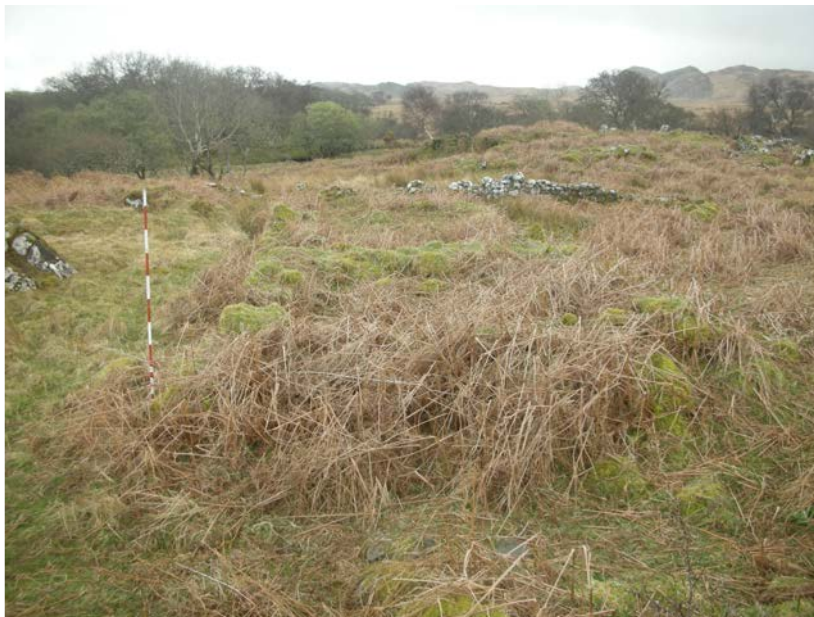
Creagfinn, Structure 6

Rectangular SW/NE oriented rubble built structure measuring 15m long and wide 5.50m wide with walls 0.70m wide and standing in up to 0.60m height. The building is divided into two parts with opposing entrances in the southern room and a single entrance in the SE wall of the northern room.

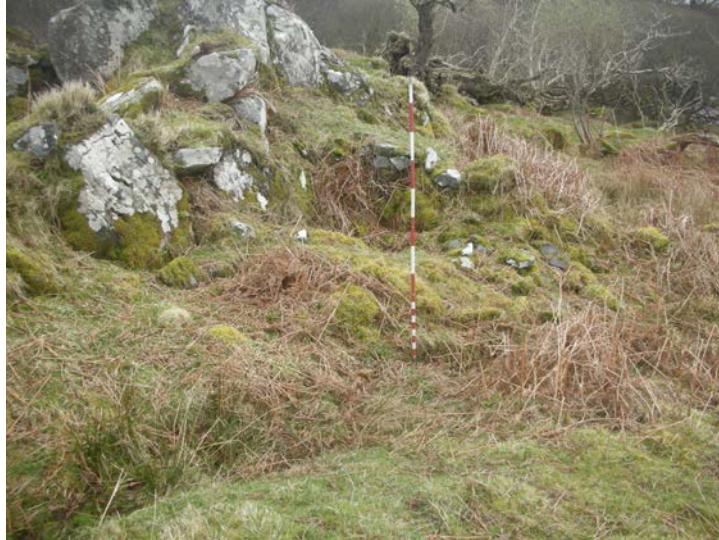
Creagfinn, Structure 7

This kiln structure was constructed against a natural scarp at the north and a enclosure wall on the east. The structure measured 4.0m by 2.70m with walls measuring 0.80m wide and standing up to 1.00m high.

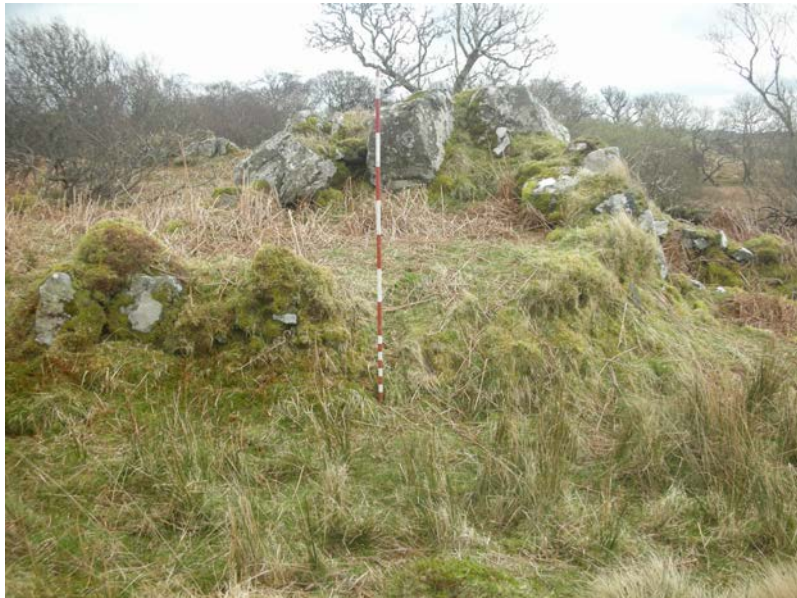
Creagfinn, Structure 8

This could be the remains of an irregular structure or a small enclosure measuring 10m by 8m with walls 0.60m wide and standing up to 0.45m high.

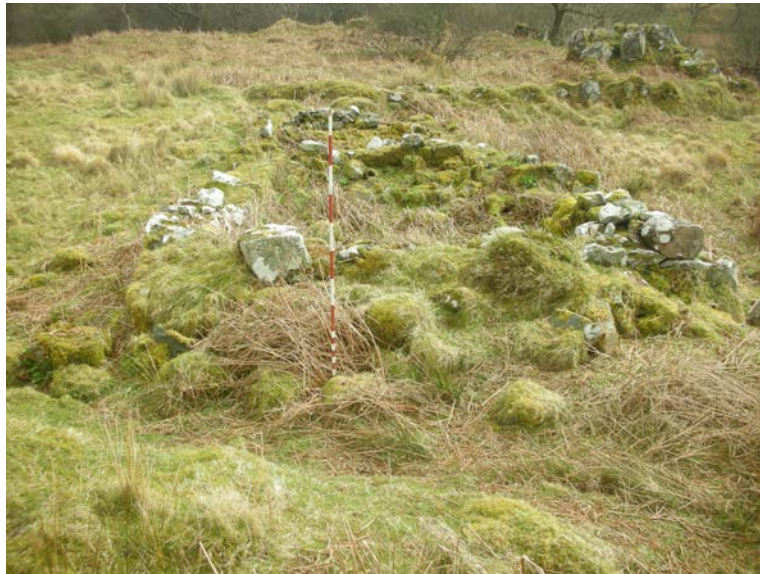
Creagfinn, Structure 9

Rectangular NW/SE oriented rubble built structure measuring 15.60m long and 5.80m wide externally with walls 0.80m wide and standing up to 1.15m in height. The building is divided into three parts (although what may be the remains of a later wall suggest a fourth division). Two entrances on the south side of the building give access to the eastern and western rooms, while a now blocked entrance on the north side gives access to the central room or bay.

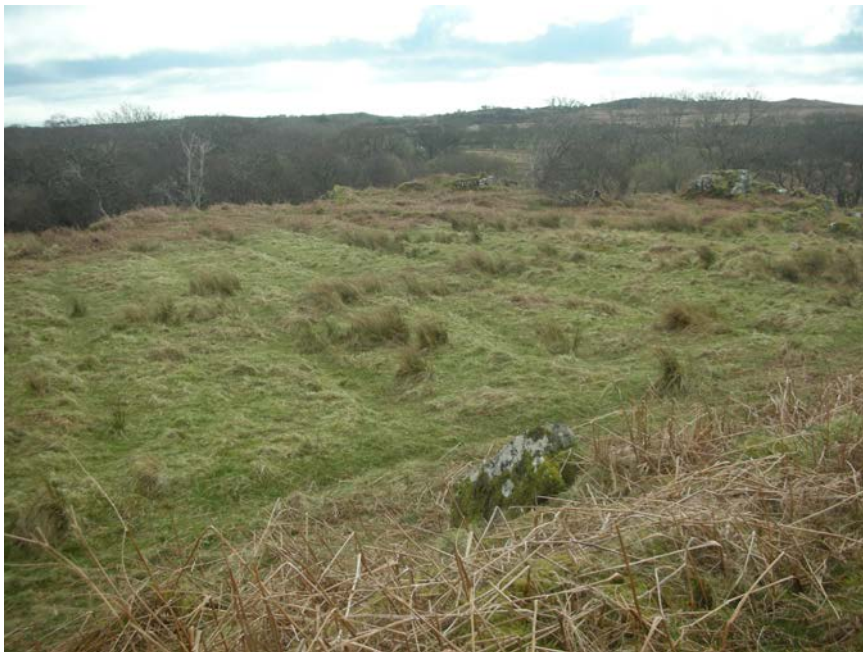
Rig and furrow cultivation at Creagfinn
