**DUN FHINN  
KILDALTON, ISLAY  
AN ARCHAEOLOGICAL SURVEY**

**DATA STRUCTURE REPORT  
May 2017  
Roderick Regan**

## 1. Introduction

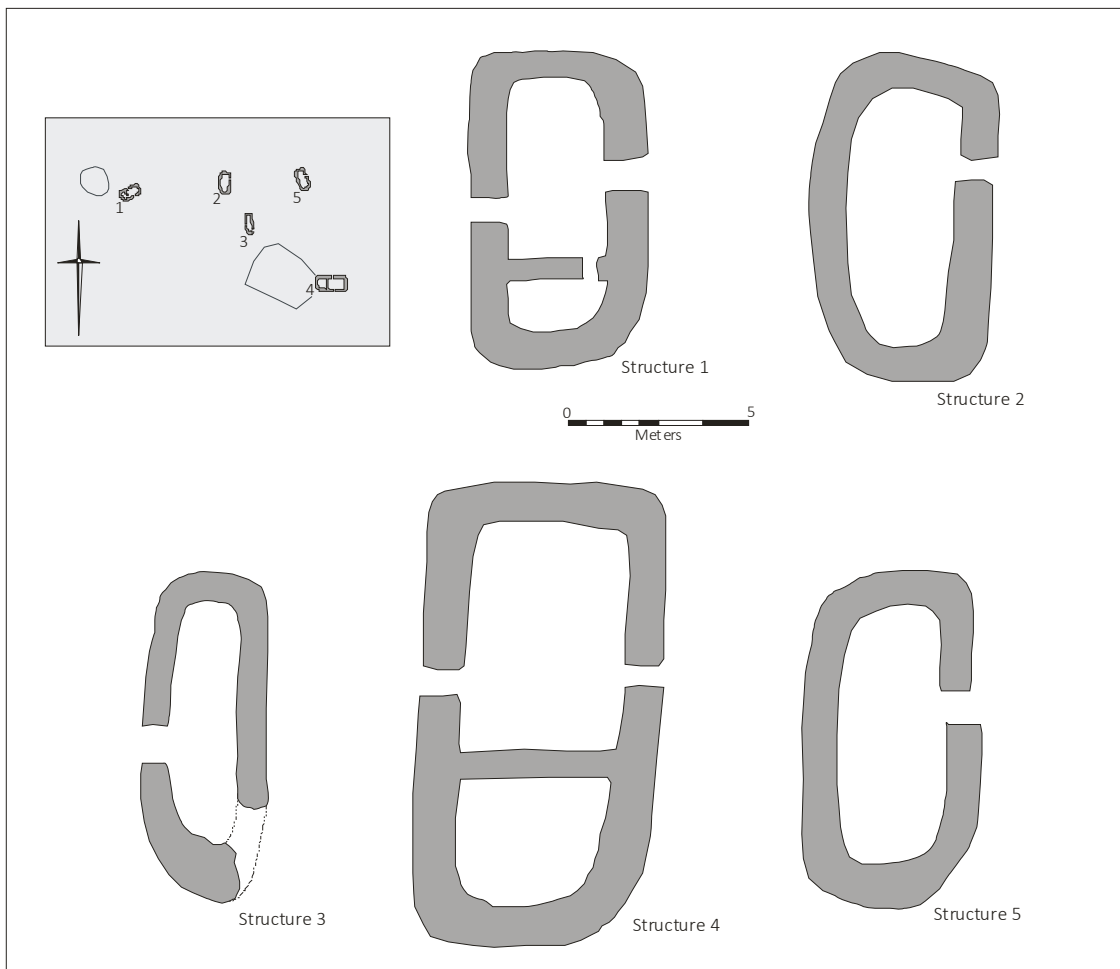
Figure 18: Ballore Structures

Located east of Creagfinn and located on the next prominent rise were the remains of Ballore, which had previously been described in Canmore (Appendix 2, Site 21). The settlement consisted of five definite structures (and 1 possible) along with two enclosures.

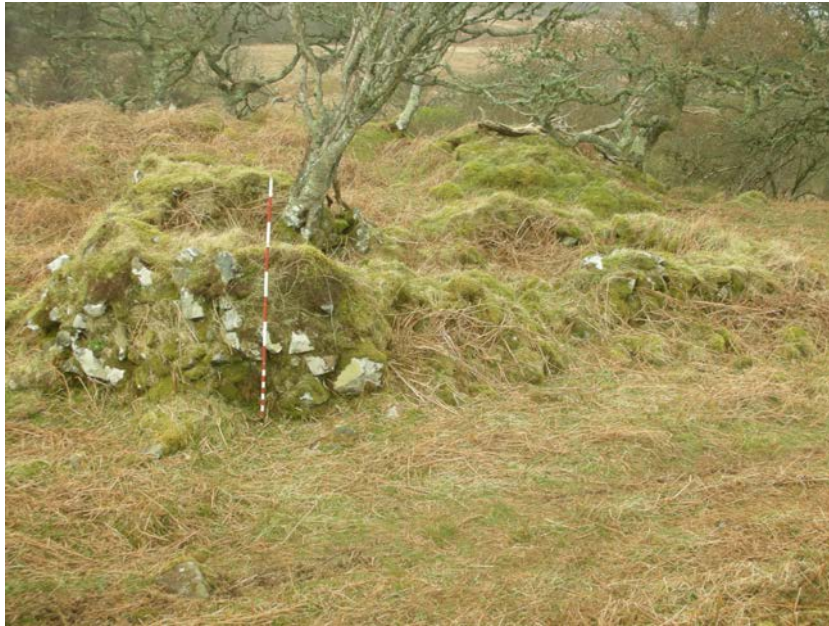
Ballore, Structure 1

Oval E/W oriented rubble built structure with rounded ends measuring 7.80m long by 4.9m wide externally with walls standing up to 1.70m in height. The building has two entrances on either long side and is divided into two parts.

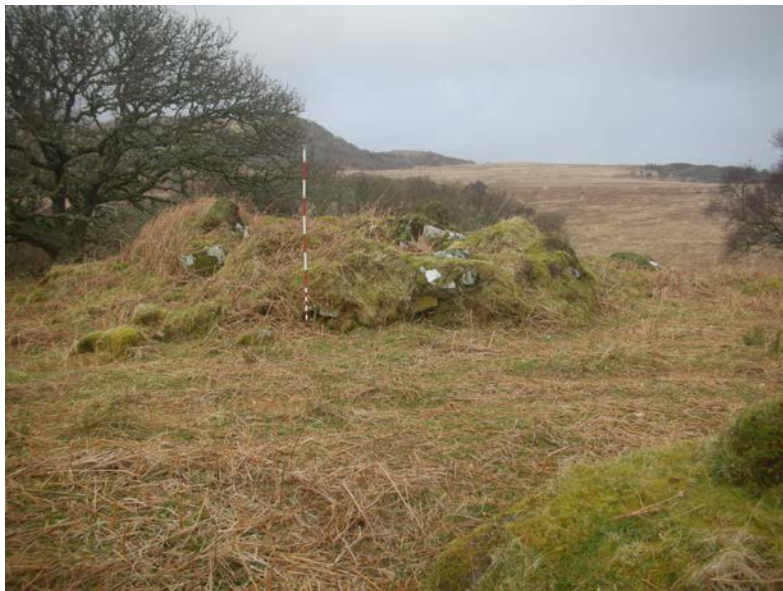
Ballore, Structure 2

Oval SW/NE oriented rubble built structure with rounded ends measuring 8.70m long by 5.0m wide externally with walls standing up to 1.60m in height. The building has an entrance on the SE side.

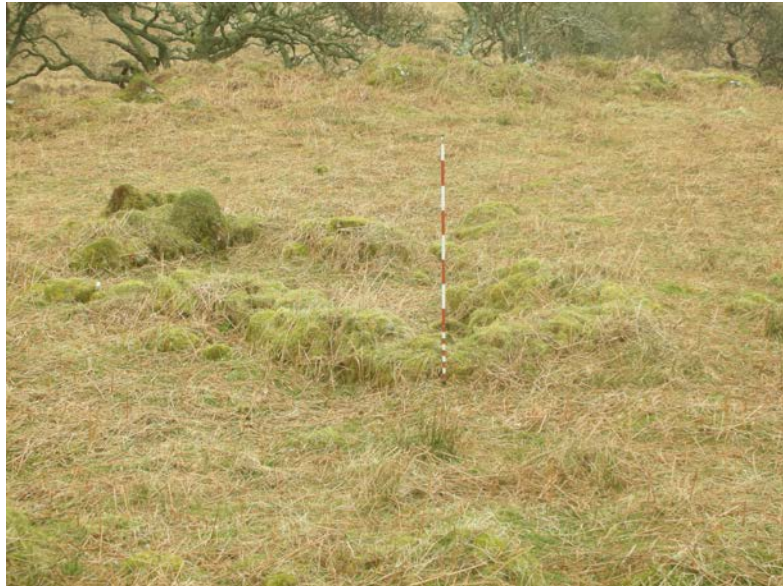
Ballore, Structure 3

Badly disturbed remains of an oval SW/NE oriented rubble built structure with rounded ends measuring 9.5m long and 3.20m wide externally with walls standing 0.60m in height. The building is with an entrance on the SE side.

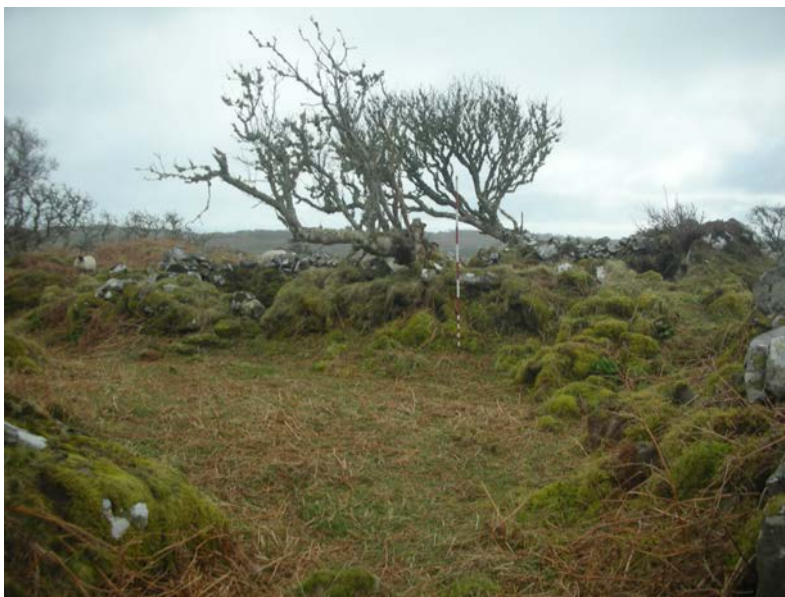
Ballore, Structure 4

Oval E/W oriented rubble built structure with rounded ends measuring 12.4m long and 6.7m wide externally with walls standing up to 1.90m in height. The building divided into two parts by a later? cross-wall and has opposed entrances on the long sides.

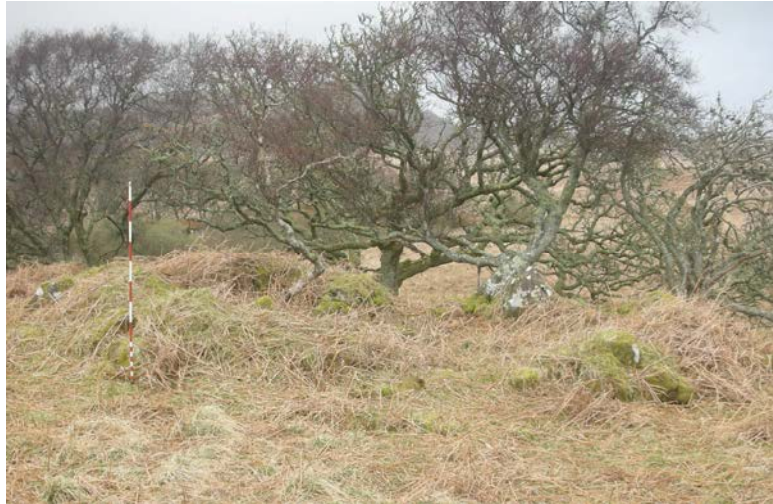
Ballore, Structure 5

Oval SW/NE oriented rubble built structure with rounded ends measuring 9.0m long by 5.0m wide externally with walls standing up to 1.10m in height. The building has an entrance on the SE side.

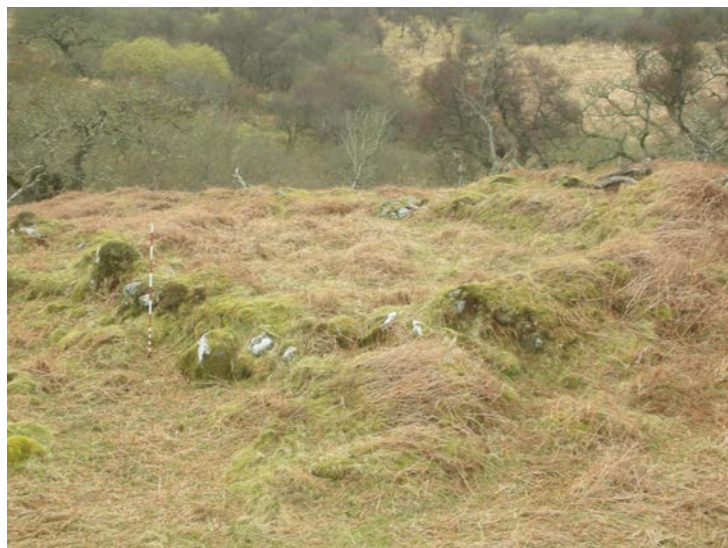
Ballore, Enclosure 1

Oval turf and stone enclosure measuring 10.5m by 8.4m externally within walls up to 1.1m wide and standing to a height of 0.8m

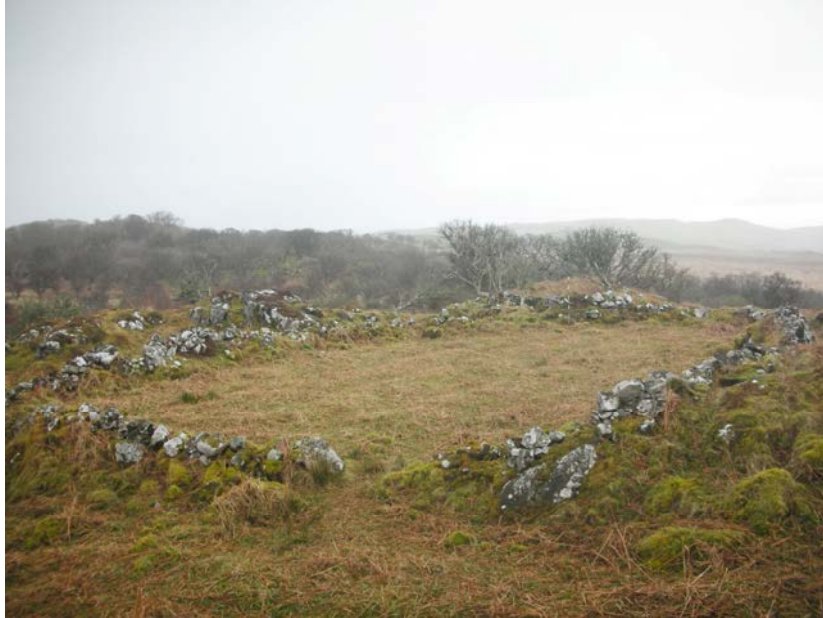
Ballore, Enclosure 2

Irregularly shaped stone and turf enclosure attached to the end of Structure 4 with evidence of internal rig and furrow cultivation.

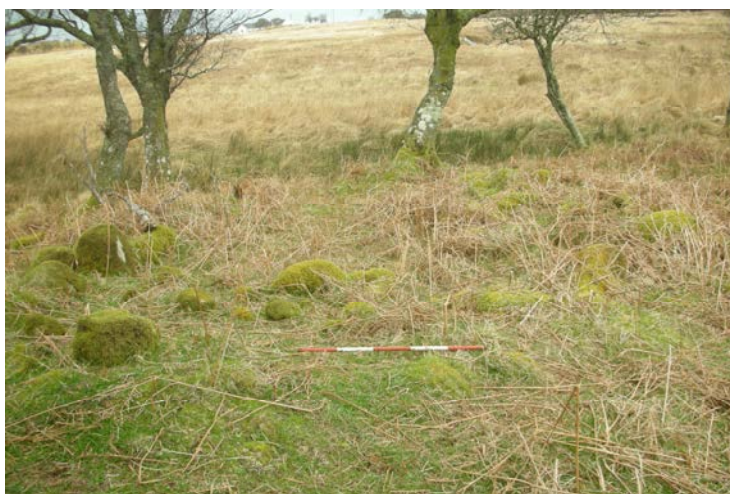
Site 19, Structure

Very dilapidated footings of an oval structure, measuring c7-8m by 6m externally. The possible structure sits within an area of improved ground.

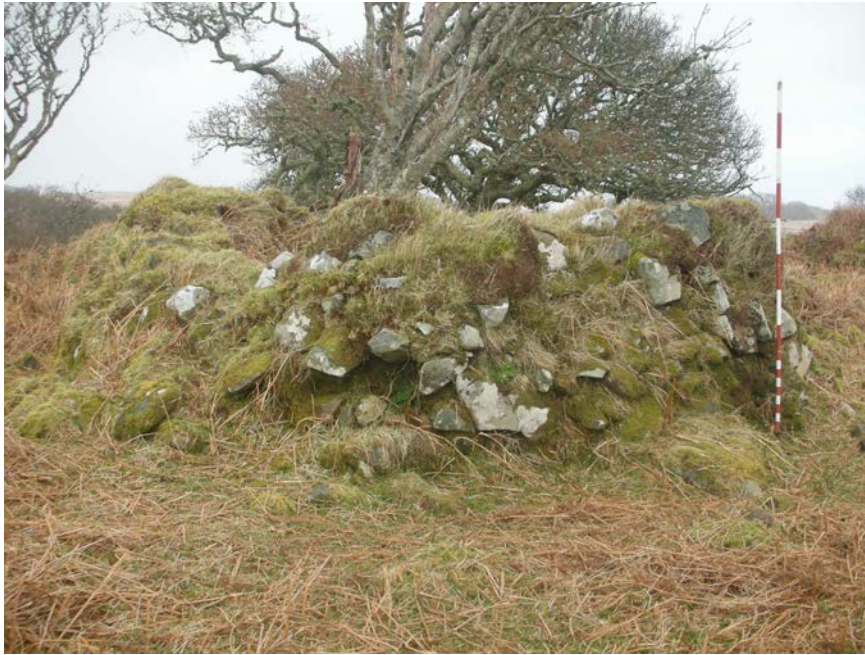
Well preserved round-ended structure at Ballore
