THE HIGH MORLAGGAN PROJECT EXCAVATION DATA STRUCTURE REPORT

February 2010

Roderick Regan

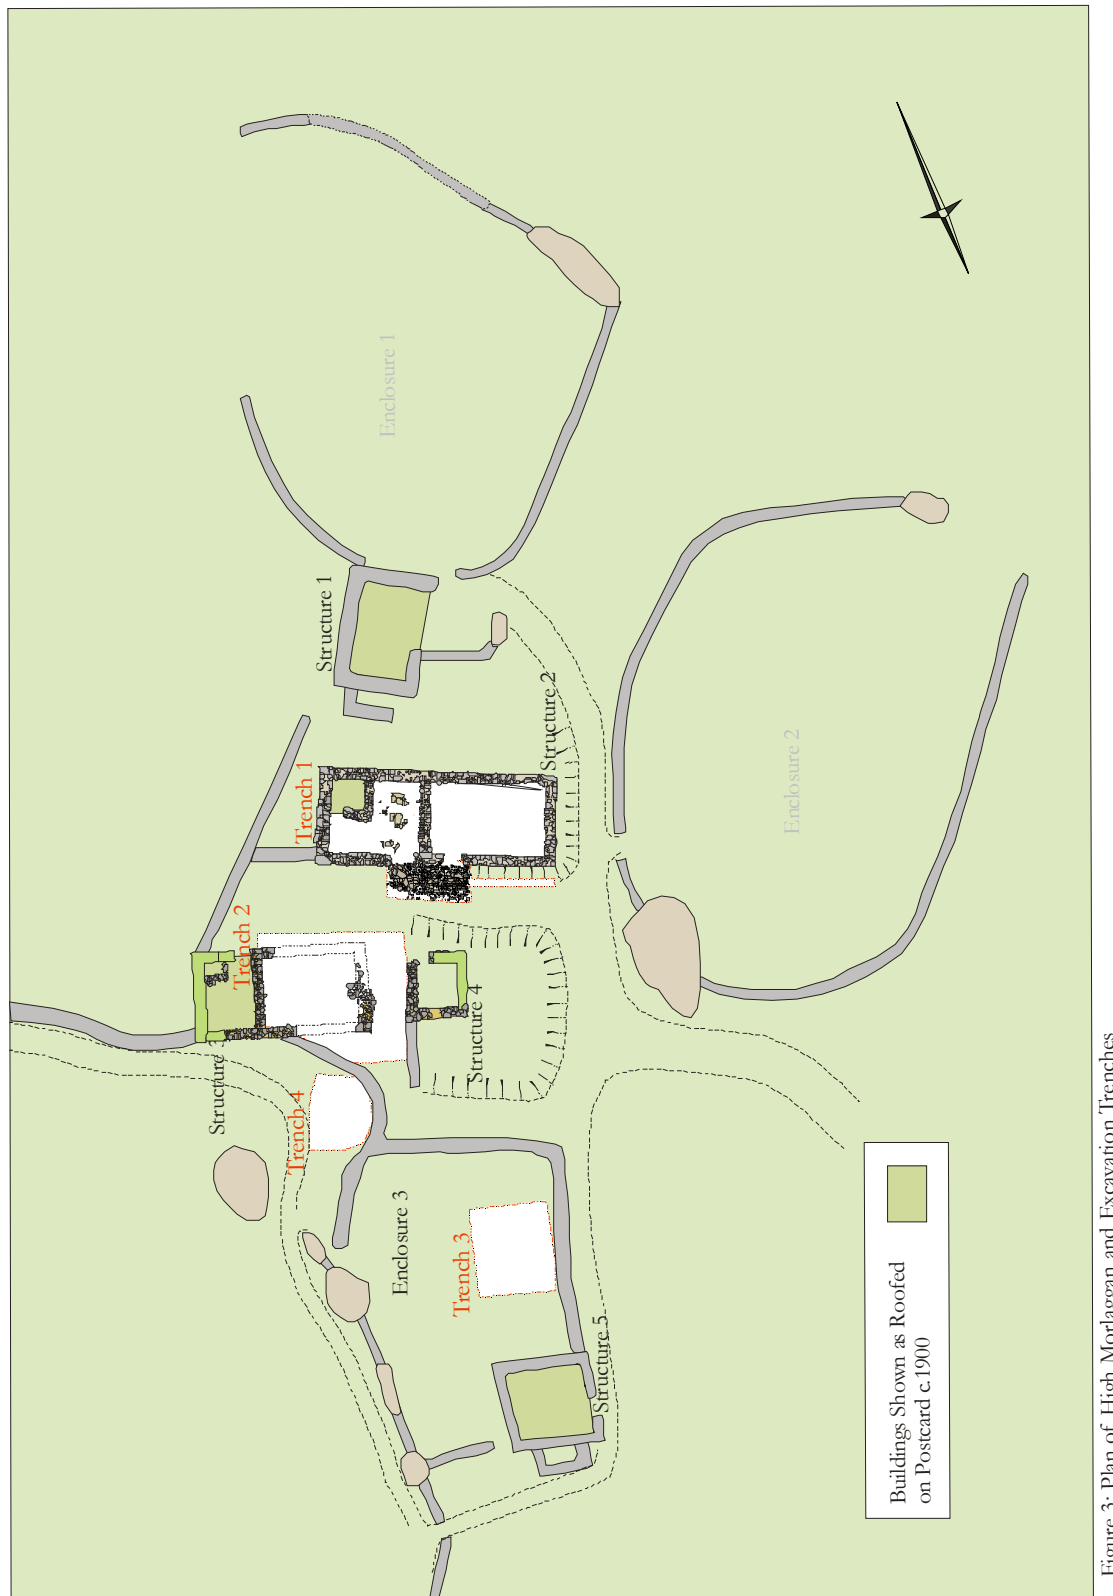
Figure 3: Plan of High Morlaggan and Excavation Trenches

The excavation took place over two weeks in November 2009 and the site code used was MOR 09. The weather conditions merit some mention as the dig coincided with one of the wettest recorded spells in Argyll, basically it rained every day (sometimes all day). This somewhat hampered the on-site excavation process so it is remarkable, and a testament to the keenness of the volunteers, that we managed to excavate as much as we did. A photographic record of the excavation was undertaken and a list of the photographs appears in Appendix 4. An EDM survey was conducted on the main structures and enclosures and the results have been incorporated into Figure 3.

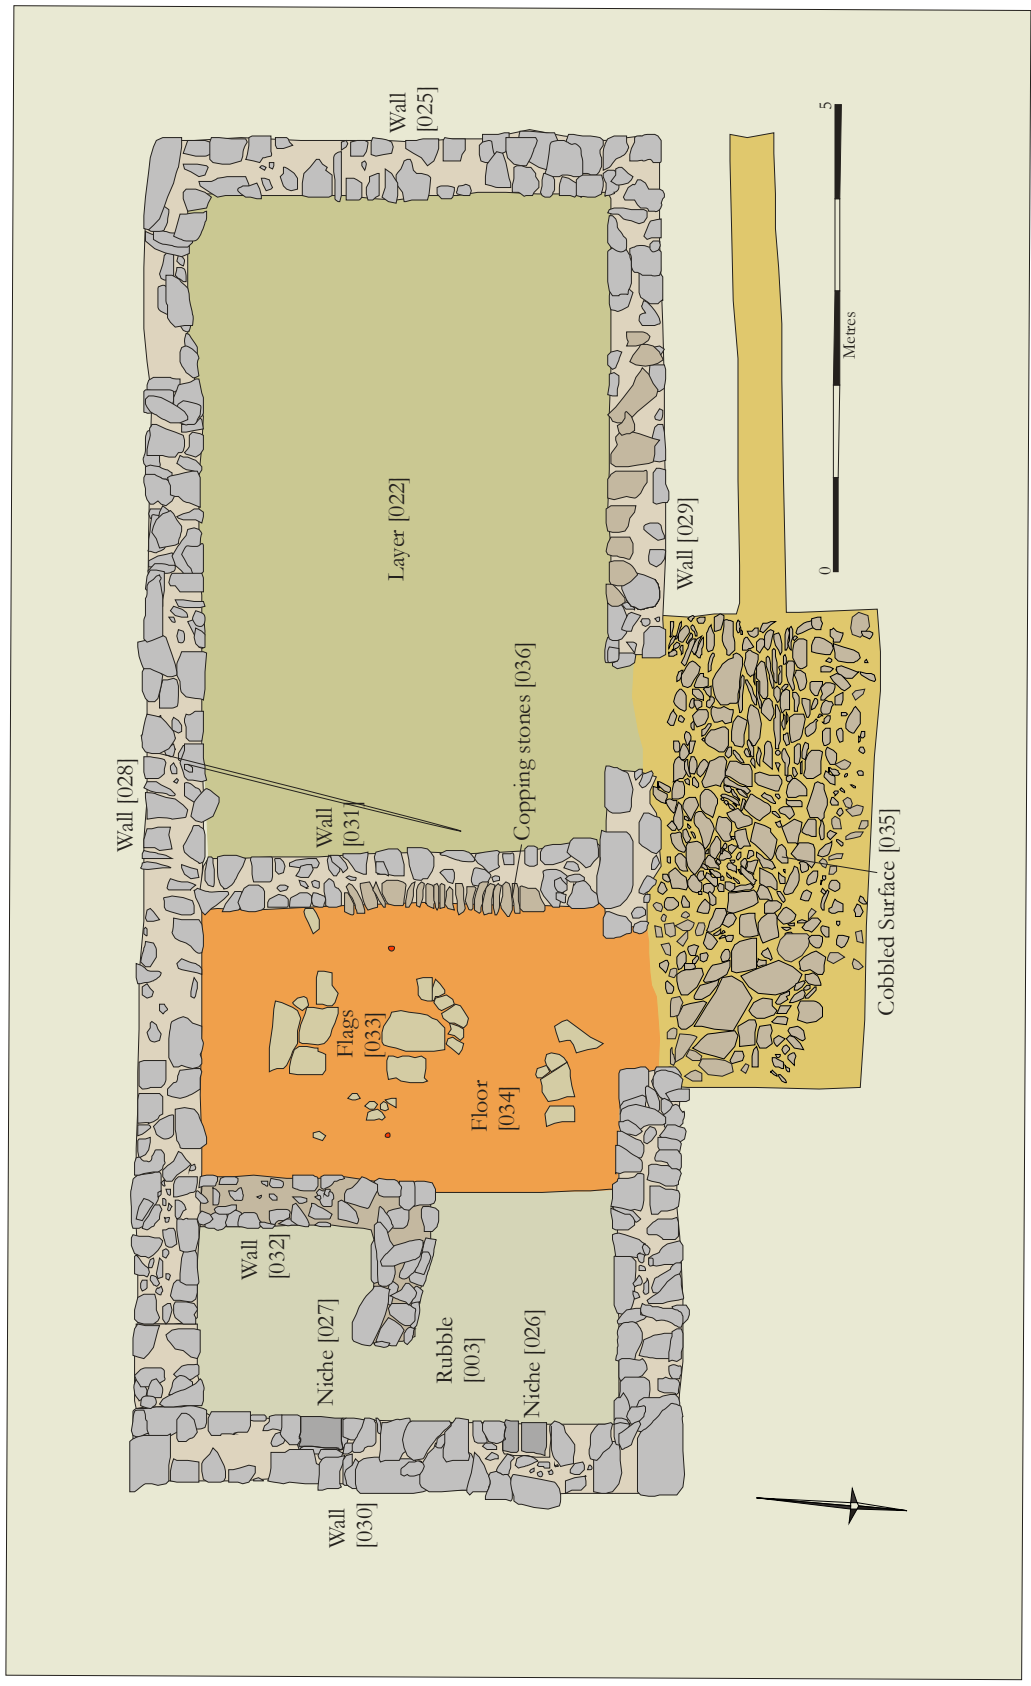
Figure 4: Trench 1 Structure 2

Structure 2 was a rectangular E/W orientated building identified during previous survey work (see Appendix 5 below). The walls [025], [028], [029] and [030], [032] respectively formed the E, N, S and W sides of the building. The building was divided into two rooms by a partition wall [031] (Figure 4). The E room measured 5.8m by 4.4m internally and appeared to have a doorway in its SE corner (this now blocked). Another door is likely to have existed in the N wall but due to later robbing its original dimensions could not now be identified with confidence. The presence of two alcoves, [026] and [027], set within the E gable end of the room also suggests this end of the structure was the principal occupied space in the building. If so it is possible that the larger W room (measuring 7m by 4.5m internally) was a byre. This however still awaits confirmation as the floor within the building was only revealed within a small sondage to the SE of the room (see below).

Only a small part of the original occupation surfaces of the structure were exposed during the excavation. Within the E room a floor level was partially revealed, this consisting of flagstones [033] and mixed gravel and clay [034]. The flags formed a rough rectangular setting and although there was no obvious trace of burning, for example reddening of the upper surface, it is likely they provided the basis for the hearth.

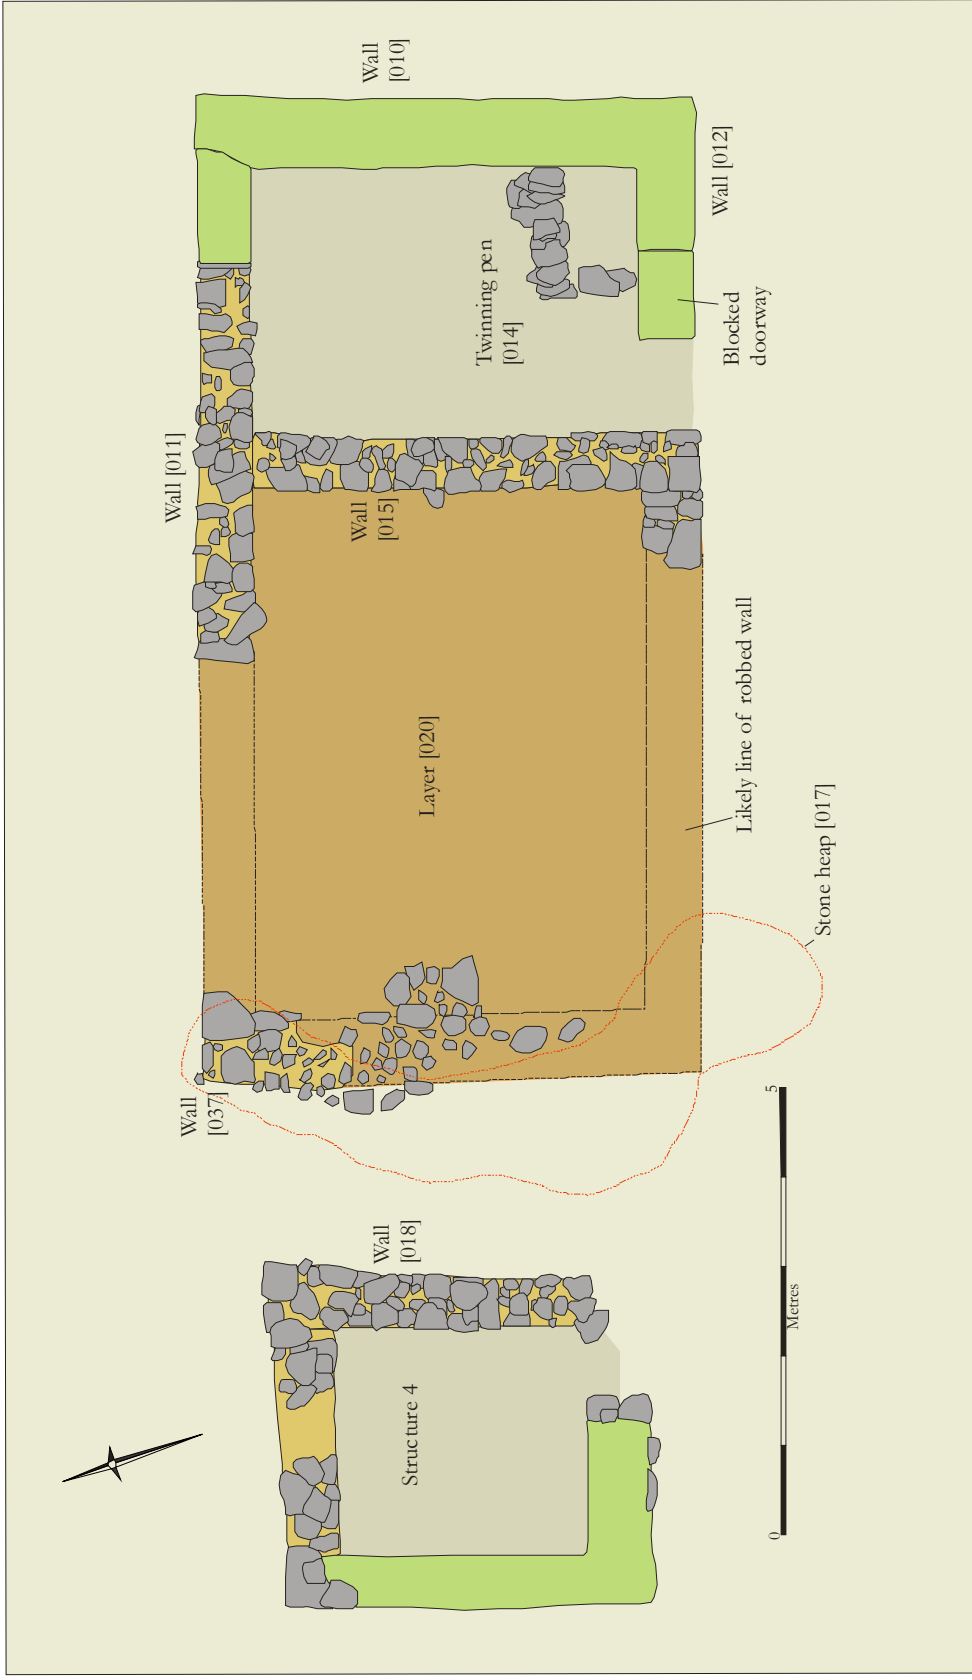
Figure 5: Trench 2, Structures 3 and 4

Structure 3 was rectangular and similarly orientated E/W as Structure 2 (Figure 5). The walls [010], [011], [012] and [037] respectively formed the E, N, S and W sides of the building.

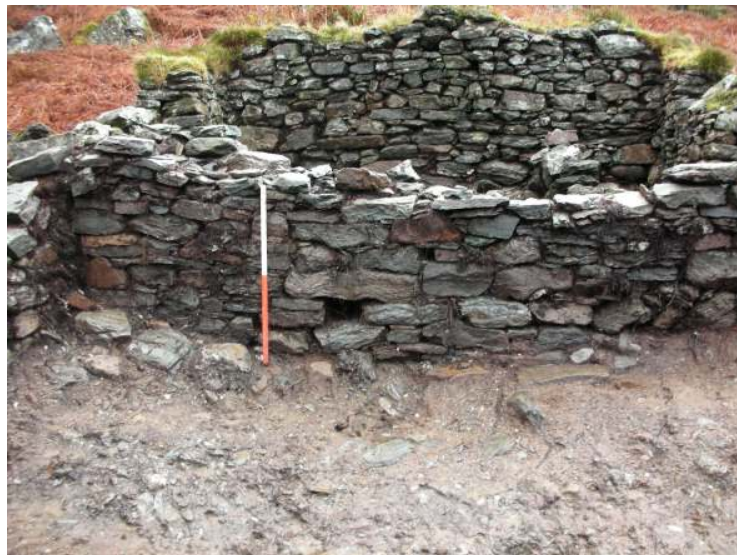
[015] Wall. Dividing wall within Structure 3. The wall measured 1.35m in visible height and was 0.60-70m wide. It was constructed in drystone rubble the largest block measuring 0.40m long. The wall abuts [011] at N.

Wall [015]

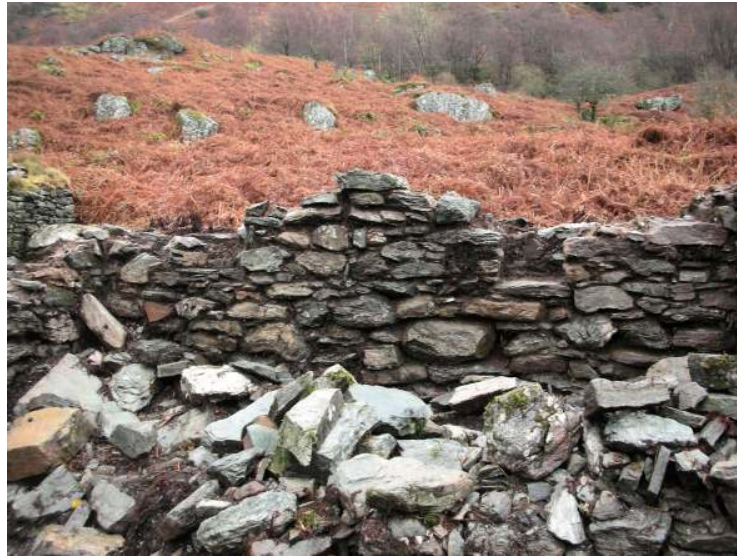
[026] Niche. Alcove constructed in E gable of Structure 2. The niche measured 0.48m high, 0.43m wide and 0.30m deep.

[027] Niche. Alcove constructed in E gable of Structure 2. The niche measured 0.31m high, 0.40m wide and 0.36m deep.

Niches in E wall of Structure 2

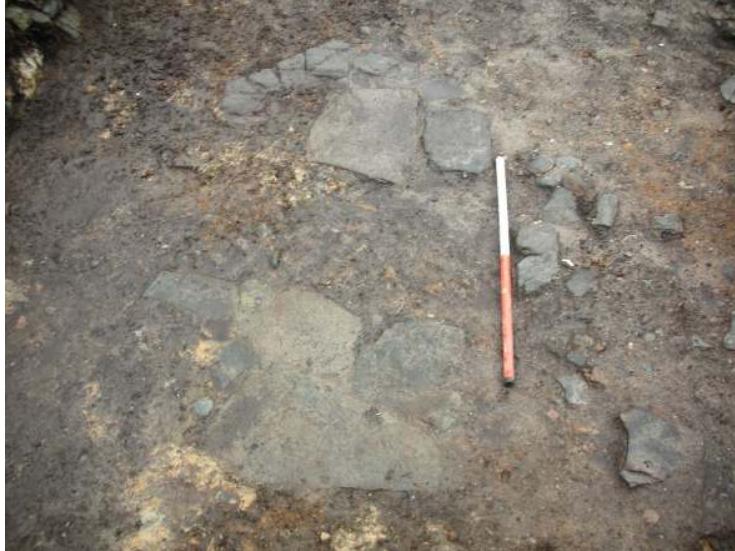
[033] Floor. Flagstone surface within E room of Structure 2. The largest flag (of chlorite schist) measured 0.70m and 0.40m. The flags partially covered the W side of the room and may have formed a hearth setting, although there was no visible fire reddening on the stones.

Flagstone surface/possible Hearth setting [033]

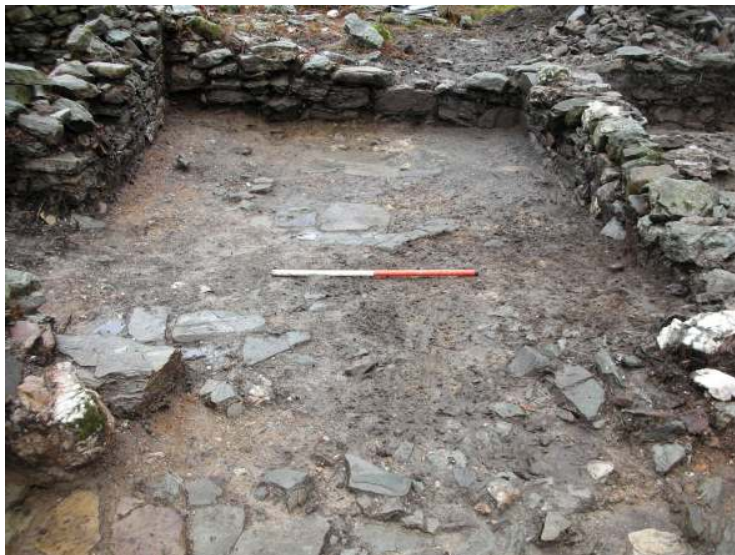
[034] Floor. Compacted surface within E room of Structure 2. This consisted of an orange/brown silty clay gravel with patches of lighter yellow clay (possible repair).

Floor surface in Structure 2

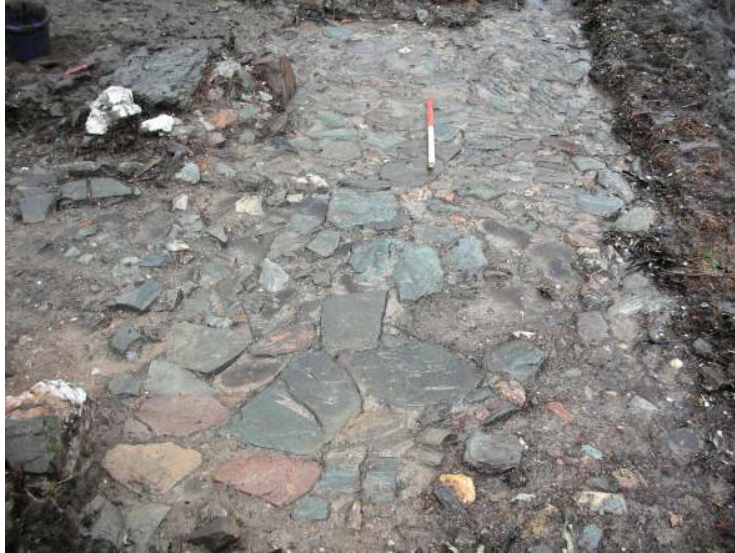
[035] Surface. Compacted and well laid cobbled surface running down the N side of Structure 2. The surface slopes down to the W and N away from the presumed entrance of the Structure and is mainly comprised of mixed stone type water rolled stones (these possibly collected from the beach or from glacial terraces below the settlement?). The largest exposed stone measured 0.45m by 0.32m and the surface stones show signs of extensive wear.

Cobbled Surface [035]

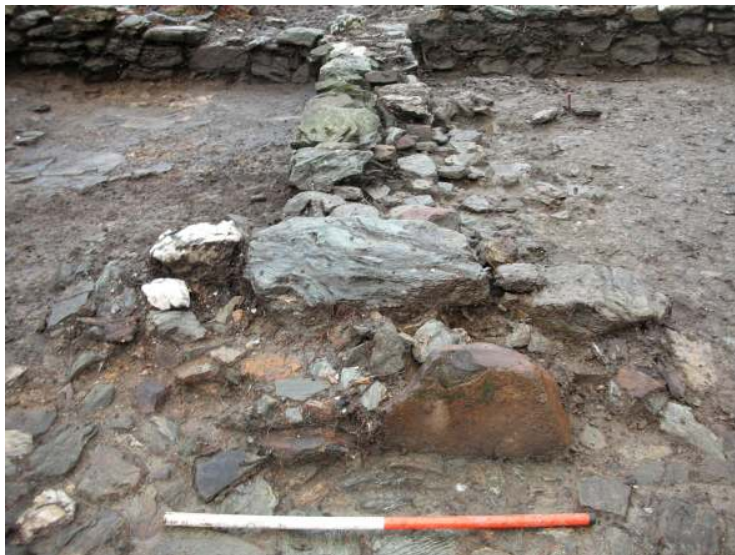
[031] Wall. Dividing wall within Structure 2. The wall measured 0.79m in visible height in 3 courses and was 0.63m wide. It was constructed in drystone rubble and appears to have been robbed and then later added to as [036].

[036] Wall. A single alignment of coping stones added to the top of wall [031].

Diving wall [031] with added coping stones [036]

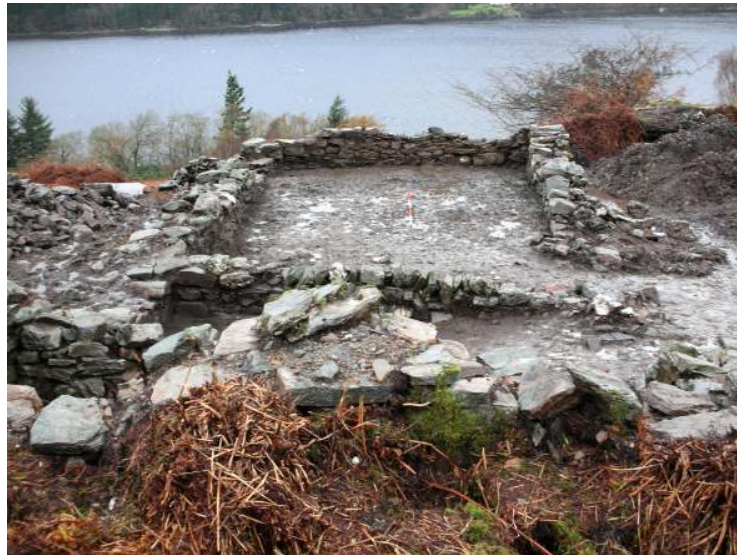
Structure 2

Structure 2: This rectangular building measured 14.6m by 5.6m externally and was orientated WNW-ESE, with two possible entrances on the NNE side. The external walls are about 0.8m thick. There is a low, internal partition wall across the width of the building dividing the building into two rooms. The E room measured 5.8m by 4.4m internally and appeared to have a doorway in its SE corner (this now blocked).

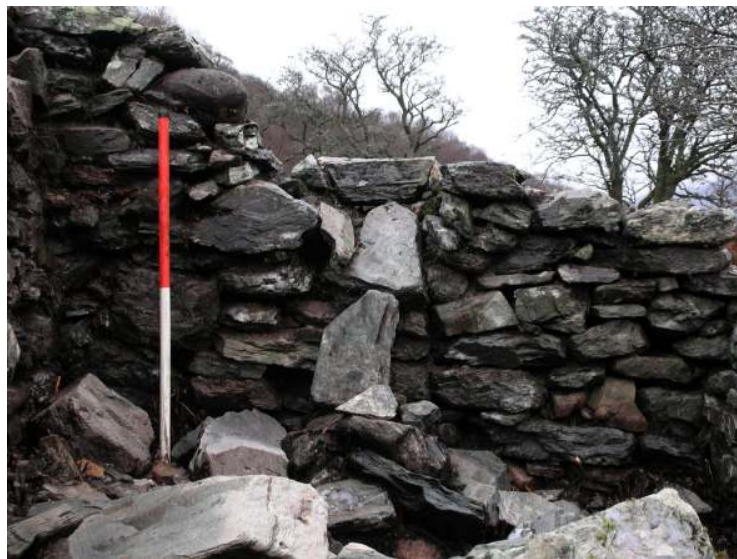
Blocked doorway

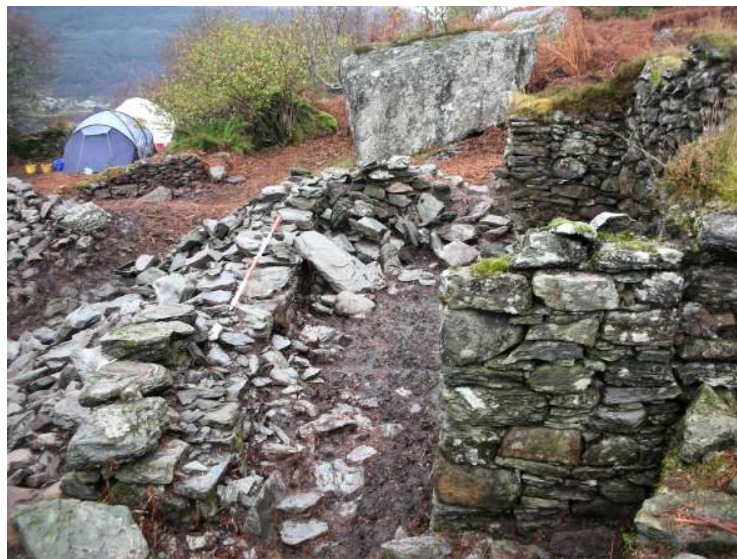
Structure 3 western modification

The remaining structure at the E end of the original building appears to be a later modification. This room or space measured 4.3m by 3.0m internally and was created by the construction of a dividing wall with a narrowing of the original entrance at the S side. An aperture was built into this dividing wall and this may represent a drain outlet into the lower W side of the building. The latest addition to the building was a roughly constructed internal partition wall in the SE corner of the structure measuring 1.0m by 1.6 m, this likely a twinning pen..

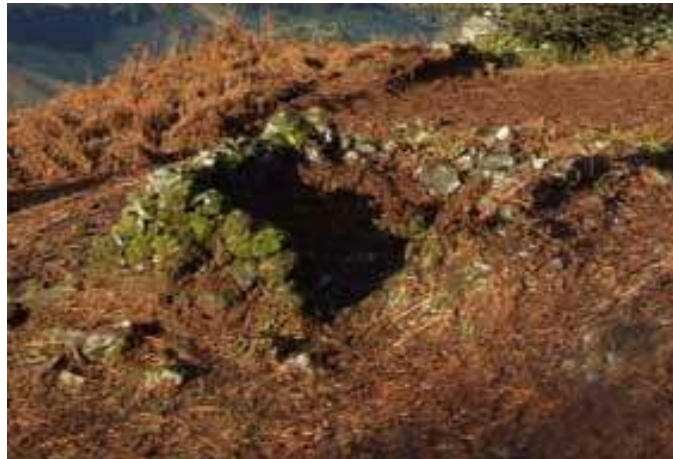
Structure 4

Structure 4: This slightly irregularly shaped building measured 4.0m by 3.8m externally and was orientated N-S. The stone work is of poorer quality, compared with other buildings and the ESE wall is slightly longer than the opposite WNW wall, with corners not at right angles. The walls are about 0.6m thick. There is an entrance in the SSW corner.

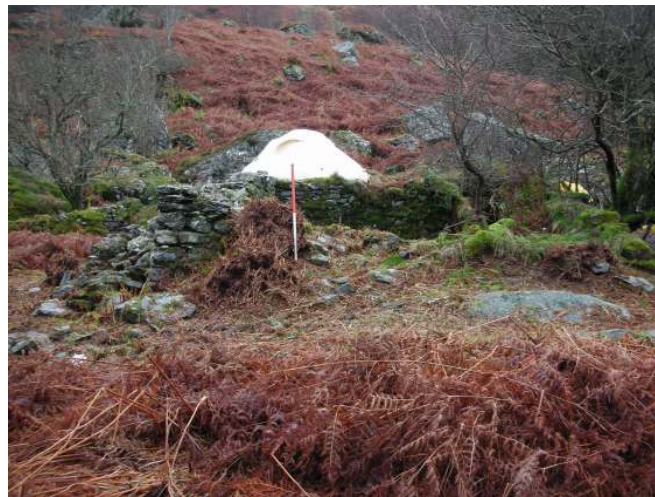
Structure 5

Structure 5: This almost square building measured 5.8m by 5.8m externally, and was orientated N-S with an entrance in the W wall and a possible window in the S wall. The external walls are about 0.7m thick. A small rectangular structure, Structure 5a, approx 1.4m by 4.0 m lies outside the N wall. A roughly rectangular plot bordered by a stone wall surrounds the building, joined to the NE and SW corners, with an entrance to the W, adjacent to the building. The plot (including the house) measured about 19m by 14m (approx. 260sqm. and its enclosing wall incorporates some large, natural boulders.
