**Kilmory Oib, North Knapdale  
Dalriada Project**

**Data Structure Report**

June 2008

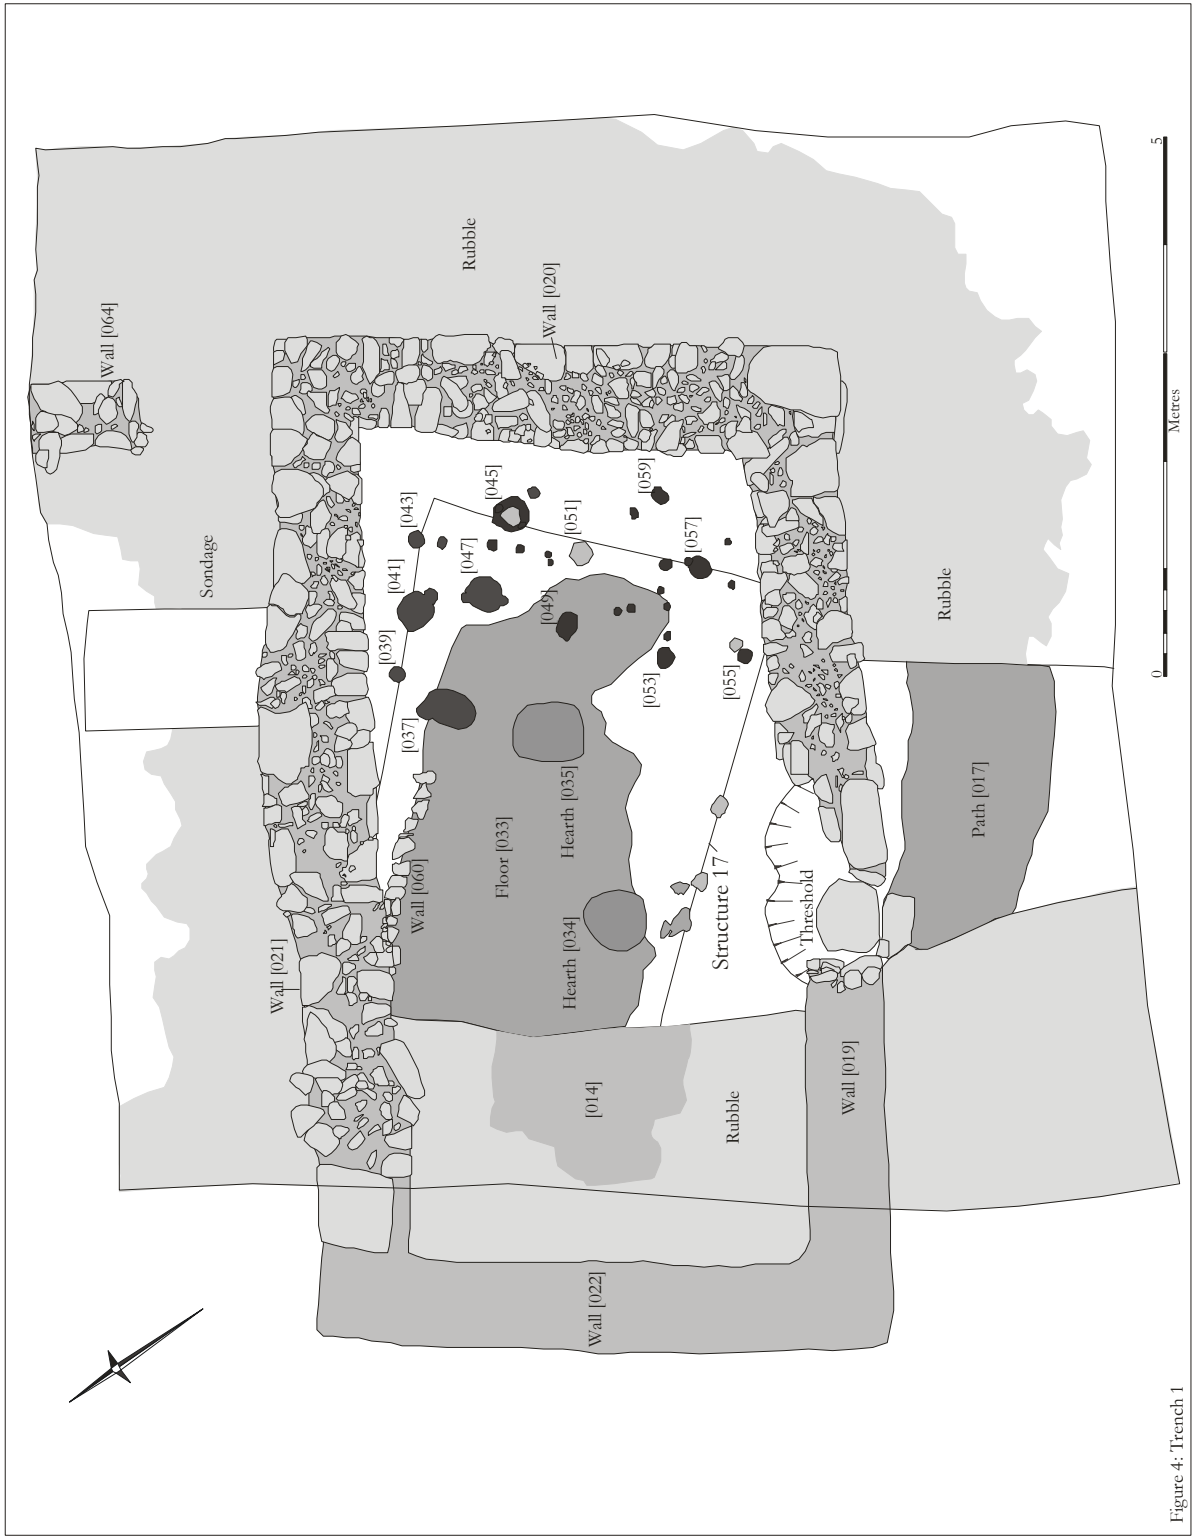
Figure 4: Trench 1

Structure 3- This was an NW/SE oriented rectangular structure that measured 9.30m by 5.70m externally. The building consisted of south, east, north and west walls, respectively, [019]-[022]. A threshold was located along the southern wall. The walls measured between 0.82m-1.00m in width and stood up to 1.70m high at the western gable end. The western end of the structure appears to have been cut into the slope of the hill, although little attempt appears to have been made to create a more level platform as the ground/surface sloped decidedly from west to east..

The vegetation cover over the structure consisted of moss and grass with some bracken, brambles and nettles [026]. Removal of the topsoil revealed rubble collapse within and around the perimeter of the walls ([012], [013] and [016]). The bulk of the collapse was situated at the eastern end of the building and perhaps suggested sudden collapse of the eastern gable end, rather than gradual decline. In comparison to this there was comparatively little stone collapse at the western. end of the structure. This suggesting the wall stones had been robbed or the rubble constructed walls never stood to any great height along the longer sides of the building.

The internal rubble collapse [012] lay partially within and over a brown humic deposit that became thicker at the eastern and lower area of the building [014]. The 'blocky' nature of this deposit suggested that this may have been degraded peat, this likely stored in the building before it went out of use. Below this peat deposit was a dump of rounded stones [018], this confined to the eastern end of the building. The nature of this deposit has so far proved elusive. A levelling deposit at this end of the structure would have made sense given the slope of the ground, however as a surface/floor the stones would have made a very uneven surface although it is possible they were a preparation for such a surface, this gone or never finished? This said no convincing floor for the structure was evidenced during the excavation, although it is possible that the floor of Structure 17 was utilised as the floor of the later building Structure 3.

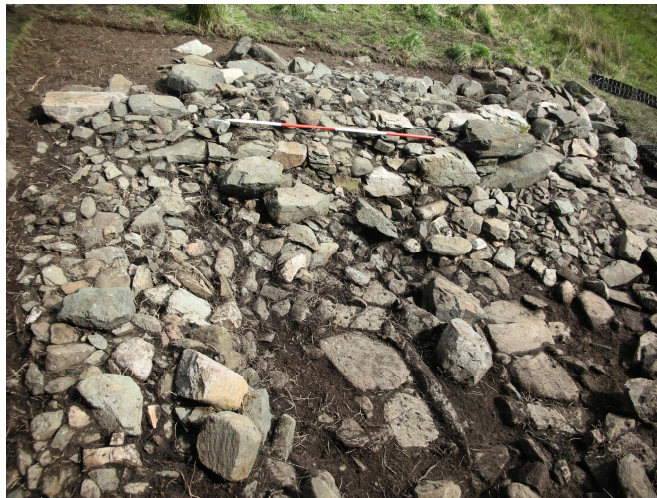
Structure 7 Rubble at North End

The rubble lay all along the outer face of the northern face of the N wall to a depth of 0.80m. The angle of the stones within the rubble collapse suggests the north gable end of the building had been pushed over rather than being subject to gradual decline. The rubble lay over the fill of the drain outlet [009], this a red brown silt. To the east of the structure a dark grey humic silt [005] lay over part of external rubble accumulation [011]. Part of this rubble was excavated to reveal an external cobble surface [063].

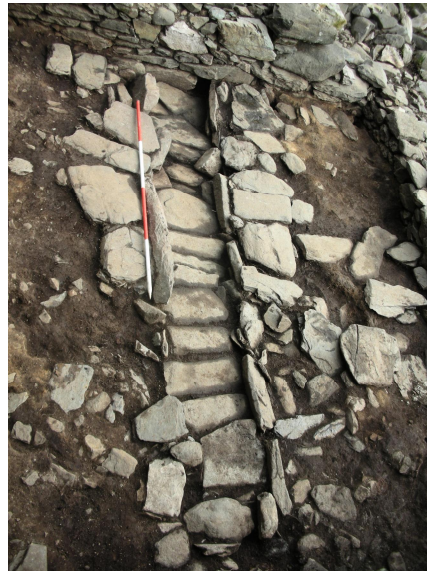
Structure 3, Drain[027] and Floor [031]

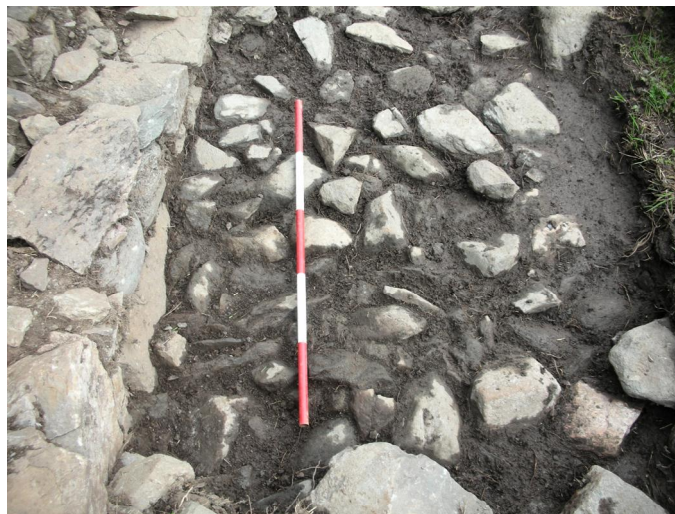
External Cobbled Surface [063] Structure 7

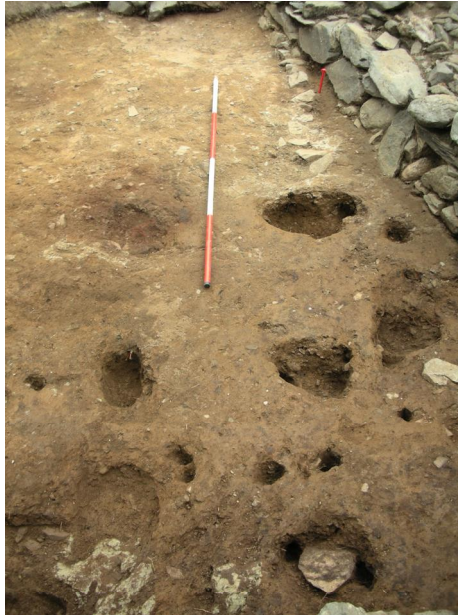
Structure 17 N side with Hearth [035] at Left of Scale

Structure 17- This building lay below the walls of Structure 3 and consisted of two sides of a building indicated by a wall footings and an alignment of post and stake holes. Associated with this structure was a compacted earthen floor which had evidence of two hearth positions. The alignment of posts suggest a rectangular building, possibly 3.0-3.20m in width, although having little trace of a southern wall this is open to question. Possibly associated with this structure was metallised gravel surface/path [017] located to the south and running under wall [019] of Structure 3.

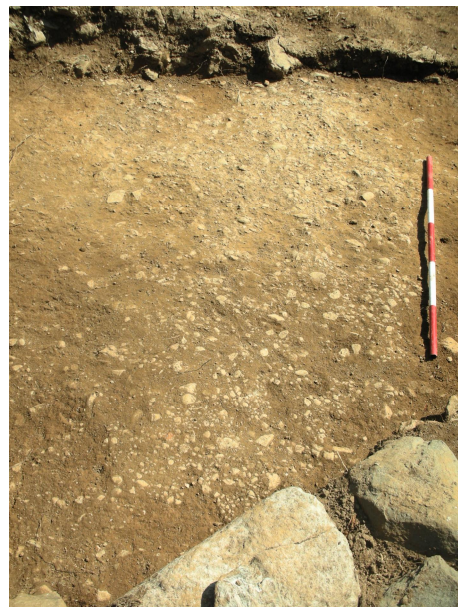
Surface [017]

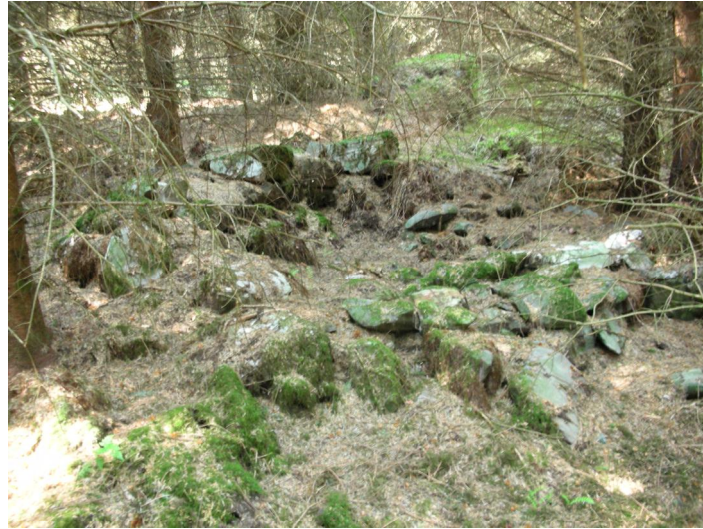
Structure 18

Structure 18-Was oval in shape and measured 4.40m by 3.80m externally with walls 0.90m to 1.00m wide and up to 0.80m high. The internal facing appeared to be fire reddened indicating this may have been a small kiln.
