**SHIAN WOOD
AN ARCHAEOLOGICAL AND HISTORICAL SURVEY**

**January 2004
Roddy Regan, Bob Black & Sharon Webb**

**Scottish Wildlife Trust
Reserves Project**

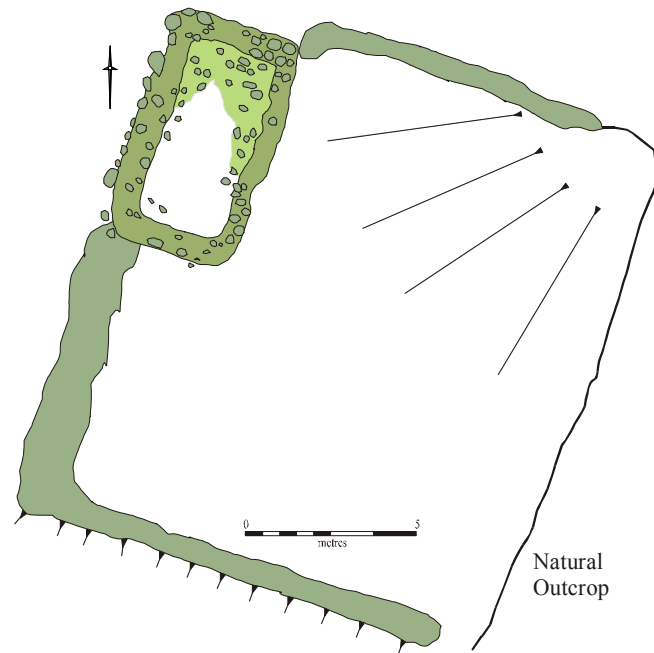
The only possible habitable structure within the reserve was structure 27. The rectangular structure sat within the north east corner of an enclosure, the walls measuring 3.5m-4m by 8m, with a maximum height of 1.10m from the central area. Curiously, the walls appear to be rubble built with rounded stones (glacial or beach eroded) and not constructed of stone from the nearby rocky outcrop, which appears to naturally split into flatter squarer blocks.

The surrounding enclosure consists of a mainly earthen dyke, although in parts quantities of stone may have been used within its construction. The dyke is no more than a slight bank now, although it is best preserved as a barrier along its southern side. Here, the natural slope of the ground has been cut into and the soil perhaps thrown internally, which in effect, creating a raised platform. However, the ground within the enclosure is by no means even and has a decided slope rising to the north west.

Figure 4. Building and Enclosure Feature 27

The building appears on the 1st edition Ordnance Survey of 1871 and is depicted as being roof-less. Either the building was in decay by this time or it never had a roof and served some other function, such as an animal pen.

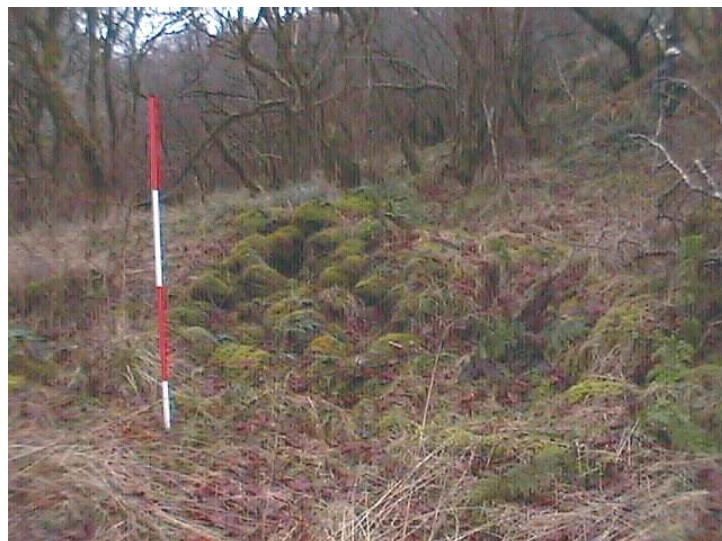
Figure 5. Building within feature 27

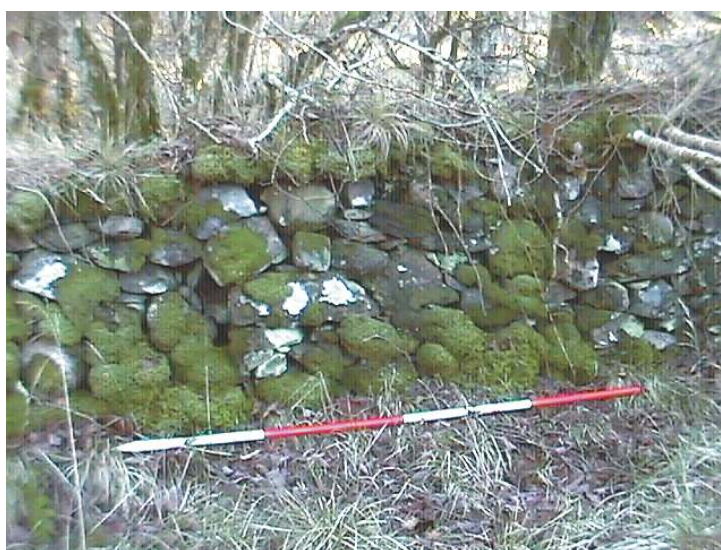
Several enclosure dykes traversed the reserve, dividing it into seven Areas, (**A-G** Figure 3). The northern tip of the reserve, the hill of An Sithean, was enclosed by an elliptical shaped walled enclosure, (**18**, Area A). The wall of the enclosure was best preserved on the west, standing to a height of 1.7m. At the east the wall was accompanied by a ditch running along its eastern side, while on the western side of the wall, a more level area had perhaps been used as a trackway or path.

Figure 6. Enclosure Wall 18

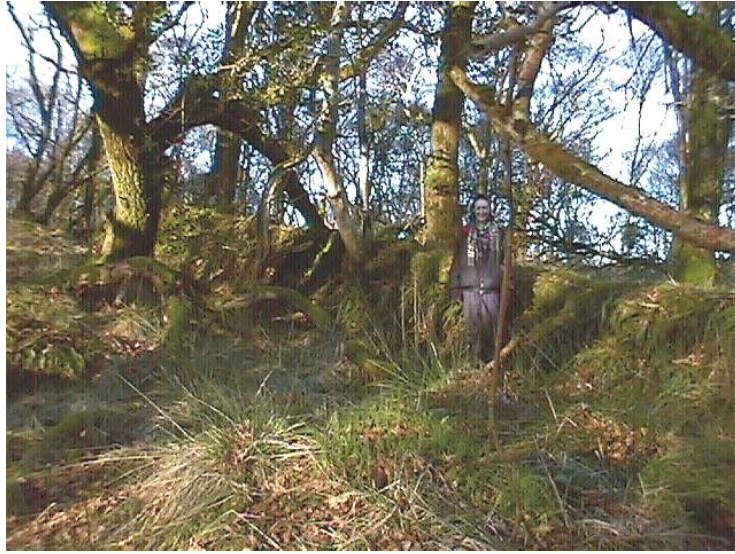
Two NW/SE aligned dykes (**20** and **36**), cut across the Reserve from east to west. The area of the reserve was further subdivided by a NE/SW aligned dyke (**21**). All these turf dykes, or fales, comprised of ditch and up-cast earthen bank. From the aerial photographs the ditch of dyke **36**, appears to continue north-west onto and across the foreshore, to the low tide level.

Figure 7. Enclosure Dyke 36

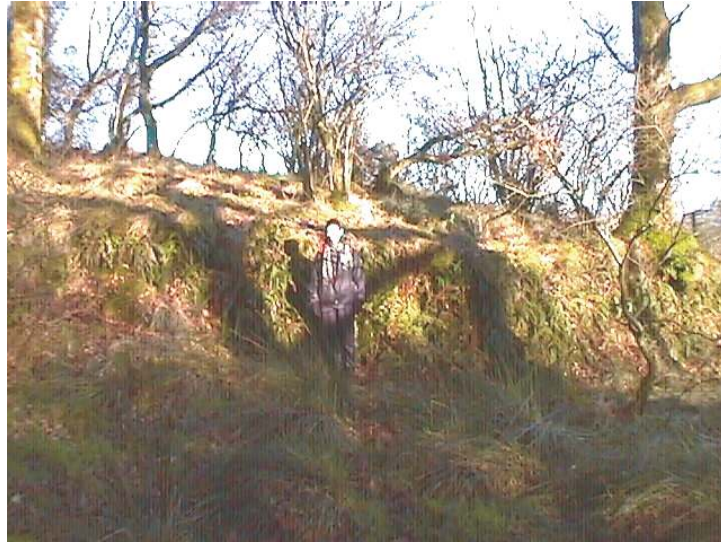
Several trackways leading to the enclosed fields were still apparent within the Reserve. As mentioned above, a track (**18**) appears to run along the western side of wall, along its eastern extent. Possibly connecting the existing road line and Area E was track **27**. The track here runs up from the road or shore area and enters the enclosed area, here represented by a high earthen bank. The burn also appears to have been ditched, possibly to keep excess water away from the track area.

Figure 8. Track and bank 27

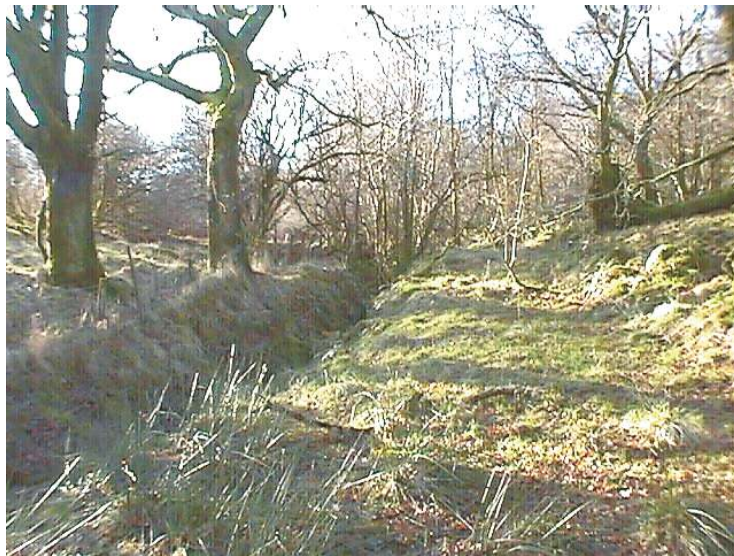
Running along the south-eastern side of the Reserve, two ditches, aligned SW/NE, sit either side of a slight raised area **29**. The larger ditch lies on the south, with the slighter parallel ditch on the north, respectively these measure 2m and 1.5m wide. The distance between the ditches was as much as 4m, certainly enough to allow access for a cart, although the control of animal movement may also have been a reason for their construction.

Figure 9. Ditched trackway 29.

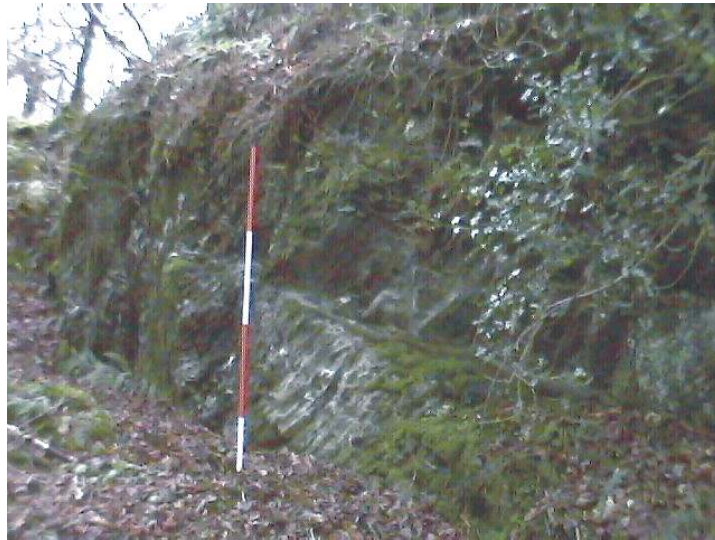
Figure 10. Quarry face 28

Two quarries have been cut into the rock cliff/escarpment running along the south western side of the reserve, **26** and **28**, no doubt sourcing the natural schist and slate outcrops.

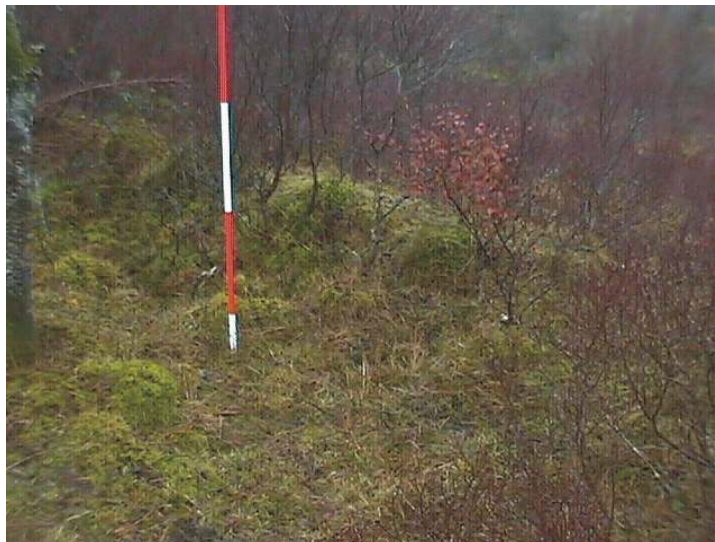
Three areas of peat cutting (**19**, **30** and **32**), were observed during the survey. These appeared as level or flat sunken areas with higher surrounding ground, this usually delineated by a straight edge, the remains of the eroded face of the hagg. Within area **32** much of the area had been reduced by peat extraction leaving a series of banks and channels running between the lower areas.

Figure 11. Peat workings 32

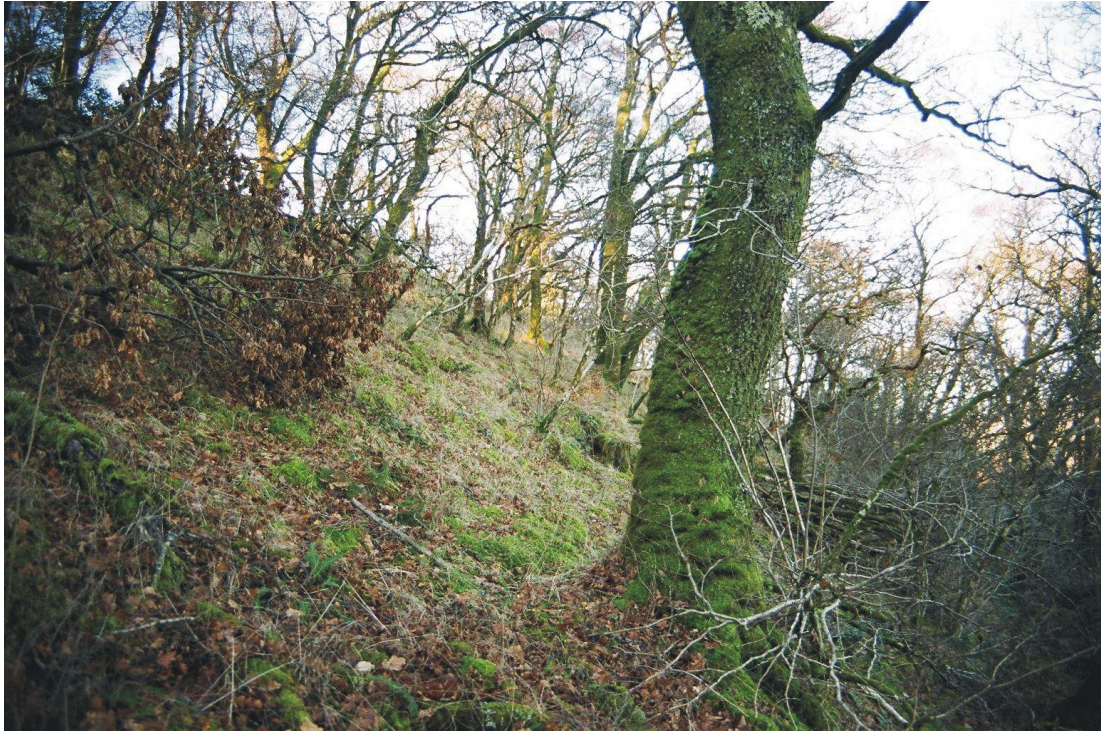
Figure 14, Oak and hazel woodland on the flank of Ad Sidean overlooking the fish processing factory. There are no clear signs of coppicing in this stand of Oak. Trees are single-stemmed, some are multi-stemmed.

today is not a coppice oakwood, though it does have an area of oak-dominant woodland on the slopes above the fish farm (Figure 14). The top of An Sidhean is too poorly drained to have supported a pure oak woodland though it may have once supported more oak than it does now. There is much birch, including silver birch, which is a species naturally scarce in Argyll but often planted in policy woodlands. Both silver and downy birch are relatively short-lived species, usually living for less than 100 years, suggesting that the present woodland structure of this top area is not long-established.

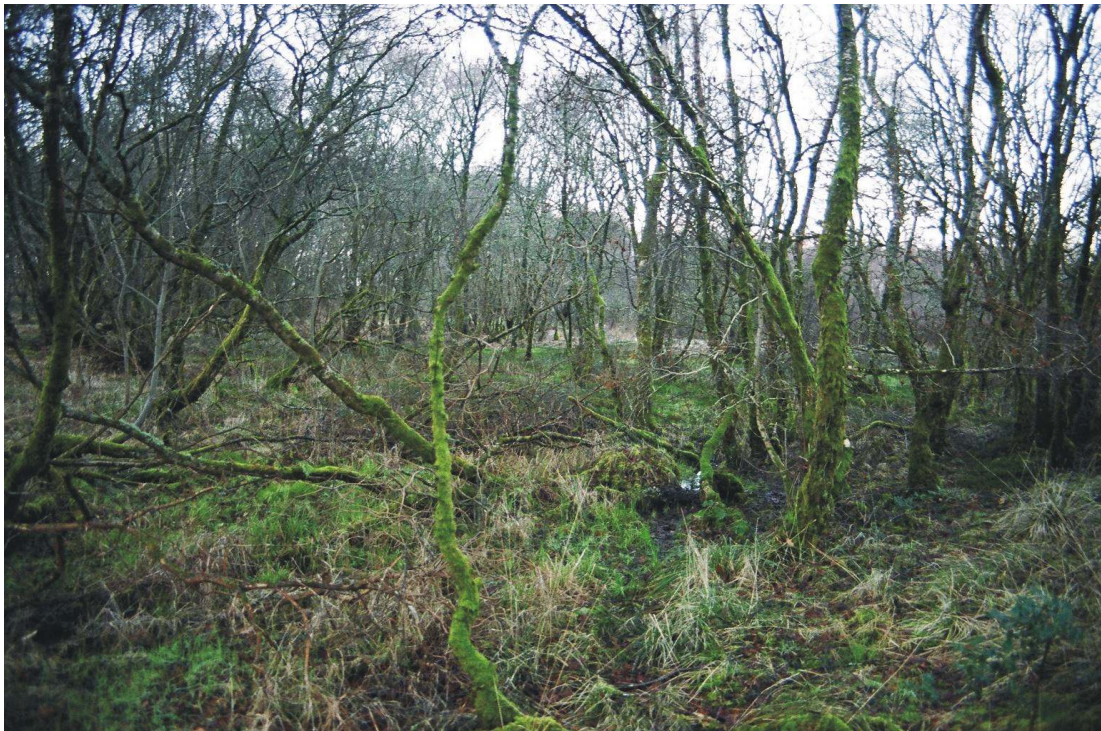
Figure 15, Young birch woodland, maybe 20-40 years old. Various age classes of birch are present in the wood.

The whole area was grazed for many years before being bought by Scottish Wildlife Trust in 1995. The grazing could not have been intensive enough to prevent tree regeneration and woodland expansion. The result is a dynamic mix of mature woodland and young woodland of various ages (Figure 15).

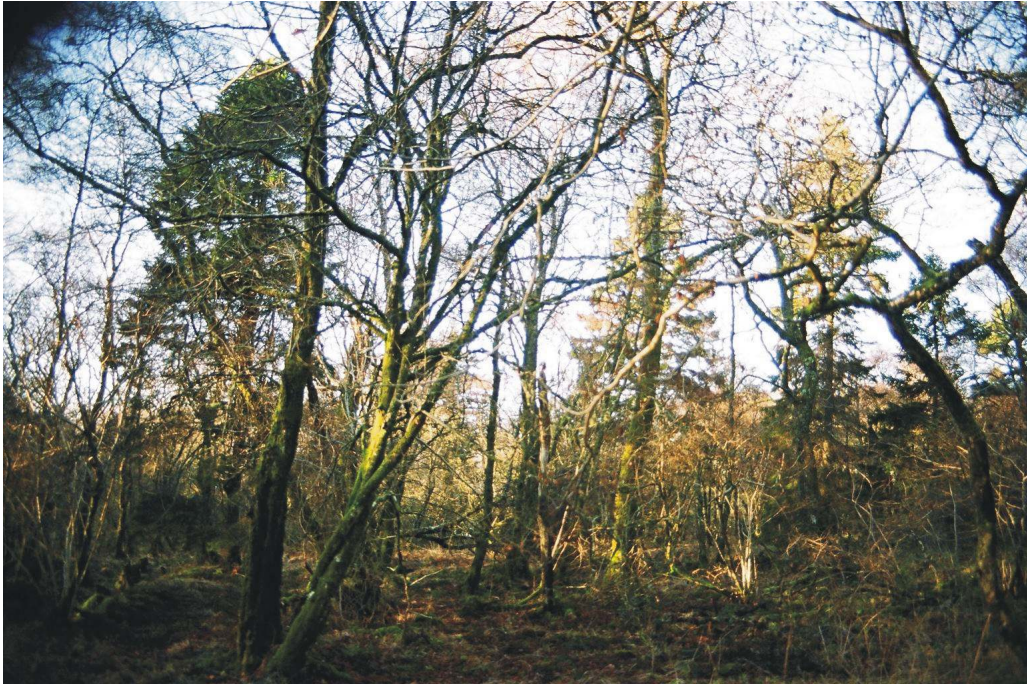
Figure 12. On top of An Sidhean, showing conifers and native woodland, mostly birch. The ground is poorly drained and trees are not of good form or great age.

There are still a few non-native trees on An Sidhean, primarily conifers (Figure 12), including a mature larch and silver fir and a group of either younger or more stunted spruce, and Scots pine growing in poorly drained ground nearby. These trees are unlikely to date from the 19th century and the larger ones were probably planted in the first decades of the 20th century. There is also a large mature beech which could date back to the mid 19th century. These trees are individually mapped in the reserve botanical survey (Averis, 1999). Averis' survey also maps and describes the native

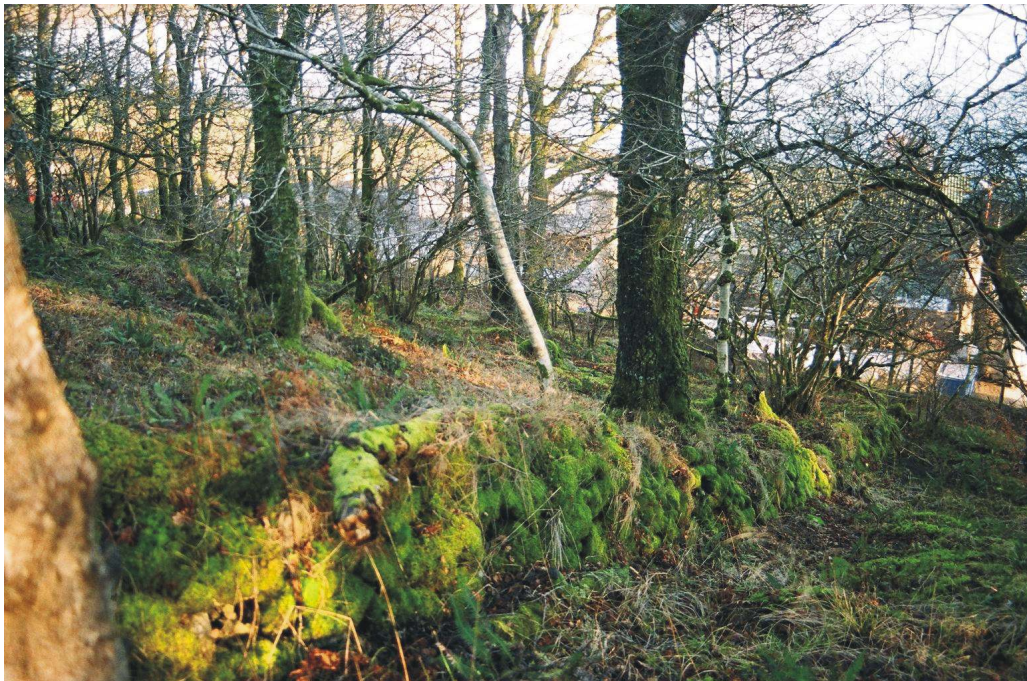
Figure 13. The enclosure dyke around An Sidean. A mature birch is growing atop the dyke. The dyke makes no sharp change in woodland structure.

This attention to policy woodland and agriculture is reflected in what we see at South Shian today. The woodland was carefully enclosed to control the access of stock. The prominent enclosure dyke around An Sidhean (Figure 13) probably dates from the 19th century, though the turf dykes may be older. Mature trees now grow on the enclosure dyke.
