# **DUNOLLIE HOUSE OBAN, ARGYLL**

An Archaeological Watching Brief

Data Structure Report  
March 2011

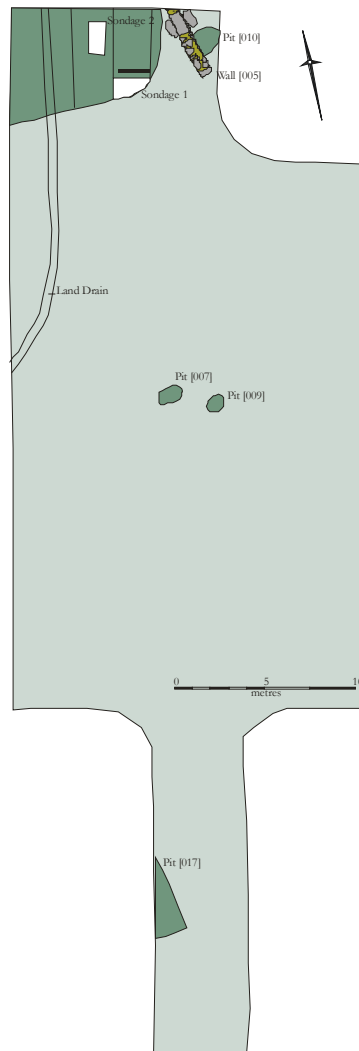
Figure 3: Feature Locations

Several archaeological features were revealed below the topsoil. In the NE corner of the stripped area was a distinctive deposit of mortar and rubble fragments [002]. This deposit sealed the footings of a NW/SE aligned wall indicating [002] was a demolition deposit. The wall continued into the N section and was constructed of water rounded cobbles and schist or slate slabs bound by a light brown sandy mortar. Two horizontally lain slabs lay either side of the wall indicating that this was a former threshold. The wall appeared to terminate at the SE and there was no indication of a NE return (robbed or otherwise) or any indication it continued SE in another form, such as a wooden structure for example.

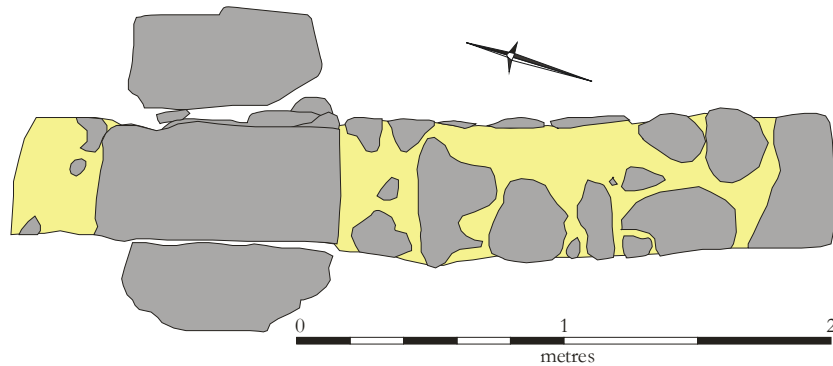
Figure 4: Wall [005]

[005] Wall. Stone rubble and mortar wall footings. Measures 3.10m long and 0.52m wide and stands 0.24m high. The stones consist of water rounded blocks and schist slate slabs (largest 0.94 x 0.55 x 80mm) bonded by a soft to moderately compacted light brown mortar with frequent coarse sand inclusions. Two horizontal stones either side of the wall form a threshold.

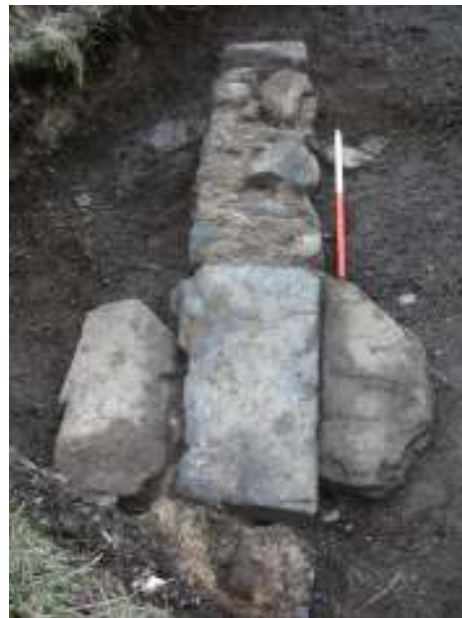
Wall [005]

The large amounts of broken red earthenware plant pots (many appearing unused) along with the remnants of a iron rake-head amongst the demolition material perhaps suggest the building had been utilised as a potting shed.

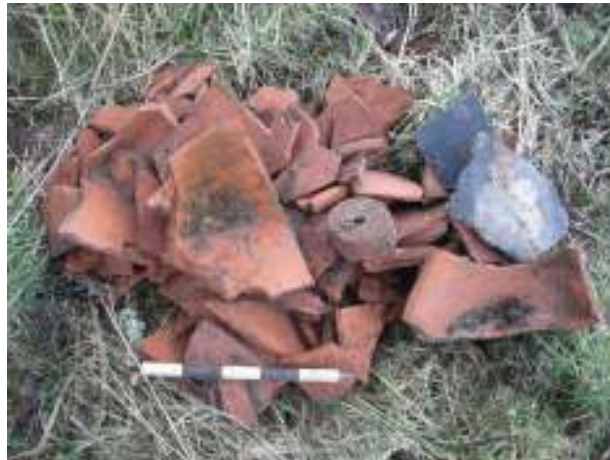
Plant pot sherds and slate from layer [002]

[002] Layer. Demolition rubble, consisting of yellow brown mortar with frequent plant pot fragments (these in two sizes; larger 0.30m base diameter, smaller 80mm base diameter), occasional stone (largest 0.26m x 0.26m x 0.16m) and occasional roof slate fragment. Up to 0.26m deep.

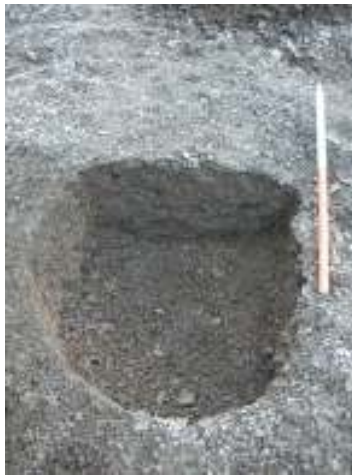
Pit [007]

Two other small oval pits were located within the centre of the stripped area, pits [007] and [009]. The fills of these were similar in nature and pit [007] contained white glazed earthenware, suggesting a late date. The purpose of the pits remains unclear, although they may be pits for planting shrubs or trees?.

[007] Cut. Oval pit measuring 1.45m long and 0.86m wide with steep sides (70°-80°) and a flattish base, 0.40m deep.

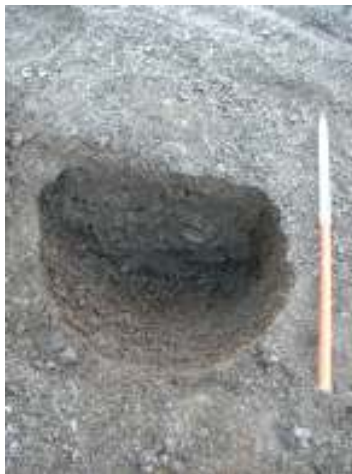
Pit [009]

[009] Cut. Oval pit measuring 1.16m long and 0.80m wide with steep sides (70°-90°) and a flattish base, 0.50m deep.
