**NETHER LARGIE
FALLEN STANDING STONE**

EXCAVATION REPORT

March 2013
Roderick Regan

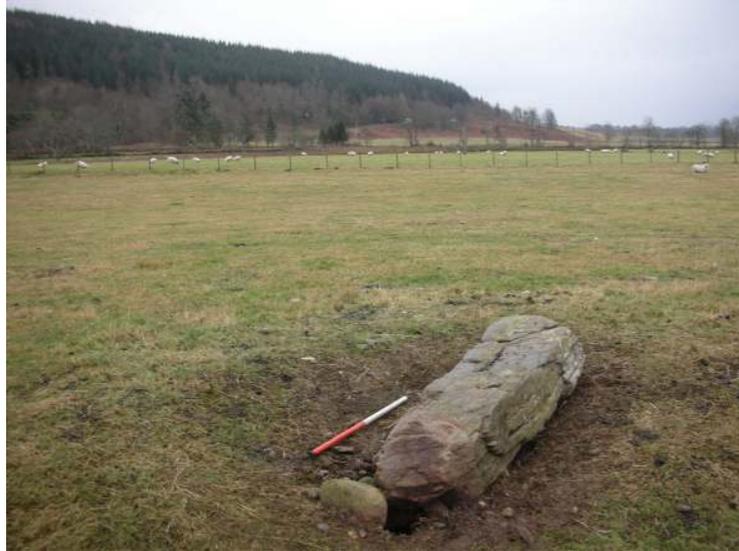
Fallen stone with the main Nether Largie grouping in the background

Prior to collapse, a slight hollow had formed around the base of the stone, likely due to livestock using the stone as weather protection and perhaps also rubbing against the stone itself. The existing hole left by the fallen stone is no more than deep 0.34m and 0.51m wide. There was also a disturbed hollow running up the western side of the stone 0.18m wide which may have been caused by recent animal burrowing. Three packing stones are now visible, these all water rounded cobbles the largest measuring 0.30m x 0.24m x 0.20m. Examination of the upper (E) face of the fallen stone revealed as three cup marks at the base of the stone, with perhaps a further three (eroded) cups at the upper end of the stone. The cups at the base would not have been visible when the stone was upright indicating these must have been done prior to the original erection of the stone. The stone unsurprisingly had fallen in the direction it was leaning (S) and had twisted to fall onto its W face.

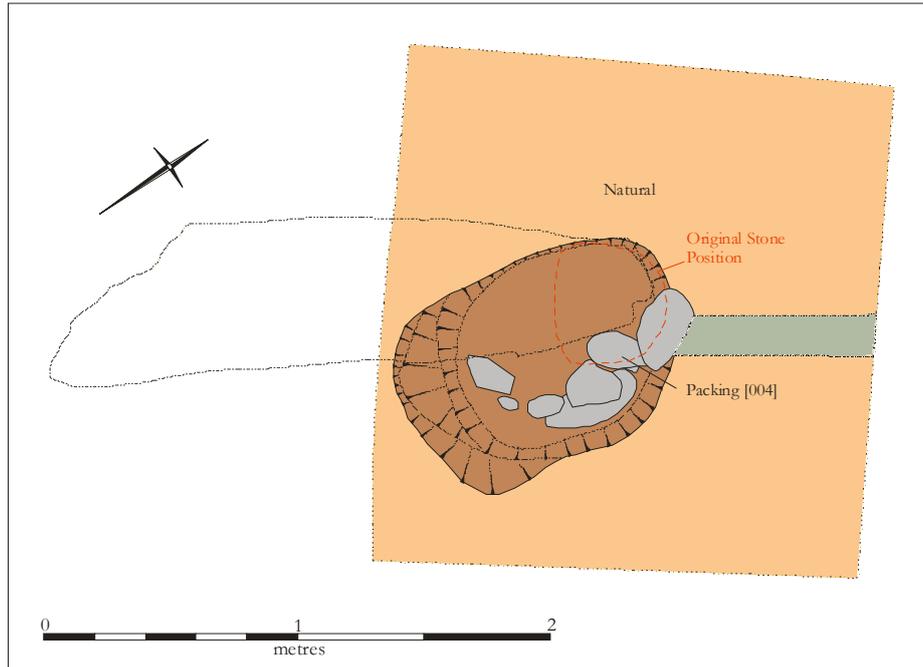
Figure 3: Stone Pit

The original pit cut [006] was an irregular oval in shape measuring 1.15m N/S by 0.90m-1.05m E/W at the top. The S edge of the pit fell sharply then shelved away more gradually before again falling away steeply to the flattish concave base. The N, W and E sides fell steeply (the N edge near vertical) at the top forming a steep concave curve nearer the base. The pit was 0.53m deep. The standing stone would appear to have originally occupied the NW of the pit standing nearly flush against the N and W edges of the pit. The E and part of the S side were then packed with stones [004] these sitting in a compact backfill material [005]. The upper stones of this packing had obviously been moved from their original positions by the leaning standing stone and its subsequent collapse. The lower stones on the W however, appeared to be *in situ*. The relative absence of packing stones at the S side of the pit may have allowed the standing stone to collapse in this direction although this may not have been the original cause. Lying over this packing was a fill of grey brown silt [003] which had formed around the base of the standing stone and appeared to be an accumulation that had gradually collected after the stone had begun to lean to the SW.

[006] Cut. Pit cut for standing stone. Irregular oval in shape measuring 1.15m N/S by 0.90m-1.05m E/W at the top. The S edge of the pit fell sharply then shelved away more gradually before again falling away steeply to the flattish concave base. The N, W and E sides fell steeply (the N edge near vertical) at the top forming a steep concave curve nearer the base. The pit was 0.53m deep.

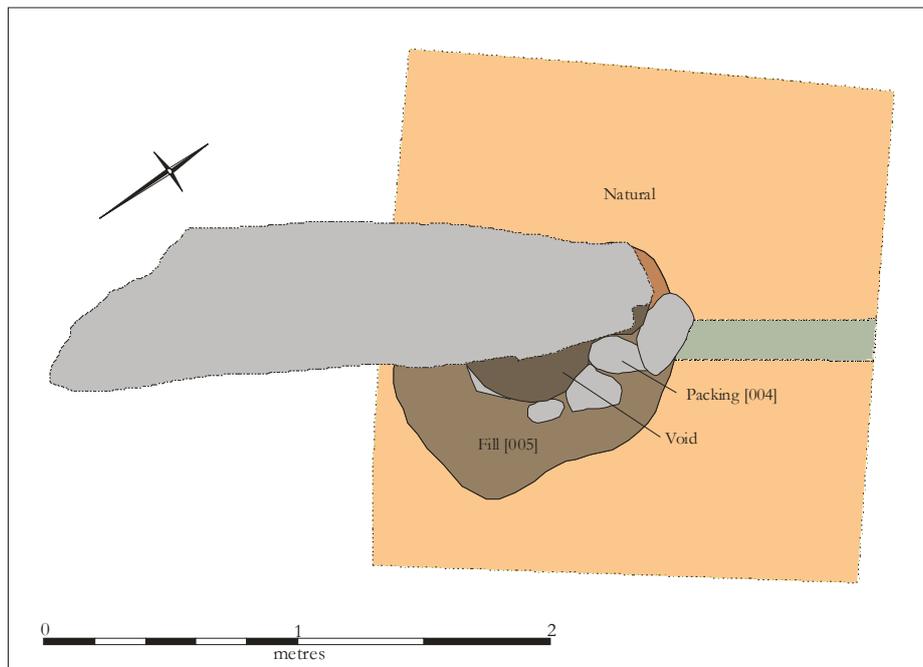
Figure 4: Upper Fills

The collapse of the stone had left a void that the standing stone had previously occupied, this partially filled with loose post collapse material [002]. The depth of the topsoil/plough soil [001] varied across the Trench measuring between 5cm and 10cm at the base of the fallen stone, but was as much as 0.19m at the NE of the trench. The topsoil was very compacted around the base of the stone, this possibly a result of animal trample in the area.

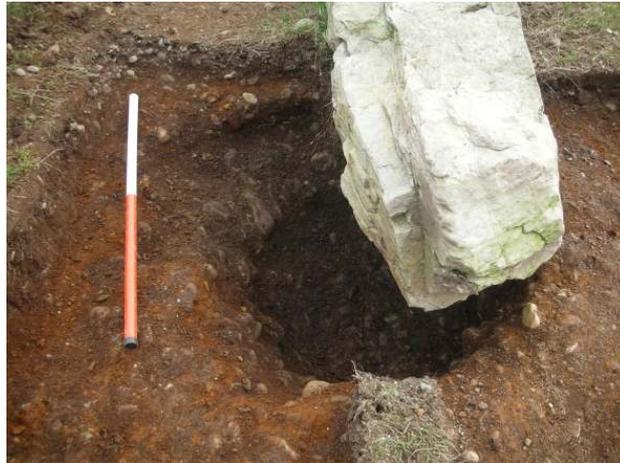
Stone Pit from N

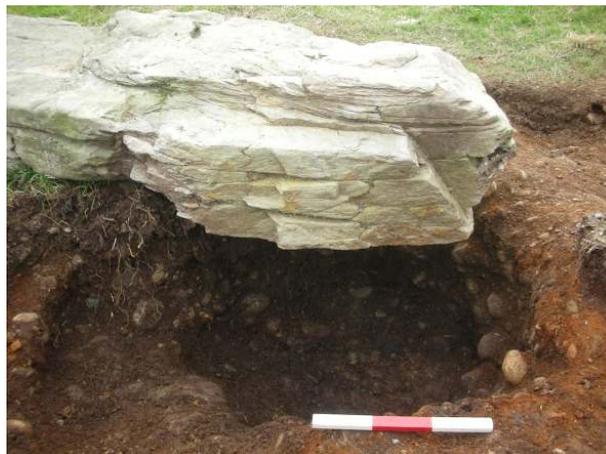
Stone Pit from E

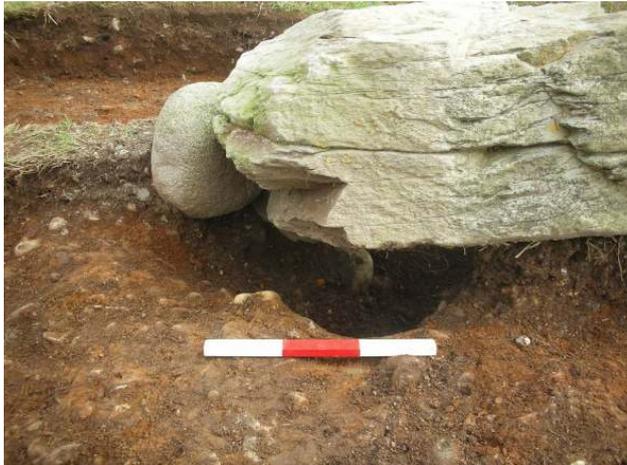
Stone Pit from W

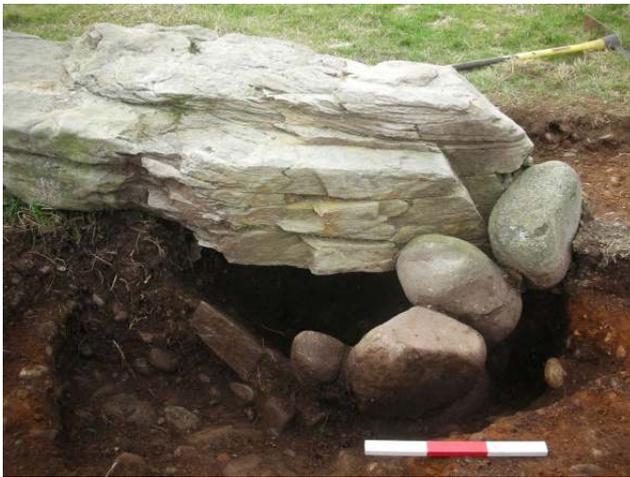
Stone Packing [004]

[004] Fill. Stone packing around base of standing stone, all the stones apart from one (an angular schist slab) were water rounded cobbles the largest measuring 0.30m x 0.24m x 0.20m. The upper stones at the NE appear to have been displaced by the movement of the standing stone.

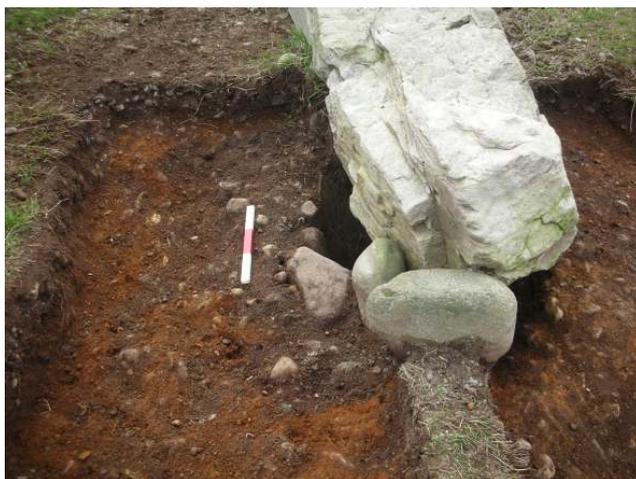
Upper Fill of Pit

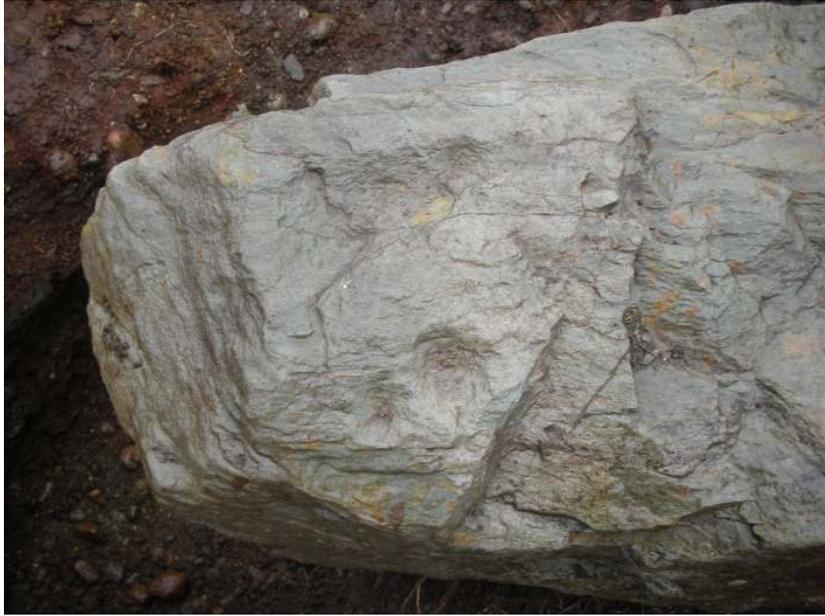
The collapsed standing stone would appear to have occupied the NW of the original pit cut its basal N and W faces lying up against the steep edge of the original pit, its base also likely in contact with the bottom of the pit. The more gradual slope of the pit edge on the S side may be deliberate and would have facilitated the sliding of the stone into its original position. Packing stones were then placed around the E side of the standing stone which probably kept the stone in place before the pit was backfilled. Whatever caused the stone to start leaning is unknown, but the relative absence of stones on the S side of the pit may have allowed the standing stone to continue leaning on this side, a process that led to the formation of a loose silt around the base of the stone and to its ultimate collapse. The discovery of the cup marks at the base of the stone is intriguing as these would not have been visible when the stone was in its original position and indicates these must have been pecked prior to the erection of the stone.

Cup marks on the base of the stone
