**DUNOLLIE CASTLE,  
ARGYLL**

**Standing Building Survey and Excavation  
Data Structure Report**  
August 2017  
Roderick Regan

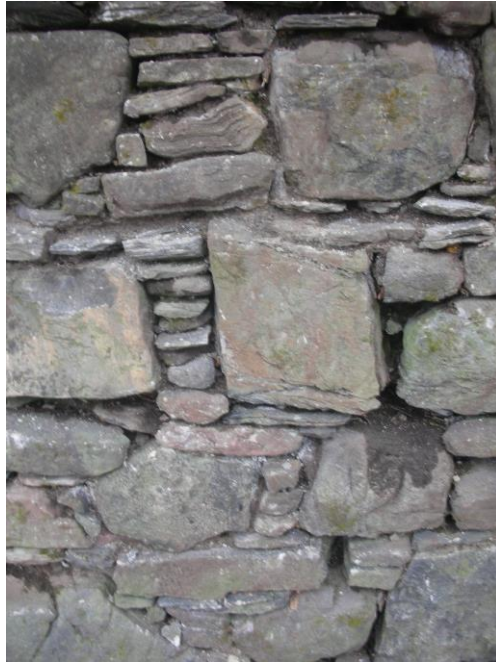
The tower is constructed from roughly coursed rubble blocks and split boulders, the gaps between the irregular blocks filled with tight closely packed pinnings all bound by a hard compact lime mortar. The mortar is light grey to light brown in colour with frequent coarse sand inclusions and occasional shell and charcoal fragments.

Stone work on tower

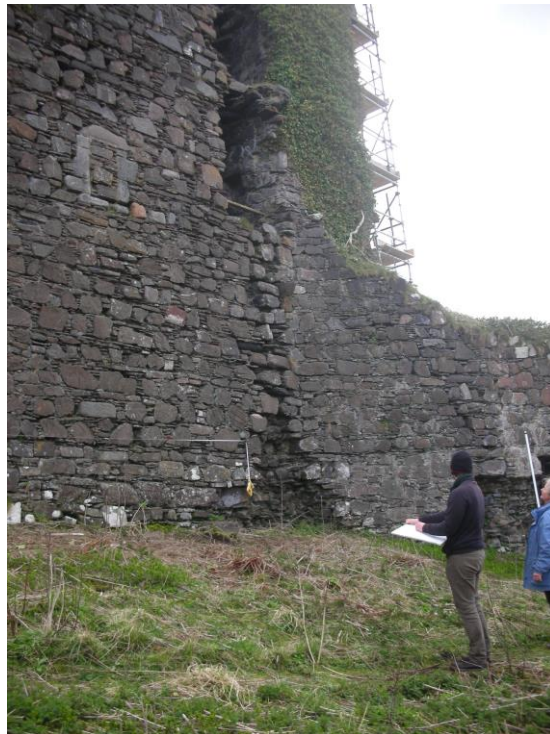
Recording stonework on NE side of the castle

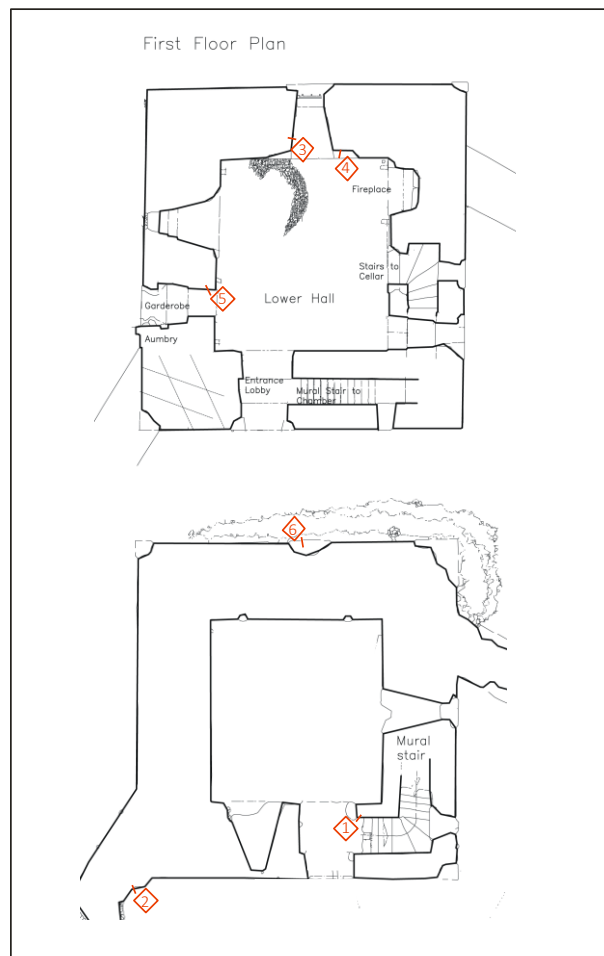
Figure 5: Location of mortar samples

Six samples of what appeared to be degraded but original mortar used in the core construction of the castle fabric were obtained during the survey work.

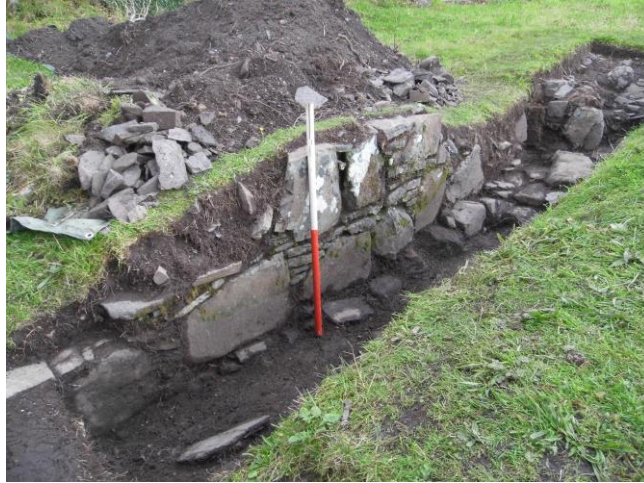
Built directly over bedrock and forming the northern side of the trench was the southern wall face [005] of a rectangular structure situated in the north west corner of the courtyard. Wall [005], of which only part of the south face was seen in the trench, was constructed from split angular and rounded rubble (max size 0.55m x 0.28m) standing up to 0.90m high. The gaps

between the larger blocks were filled by close and tight pinning all bonded with a soft light yellow mortar although much of the later had weathered from the surface area of the wall.

South facing section of trench, wall [005]

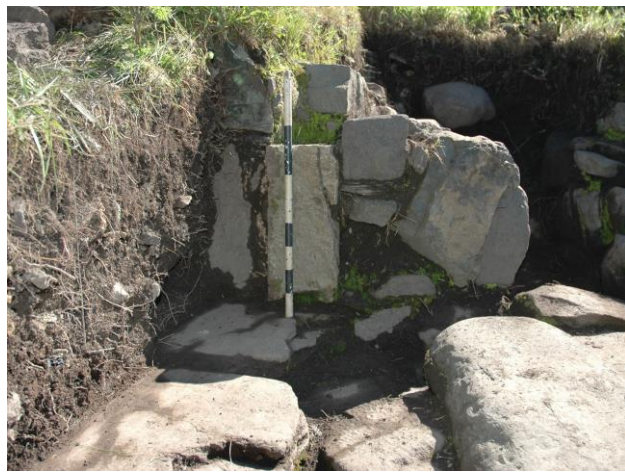
Lower door jamb

A doorway (which is likely centrally placed along the wall) gives access to the structure from the south, and the basal remnants of a door jamb is preserved on the east side of the door, which was 1.00m wide, although the west side of the door is less well preserved. The doorway was filled by a mixed rubble and loam deposit [011] that contained some midden material.

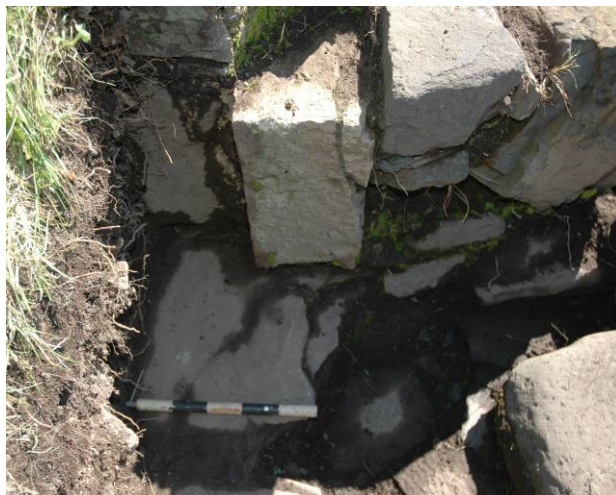
Door jamb

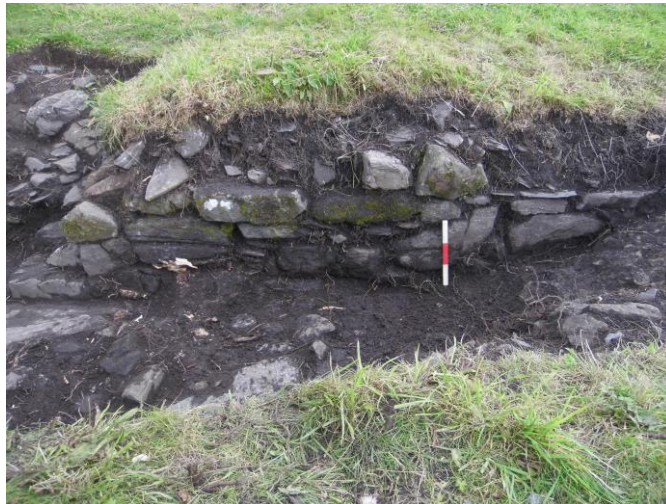
Abutting wall [005] at the north end of the trench was wall [006] which incorporated a drainage channel [008] at its northern end (measuring 0.30m wide). The wall stood up to 0.54m high and was more roughly coursed than wall [005] with no evidence of mortar used in its construction, although this might have more to do with weathering along its external face than actual absence.

Platform? wall [006]

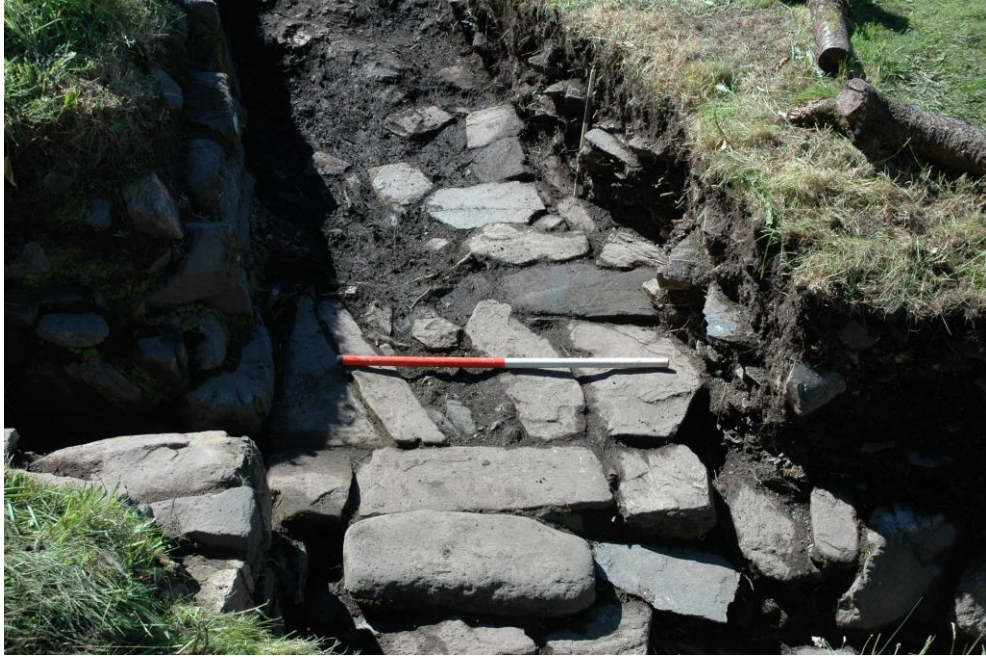
To the south of wall [005] and west of wall [006] were the remains of a well worn paved surface [007], consisting of large angular flat blocks of sandstone, split cobbles and slate. The surface lay opposite the entrance into the building at the north and might also have led to a door into a related building at the west although this has to remain speculation. The surface did not continue into the southern part of the trench and here ridges of natural bedrock were exposed. While this absence of paving may be due to robbing (and some disturbance by tree roots) it seems more likely any such paving was originally absent in this part of the trench with some flat slates providing a less robust surface.

Paved surface [007]

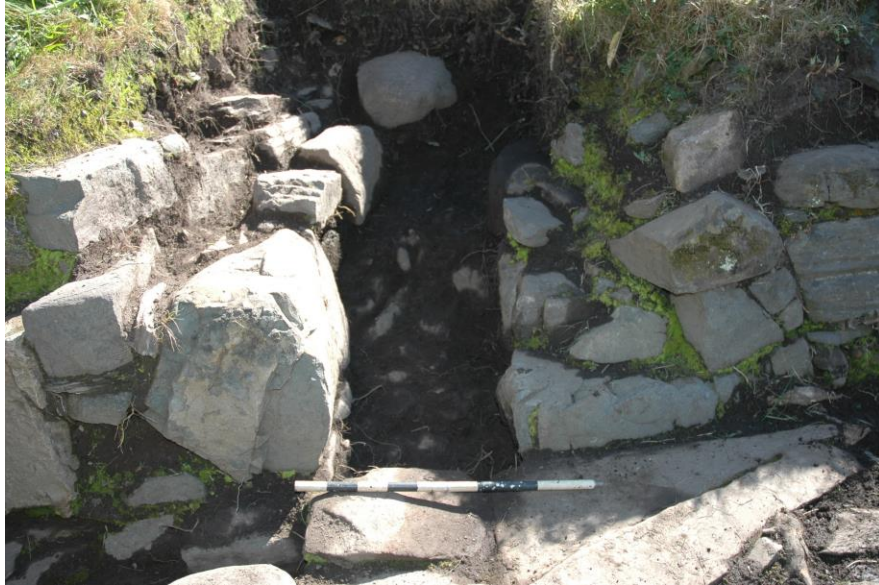
Towards the eastern part of the trench no such capping or covering was observed, suggesting that any such covering had been robbed or the drain was open in this part of the trench. The drain covering at the westernmost part of the trench was sealed by a deposit of crushed stone and sand [014]. This very likely represents the remains of a floor and is possibly associated with the upstanding structural remains beyond the trench to the west. No eastern wall to this structure was positively identified in the trench, although two substantial stones [015] revealed in section might delineate the eastern side of a building (Figures 10 and 13).

Drain [008] at east of trench

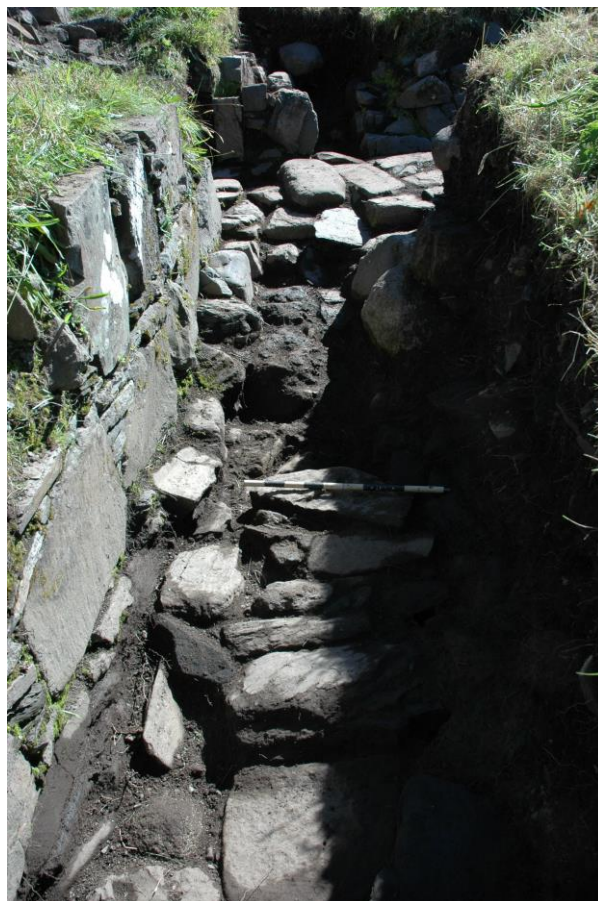
As mentioned above, drain [008] runs down the southern side of wall [005] and leads to a chute in the western wall of the courtyard surround [009]. At the north the drain is formed by a stone-lined channel running through wall [006]. It then runs through floor [007] before descending downslope through a rough-cut bedrock channel into a stone covered conduit (which presumably leads to the chute in the outer courtyard wall). The conduit was constructed with stones forming ledges either side, these supporting a stone capping, some of which had partially collapsed/subsided. Within the covered part of the drain was a dark grey clayey silt [013], although little of this was excavated and no artefacts recovered from this deposit.

Covered drain [008] at western end of trench

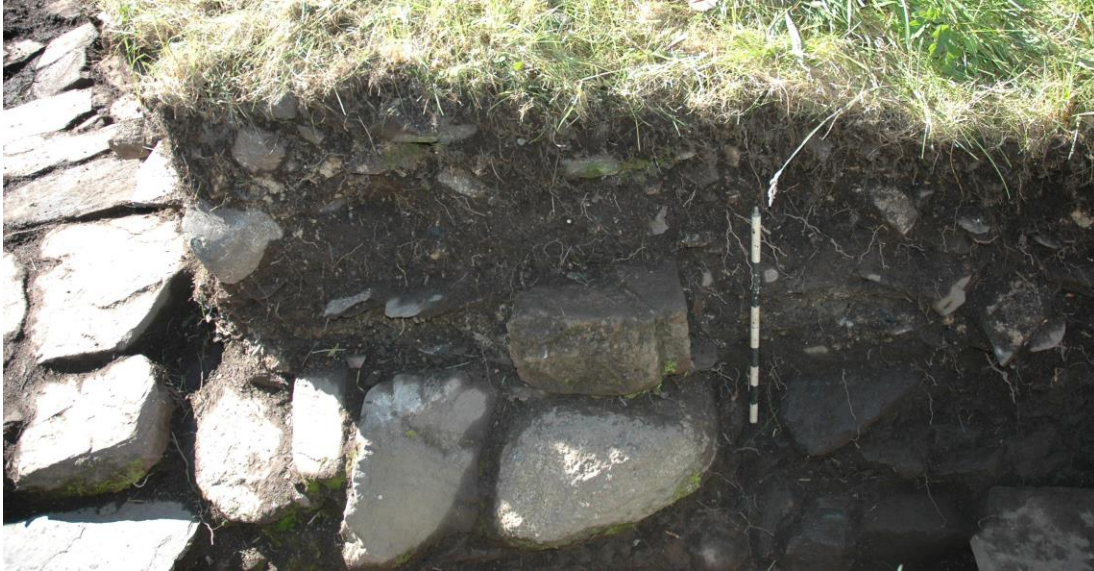
Possible wall footings [015]

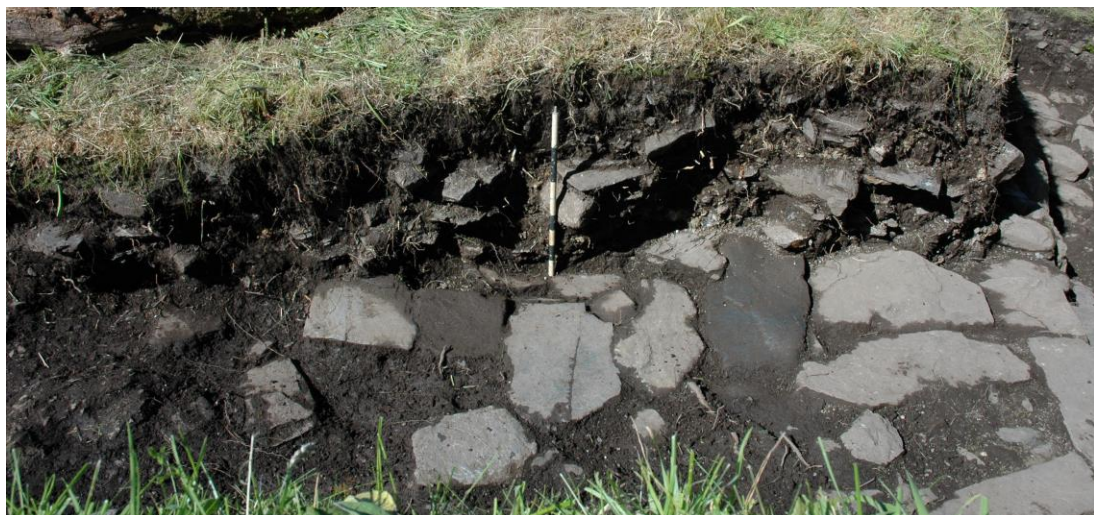
Both deposits [004] and [012] were sealed by what appears to be mainly demolition material [003], this mixed with some midden material. The demolition material [003] consisted of small to medium angular stones in a dark grey silt up to 0.43m in depth. This deposit also contained fragments of roofing slate and frequent fragments of mortar. The relatively small size of the stones within this deposit suggests it represents robbing discard rather than building collapse.

Rubble deposit [003] above occupation/midden deposits and paved surface

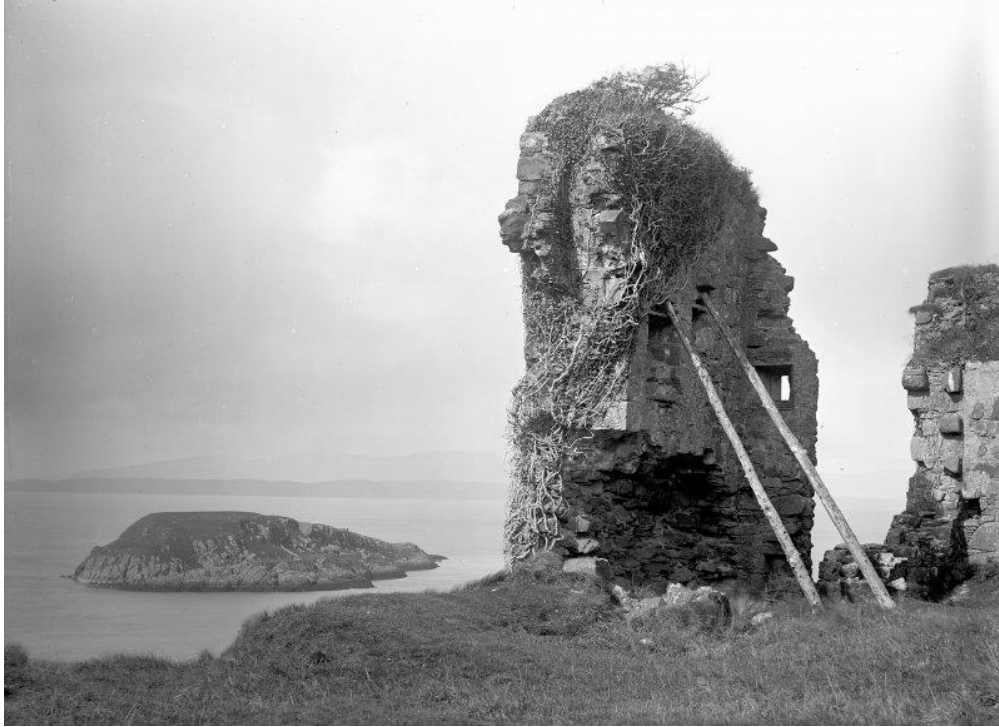
Photo SC 948543

When the trench was originally excavated is still unknown although it must have been before 1975 as both the wall of the building in the north west corner of the courtyard [005] and the edge of the revetment platform [006] are depicted within the RCHAMS Inventory plan of the castle. Two photographs held by Historic Environment Scotland likely dating to the late 19<sup>th</sup> century (c1880, SC1242436 & SC948543) show the remaining 3 storied building on the west side of the courtyard. This depicts that the lower courses of the wall of this building had been badly robbed with two timber braces supporting the upper part of the wall. What also appears to be the remains of a chimney on the south side of the upstanding masonry is also shown in the photos, this now obscured by ivy.

The overhang created by the robbing in the curtain wall is depicted in an undated sketch in the MacDougall Collection showing that it formed part of a cage to house a golden eagle, the eagle appearing in a poem written by William Wordsworth on a visit to Lorne in 1831 (MacDougall 2008). Since the time of the above photo the robbed part of the wall has been repaired and this repair work coated with cement based render. At the southern end of the previously excavated trench (just above the drainage chute as shown in Figure 10) the render of this repair stops abruptly indicating the original ground level when the repair work was undertaken, indicating the trench must post date the render repair. What is also apparent from the present survey within the courtyard was evidence of a trench that has been excavated against much of the inner face of the courtyard curtain wall (Figures 9 and 14). MacGibbon and Ross's plan of the castle, published in 1887, does not depict the two windows at the southern end of west curtain wall which suggests these were obscured when they described the castle. If both trenches were excavated at the same time then the most we can say at present is that they were likely excavated sometime after c.1887 and before 1975 (although it is tempting to see the recovered 1919 coin of George V as dating the excavation work).

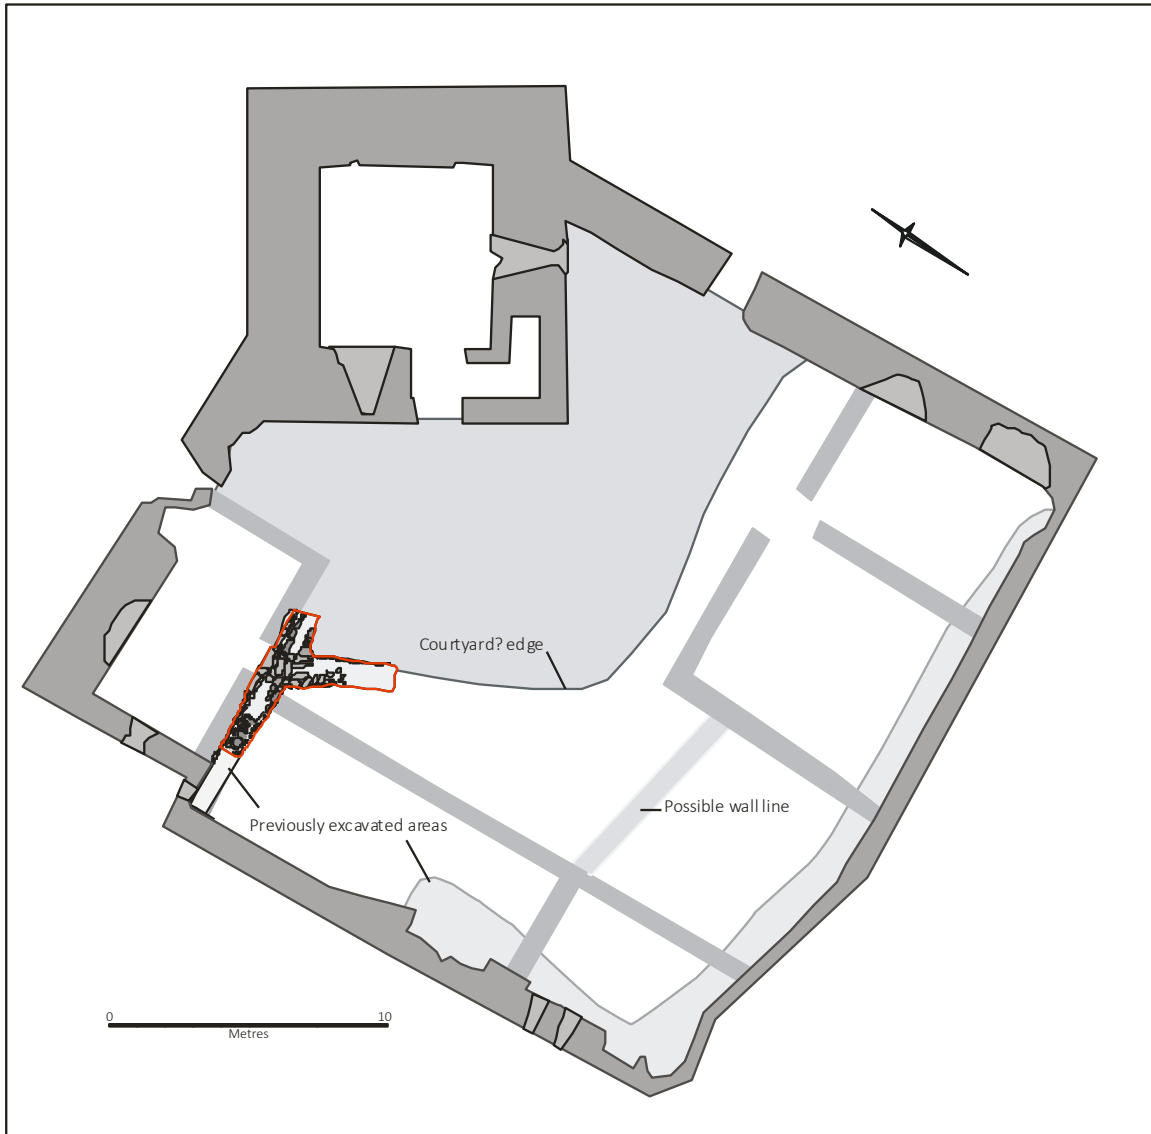
Figure 14: Interpretation of courtyard features

The survey work within the courtyard of the castle confirmed what are likely to be the remains of a suite of buildings situated around the curtain walls. Figure 6 shows the measured earthworks while Figure 14 below suggests a possible building layout.
