DUN FHINN

Ardtalla Estate, Kildalton, Islay

Survey and Excavation

Data Structure Report

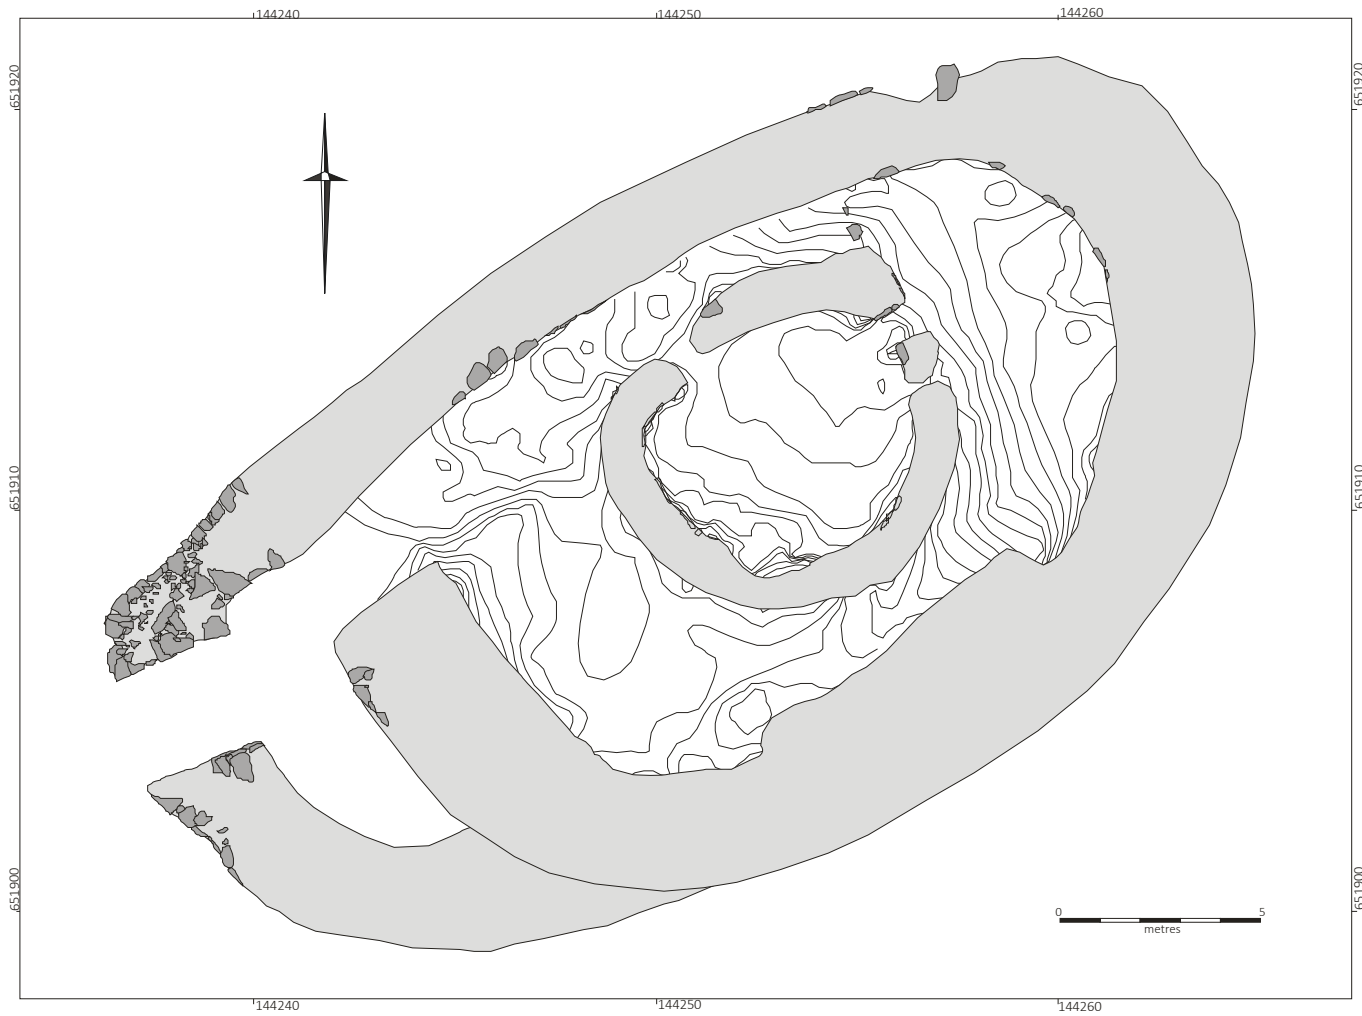
Figure 9: Plan of Dun and Roundhouse Structure

The near circular structure within the dun measures between 6.0-6.40m in internal diameter with walls up to 1.20m thick and standing up to 0.60m above the present ground surface. The RCAHMS entry in the inventory states that this circular enclosure is a later addition to the original dun and while this may be so, elsewhere this structure would have been recorded as a hut circle or 'homestead' and there seems no reason why this is not also the case here. Remnants of a circular or sub circular structures can also be found within the forts of Creagan an Ceardaich Mor, Dun Beag and Loch Nan Clach. Without the surrounding dun walls this structure is decidedly exposed when compared to other potentially later buildings recorded during the survey such as sheilings which have been constructed in relatively sheltered positions and are smaller than the structure within the dun and several sites lie on the same ridge to the south. Hollows and uneven ground on the outside of the dun entrance on the SW side, may represent some cell structures as suggested above but at present these are too amorphous to reach any definite conclusion as to their form. Again, as mentioned above, a structure lies below the dun on the NE side and while this might represent a sheiling structure it appears larger and more substantially built and might possibly be related to evidence of nearby quarrying.

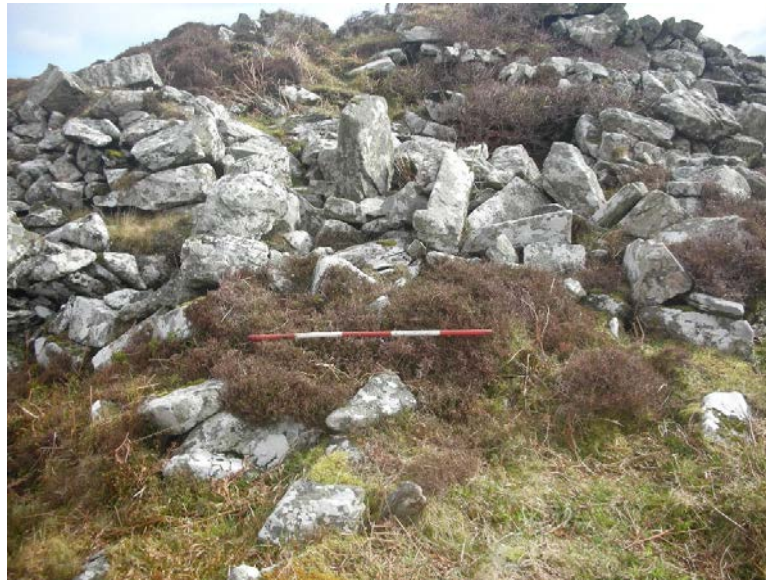
The rubble filled lower entrance through the dun outwork

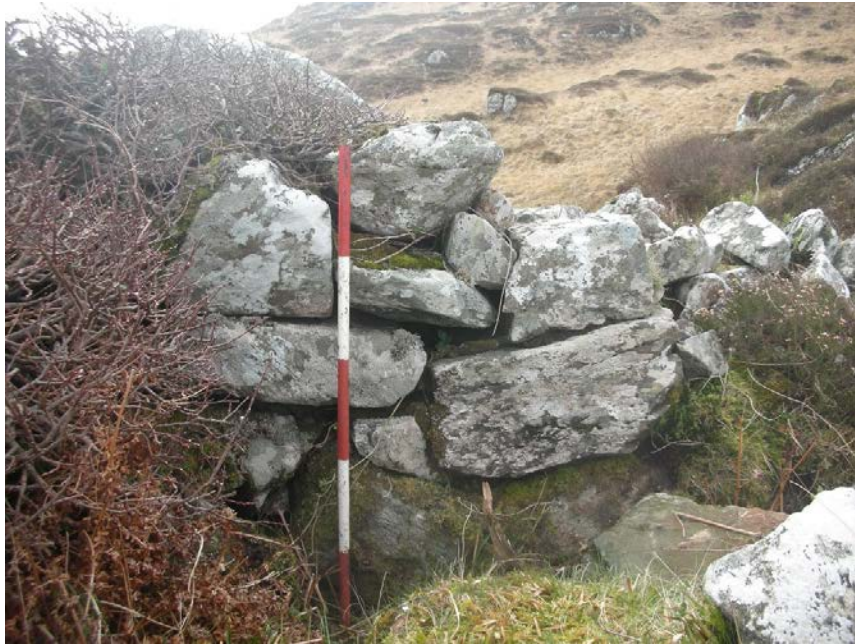
Facing stones of the eastern side of the entrance

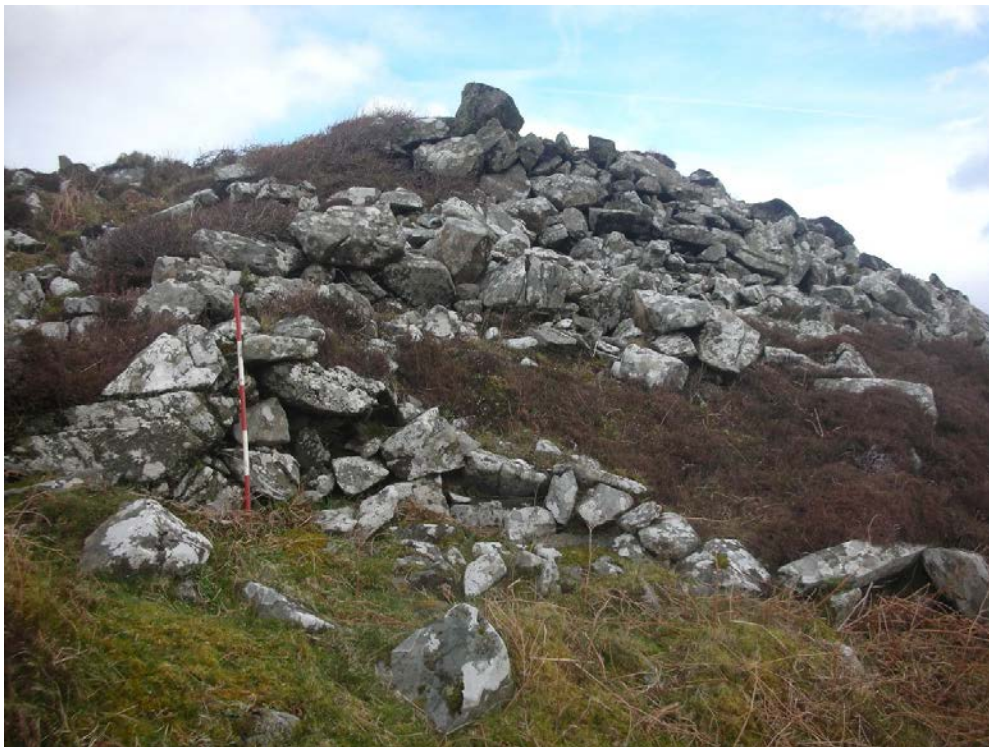
The lower out-work facing stones with the distorted facing stones of the dun wall above

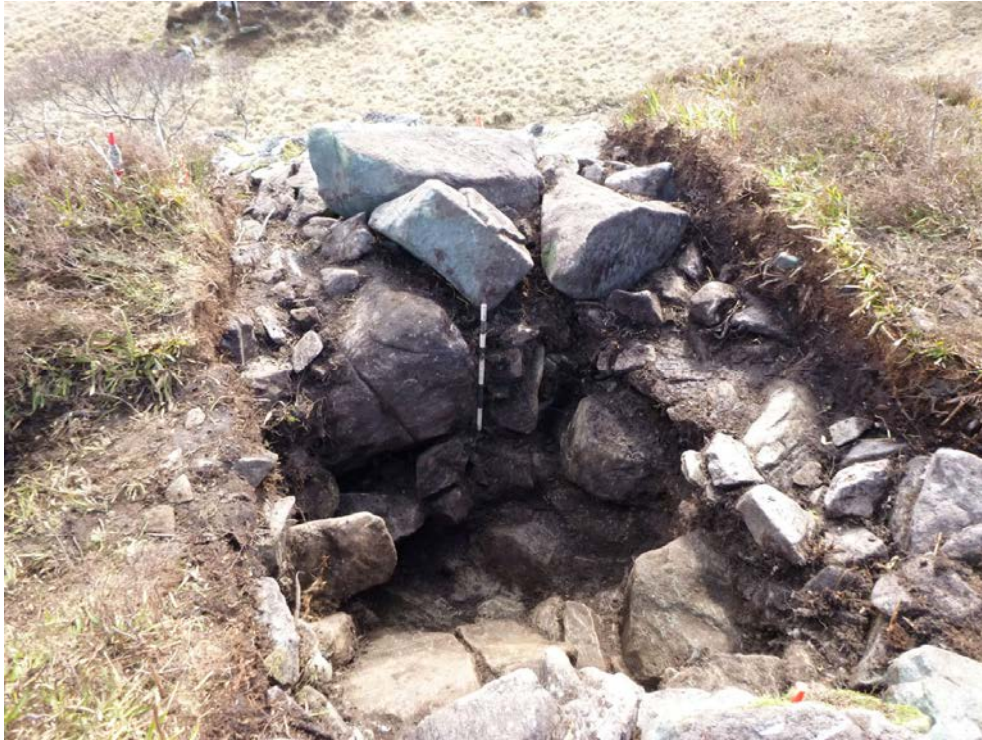
Internal face of dun wall [006] from the north east

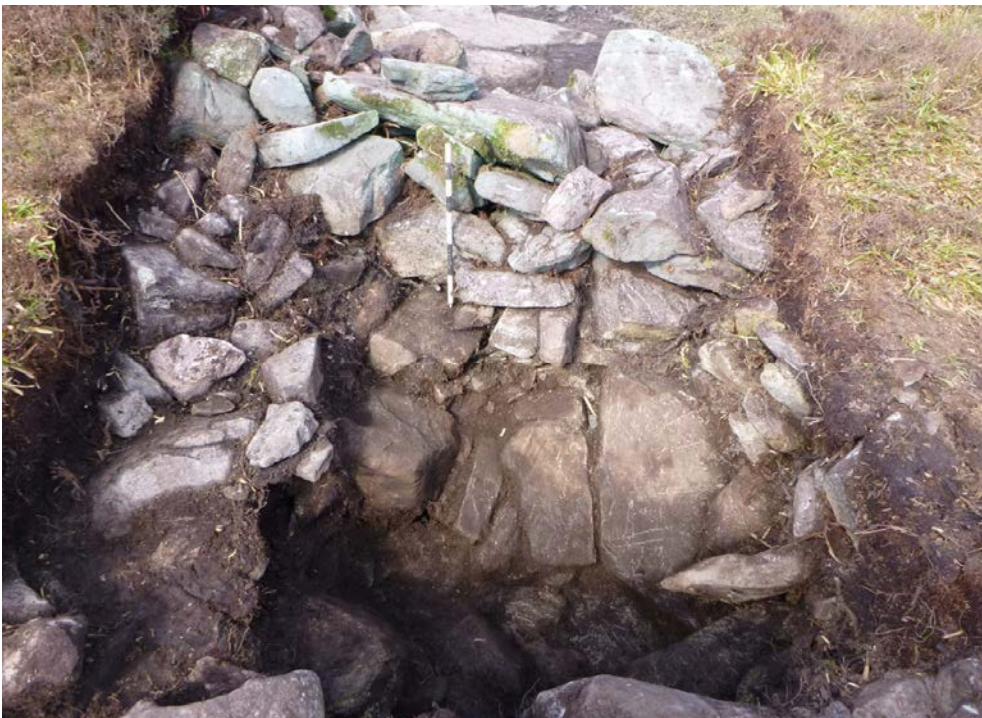
External face of roundhouse wall [005] from the south west

As mentioned above the eastern side of the roundhouse wall [005] was constructed from irregular and roughly coursed stone blocks. Internally within the roundhouse a large linear block of natural bedrock [020] had been utilised in its construction, providing the basal course for the wall. The bedrock here was higher than that encountered in the trench to the east, suggesting a drop off in that direction. If this slope was uneven or irregular then this may account for the rather rough look of the roundhouse wall on its external face, which may be due to slippage.

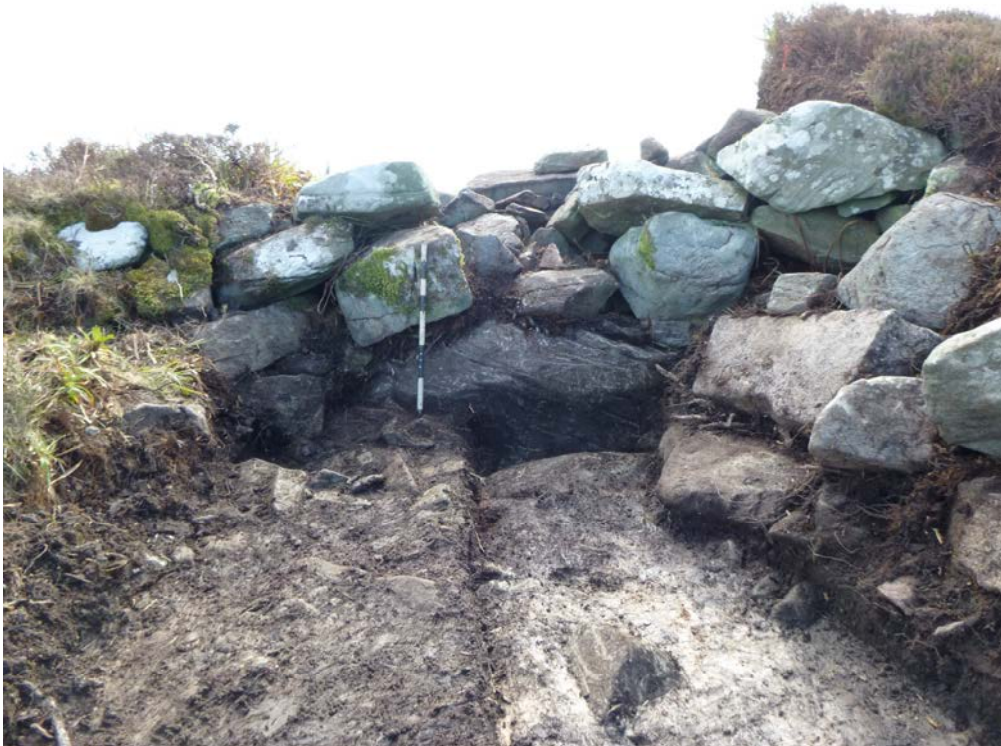
Internal face of roundhouse wall [005] from the north east

Above this bedrock the internal wall of the roundhouse was constructed with larger blocks of stone providing the facing stones of the wall with smaller stones used in the internal packing. To the west of the wall face bedrock was also encountered just below the vegetation in the central area of the roundhouse and at the extreme western end of the Trench. Between bedrock forming the base of the wall and the bedrock in the centre of the trench was a natural deposit of light grey/white clay [019]. The clay at this eastern end of the trench had a sub-circular patch of harder material [016], this coloured red brown and that may represent a patch of burning. Sealing this was a dark grey silt deposit [012] that contained charcoal fragments, this and its dark colour suggesting it was an occupation derived accumulation.

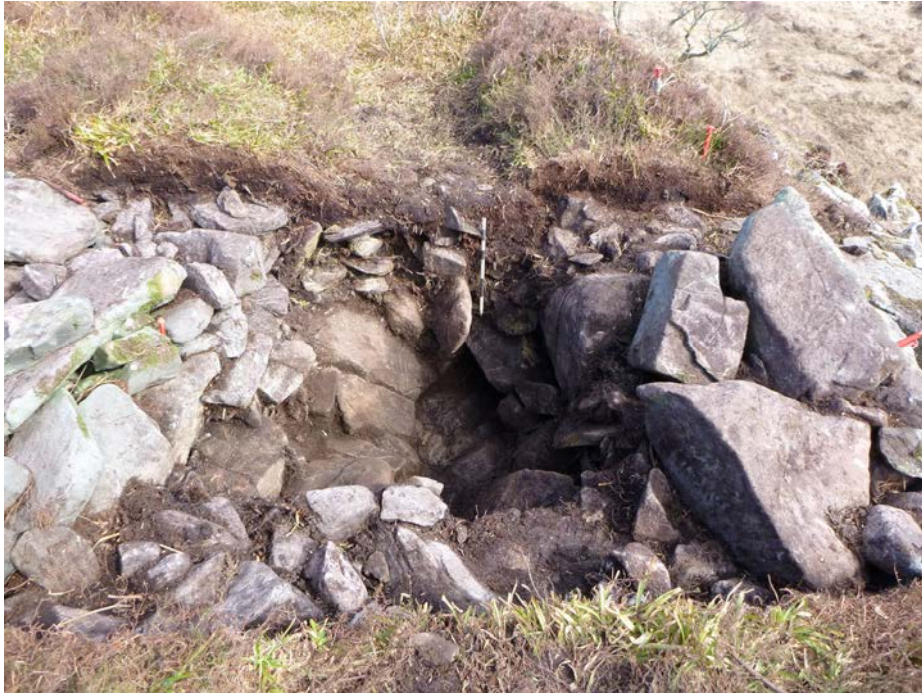
Section between dun and roundhouse walls from the west

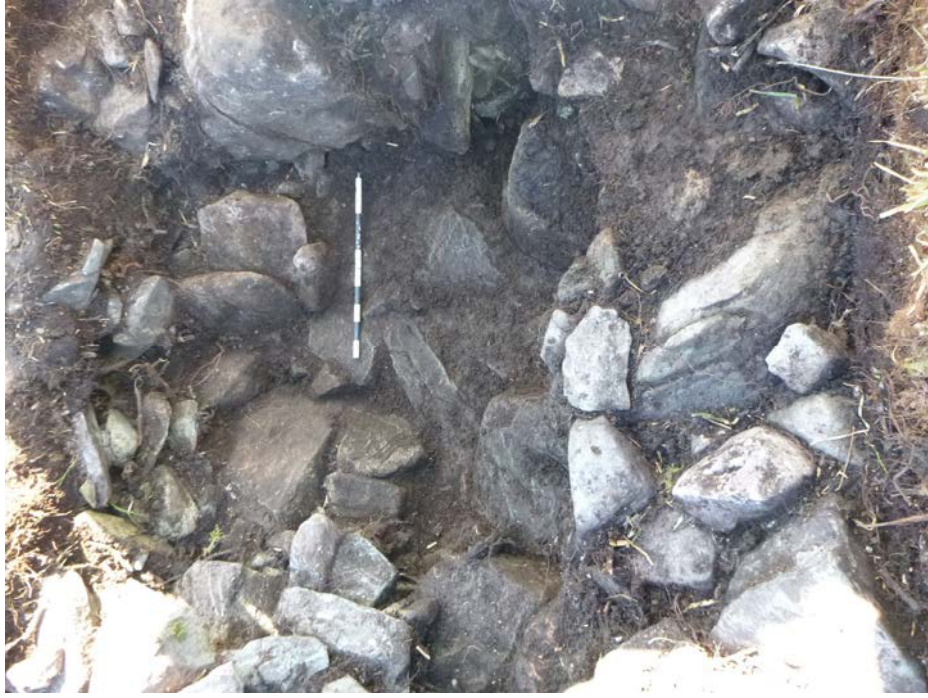
Rubble [013] between dun (at top) and roundhouse walls from the north

Natural bedrock [020] was encountered between the walls of dun and roundhouse, some 1.09m below the present ground surface, although its exposure was limited. It seems likely the dun wall was constructed from this height although, given the space restrictions within the trench at this depth, the physical contact between the natural bedrock and the base of the wall was not observed. The internal wall face of the dun [006] was constructed from large boulders, possibly levered into position. Lying over natural bedrock and against the wall face of the dun was dark brown silt deposit [015], which contained occasional charcoal fragments and also produced some very degraded pot/fired clay fragments. The presence of the charcoal and the fired clay fragments suggests this represents an occupation build up or dump within this part of the dun, between the dun and roundhouse walls. This deposit was under rubble deposit [013] and as such may have continued to the outer face of the roundhouse wall. However, this relationship was unproven as large stones (part of [013]) could not be removed, partially due to the stones continuing into the section and partially because their removal may have destabilised the extant roundhouse wall. The unexcavated stones of [013] however, sloped down distinctly from the north west to the south east suggesting they lay against the roundhouse wall [005] (Figure 16). Deposit [013] was an extensive dump of stones and rubble which at its lower level lay within mid brown silt that contained some charcoal. Above this was a similar deposit of rubble [004], although this lay within a lighter brown soil although between the stones were also numerous voids the later suggesting the stones had been rapidly deposited, possibly being collapse from the dun wall.

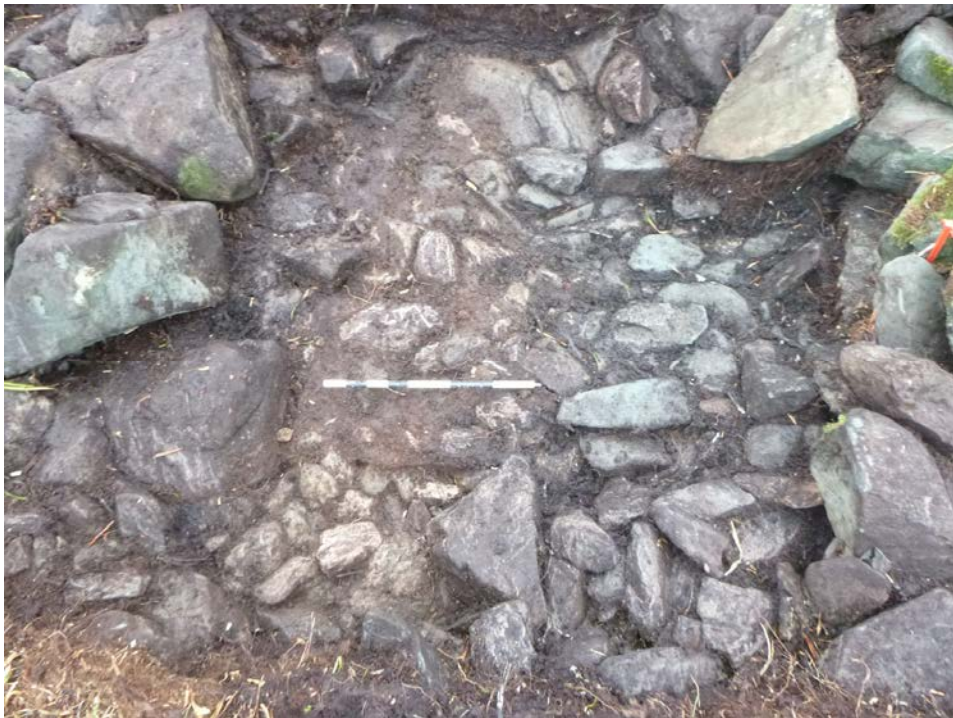
Top of rubble [004] between dun and roundhouse walls from the east

The upper extent of this rubble had the appearance of a cobbled or trampled surface, over which had accumulated a mixed deposit of silty peat-like material [002]. This 'peat-like' material was different from the peaty overburden/topsoil that had accumulated over most of the site and it is possible it represents some form of collapsed roofing material or perhaps even stored peat.

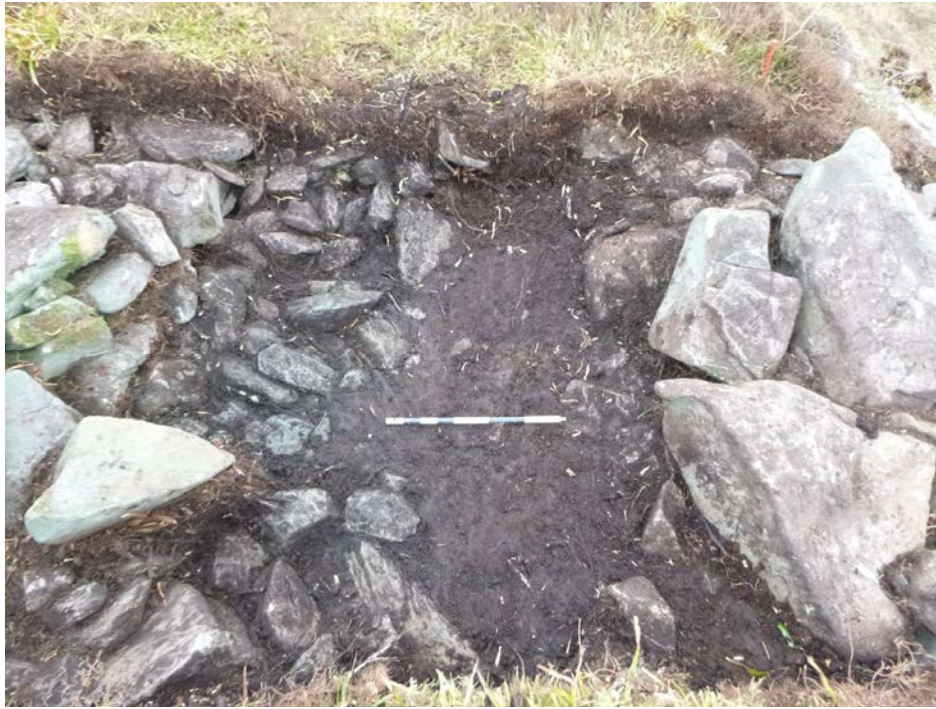
Peat deposit [002] between dun and roundhouse walls from the west

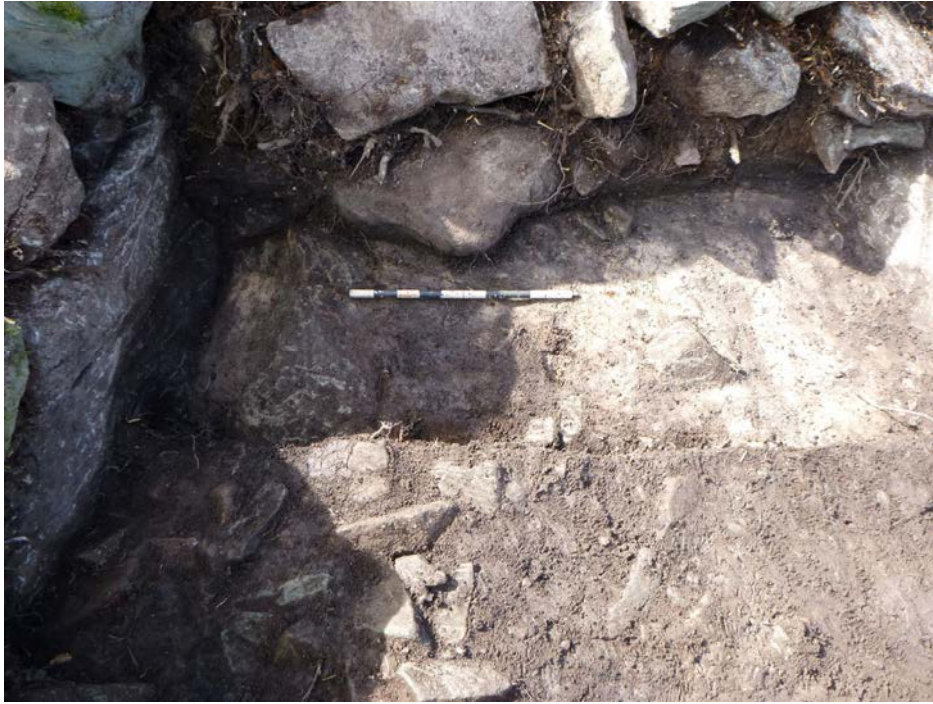
'Burnt' deposit [016] on clay natural [019] from the east

[016] Layer. Burnt? Area. Small sub circular patch of dark brown silty clay with occasional charcoal.

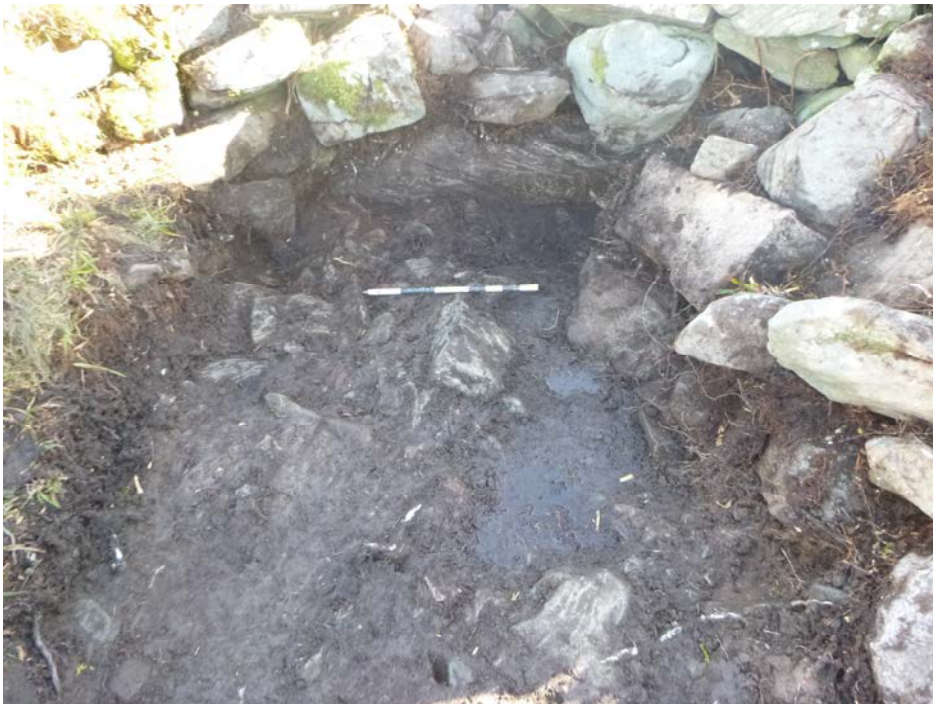
Deposits [012] and [011] against roundhouse wall [005] from the north

Above this was another dark grey deposit [011], that contained fragments of charcoal (but in smaller quantities than [012] below) along with one fragment of pot/fired clay and two utilised pebbles with surfaces smoothed through use. At the south against wall [005] this deposit contained more stones which gave the appearance of having been utilised as a rough surface. Above this were the stones from the collapse to the roundhouse wall [003], these within a red brown peaty silt, although in some places there were voids between the stones especially amongst the collapsed stones on the western side of the trench. On this side of the trench it could be discerned that at least four courses of walling had collapsed or been pushed over into the roundhouse interior, indicating the wall of the roundhouse was originally considerably higher.

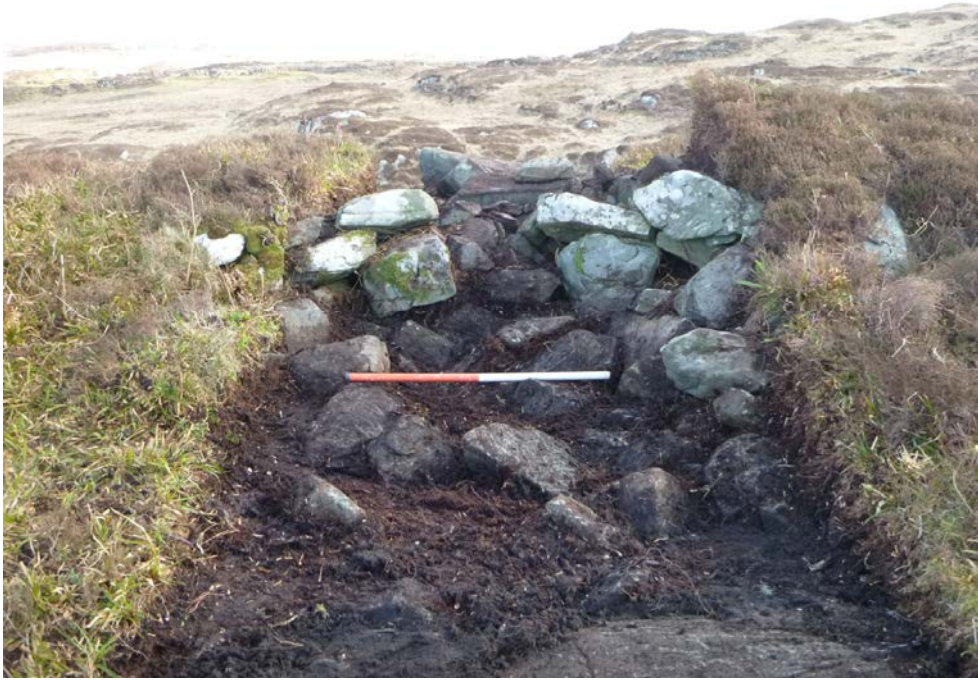
Rubble [003] within roundhouse structure from the north

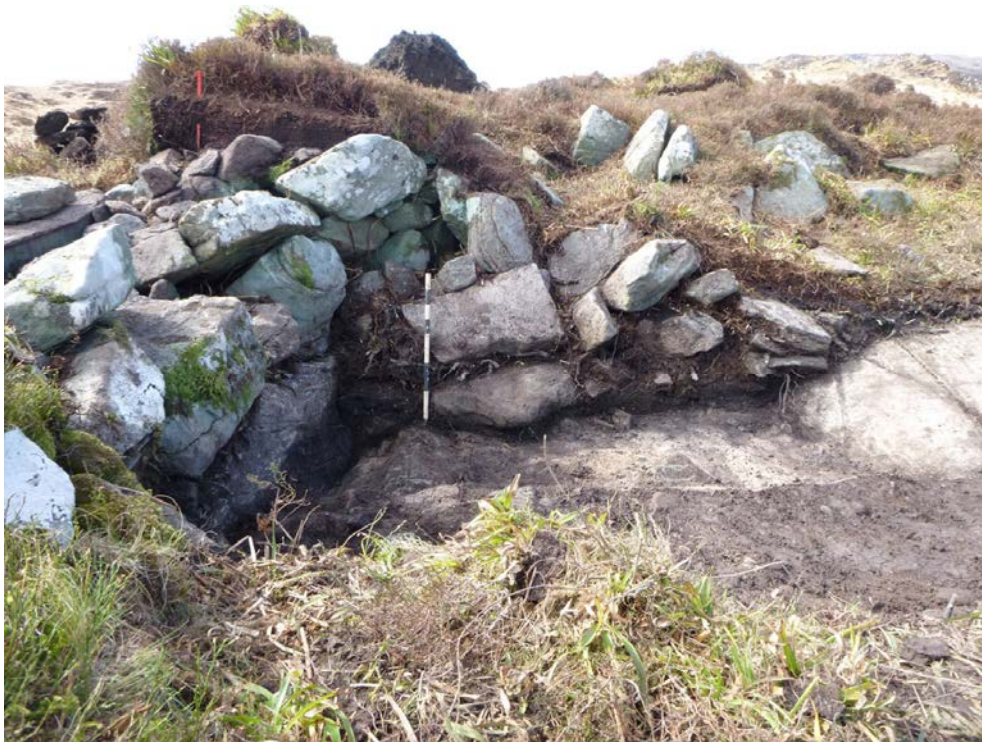
Section against internal face of roundhouse wall [005] from the east

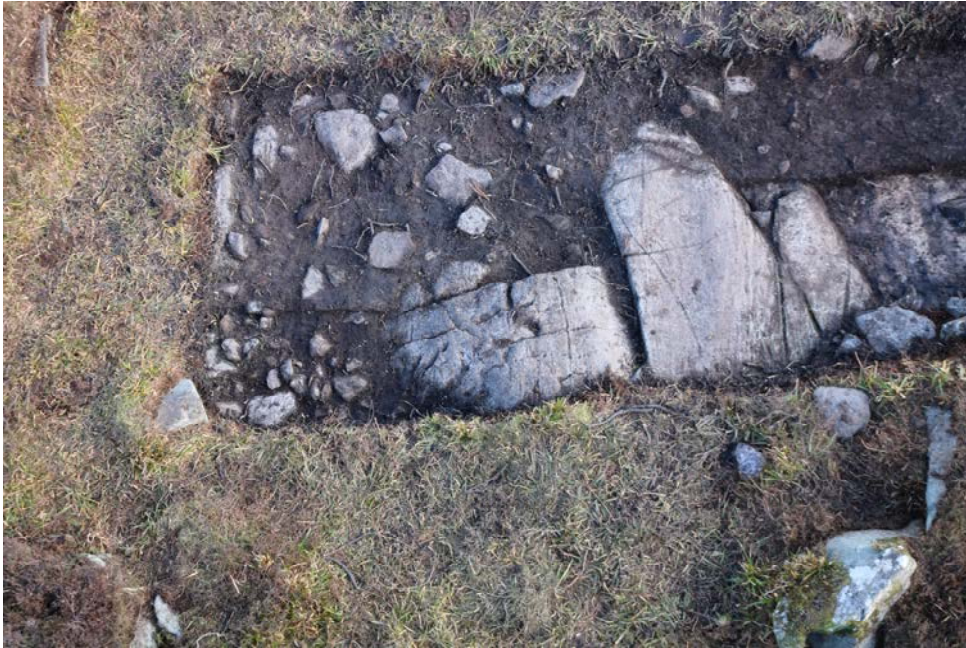
Deposits at north end of trench from the west above

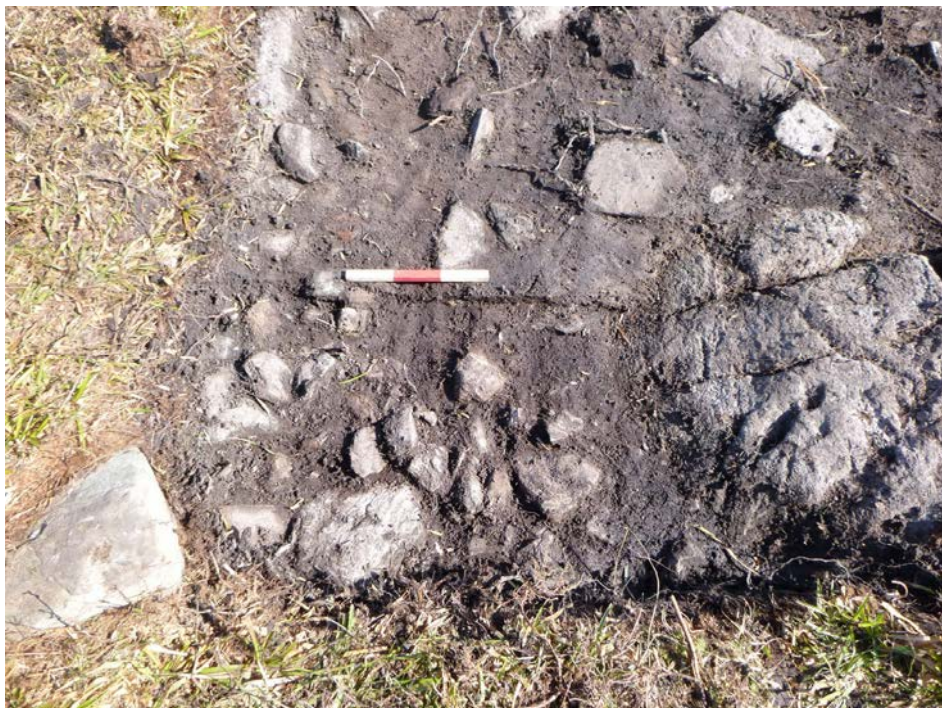
Surface [014] from the west

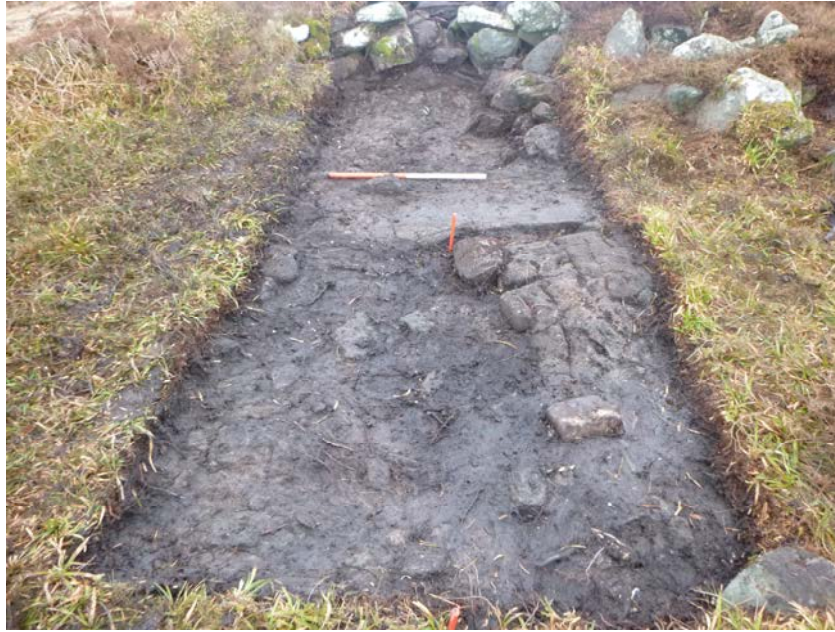
Deposit [010] (at north) and [011] (at south) from the north

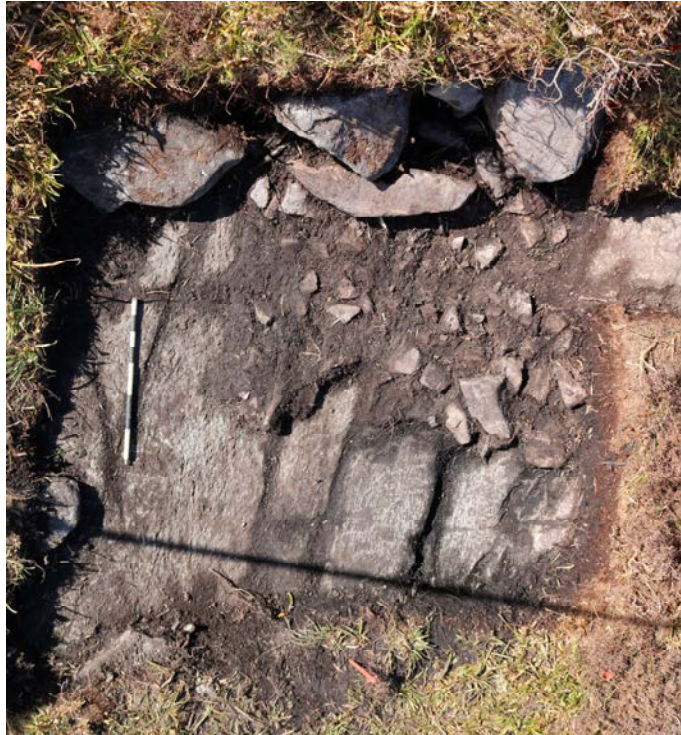
Trench 2 with partially excavated surface [009] from the east above

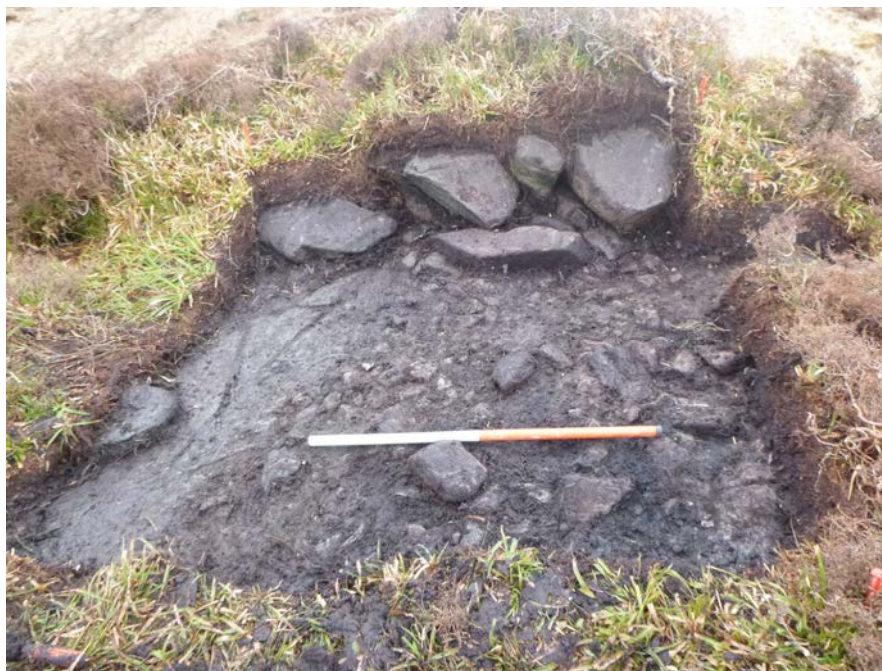
Surface deposit [009] from the east

[009] Layer. Surface/occupation deposit. Dark grey silty clay with moderate stones, pebbles and occasional charcoal. Some of the stones/pebbles appear to be slightly pinkish in colour which is likely the result of heat with the largest stone measuring 0.25m x 0.16m x 90mm.

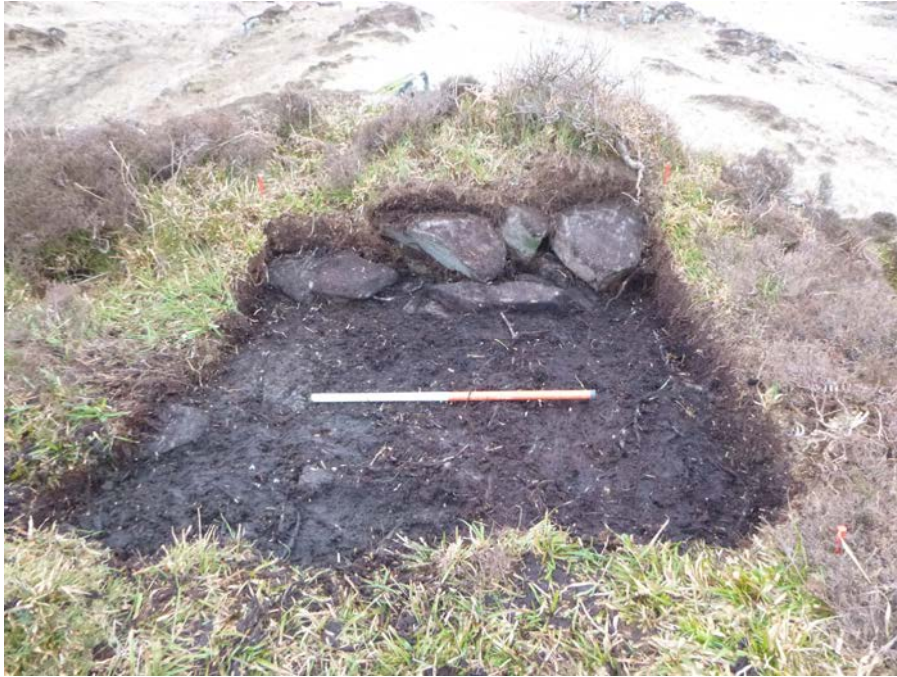
Deposit [008] from the east

[008] Layer. Occupation deposit. Dark grey humic silt, includes occasional stones and charcoal.

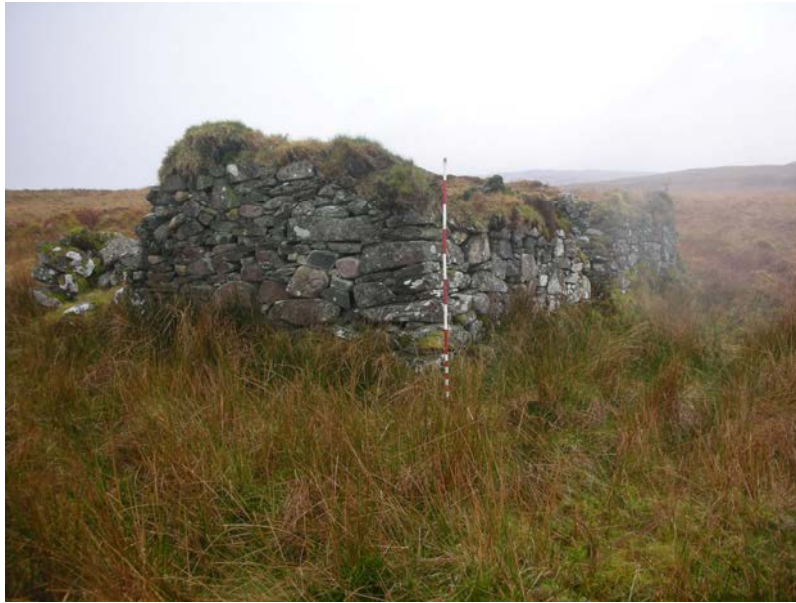
Staoin, Structure 1

Rectangular rubble built structure oriented NS and measuring 10.80m long and 6.6m wide externally. The walls in part stand to probable full height up to 2.1m. The building has two opposed entrances although the one on the side has been blocked. There is evidence of clay and sand mortar/packing within the walls.

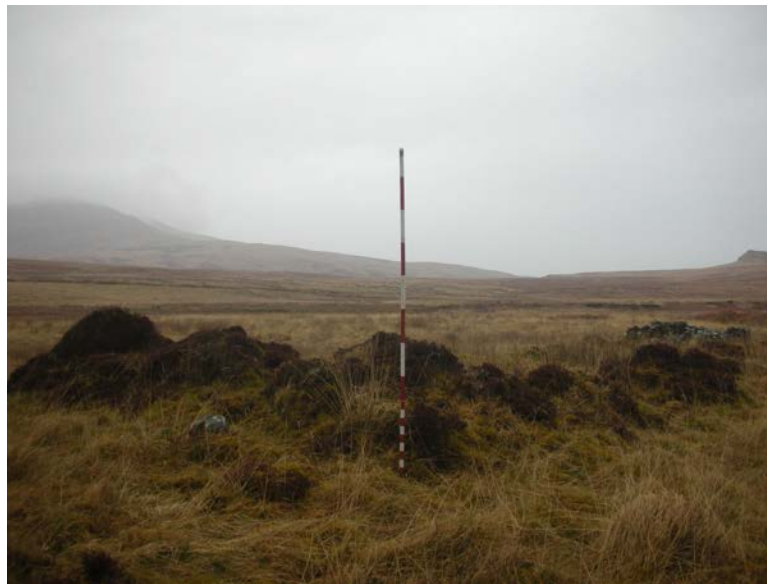
Staoin, Structure 2

Rectangular rubble built structure oriented EW and measuring 13.8m long and 7m wide externally. The denuded/robbed walls stand up to 0.60m in height. The building has two opposing entrances within the W end of the structure.

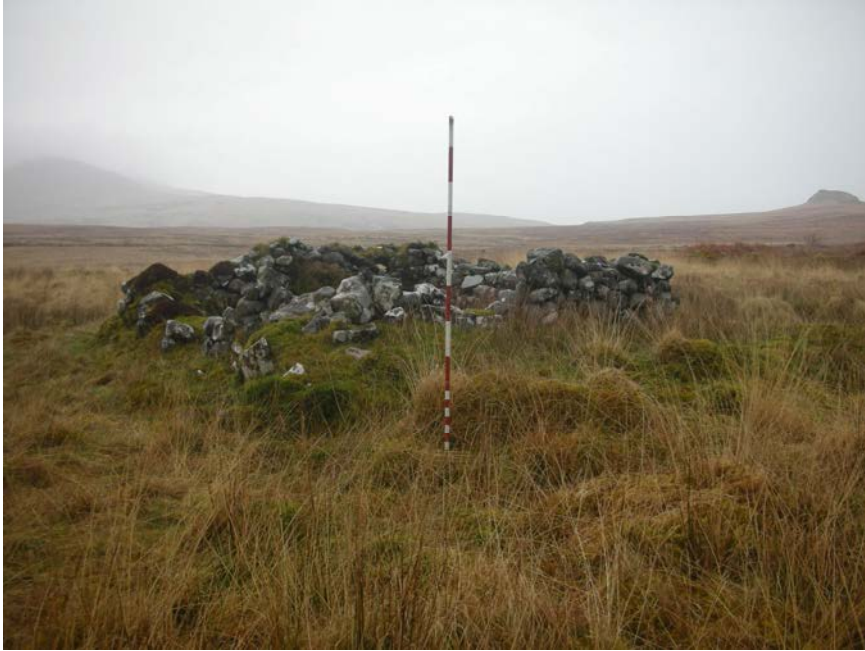
Staoin, Structure 3

Rectangular rubble built structure oriented NW/SE measuring 6.0m long and 5.40m wide externally. The walls stand up to 1.50m in height. The building has an entrance on the SE side. The building appears to have been shortened as footings of what may be an earlier version of the building extend 2m to the NW.

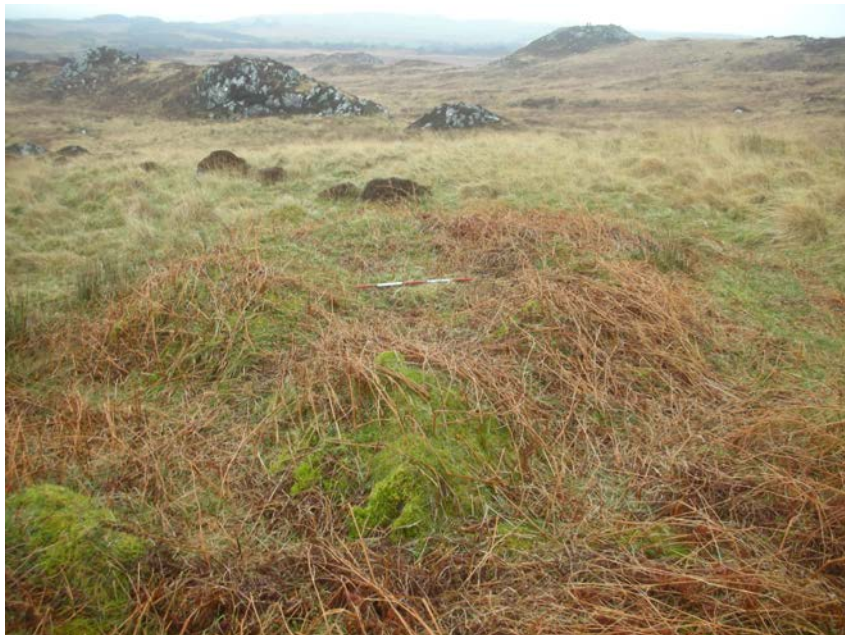
Staoin, Structure 4

Spread of rubble representing remains of oval? structure oriented NW/SE measuring c8.30m by 6.10m.

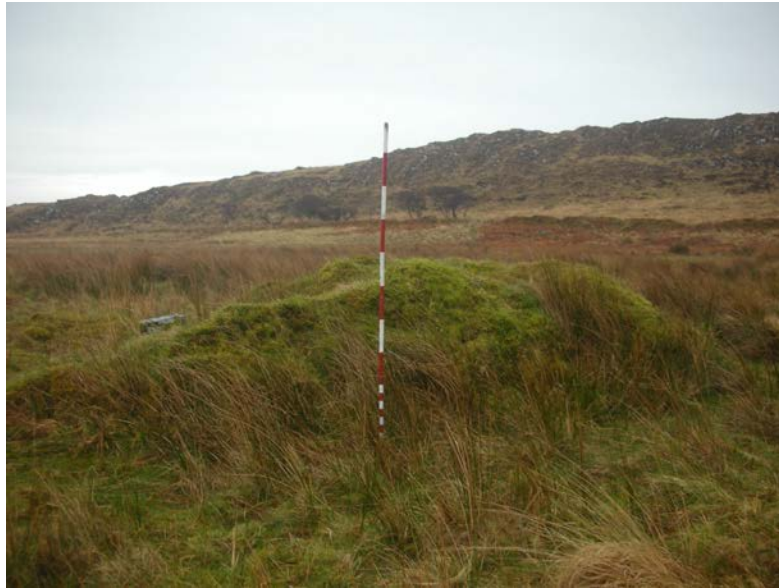
Staoin, Kiln

Overall the structure measures 7m by 5m but the main oval kiln measures 5m by 4m standing up to 1.30m in height with a flue entrance on the E side. Footings of a sub-square structure or earlier kiln extend to the W and contain a smaller sub square arrangement of stones.

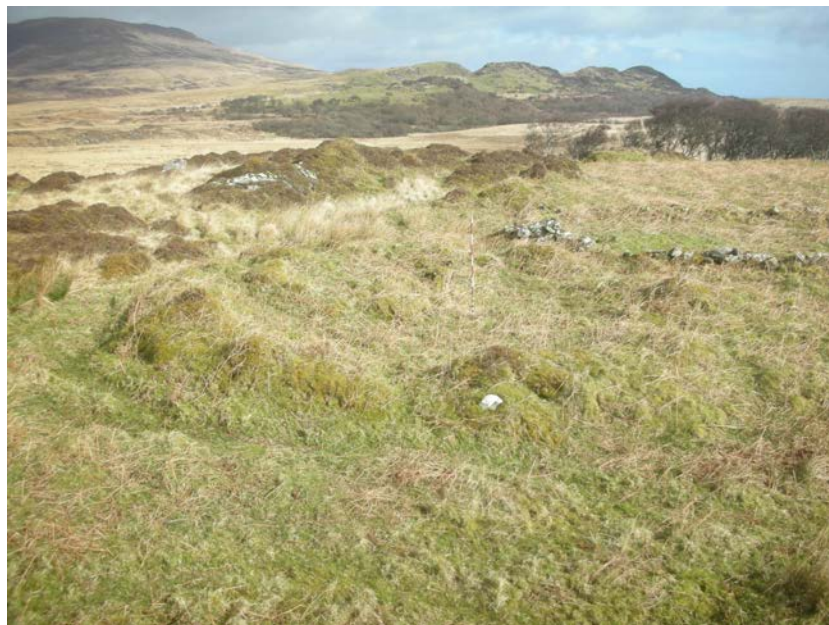
Site 14, Structure 1

Sub circular enclosure or structure measuring 12m by 11m externally with turf covered walls standing up to 0.6m high. The walls appear eroded and vary in width although 1.0m appears to be the most consistent. A gap on the SE east side suggests an entrance.

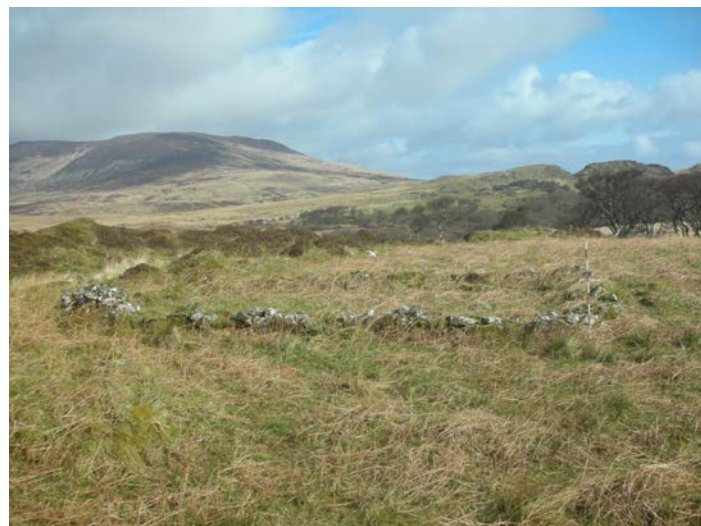
Site 14, Structure 2

Sub rectangular enclosure measuring 13m by 8.4m externally with walls generally 0.8m wide and standing up to 0.9m high with an entrance gap on its W side, although this may be due to robbing to construct a small twinning pen at the SW.

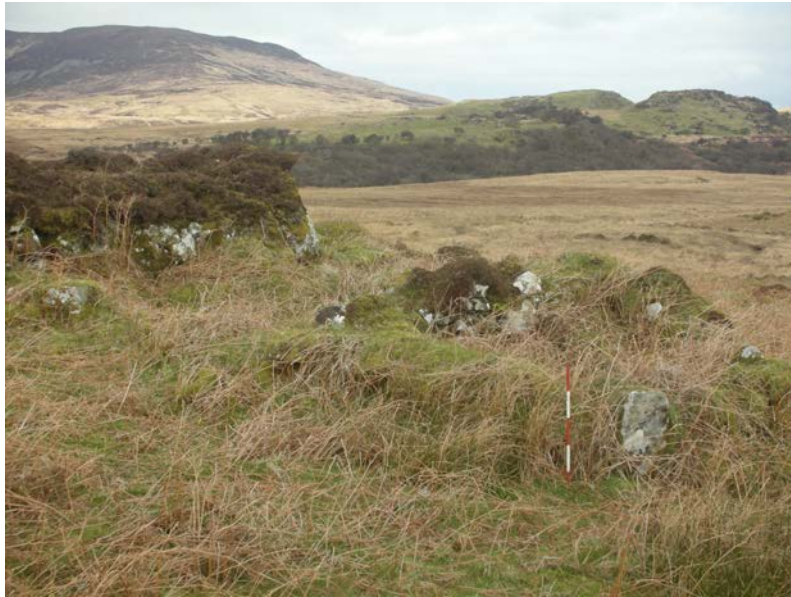
Site 14, Structure 3

Rectangular building constructed against a natural scarp which forms its NW side. The structure measures 9.8m by 4m externally with walls up to 1.2m wide and standing up to

1.8m. The building is divided into two parts by a cross wall with entrance gaps in the SW and SE sides.

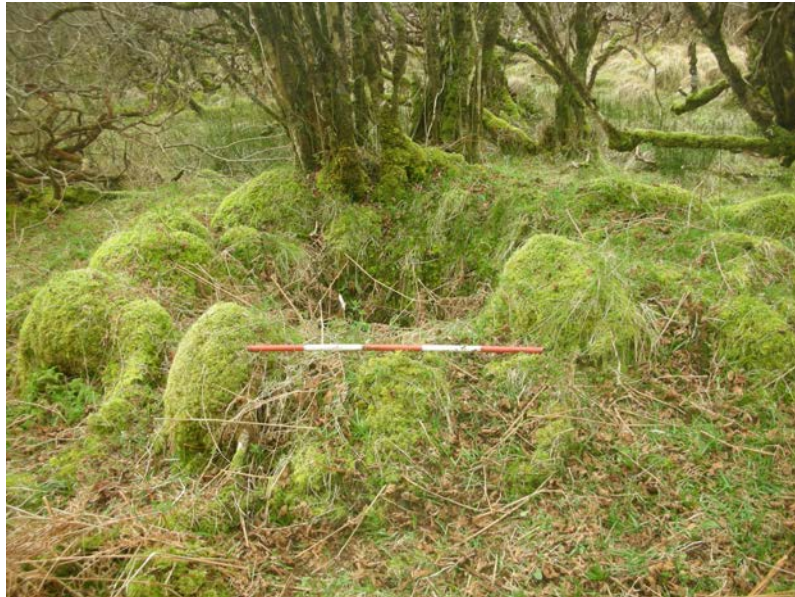
Site 15, Well

Circular stone lined well structure measuring 2m by 2m externally with walls standing up to 1.60m.

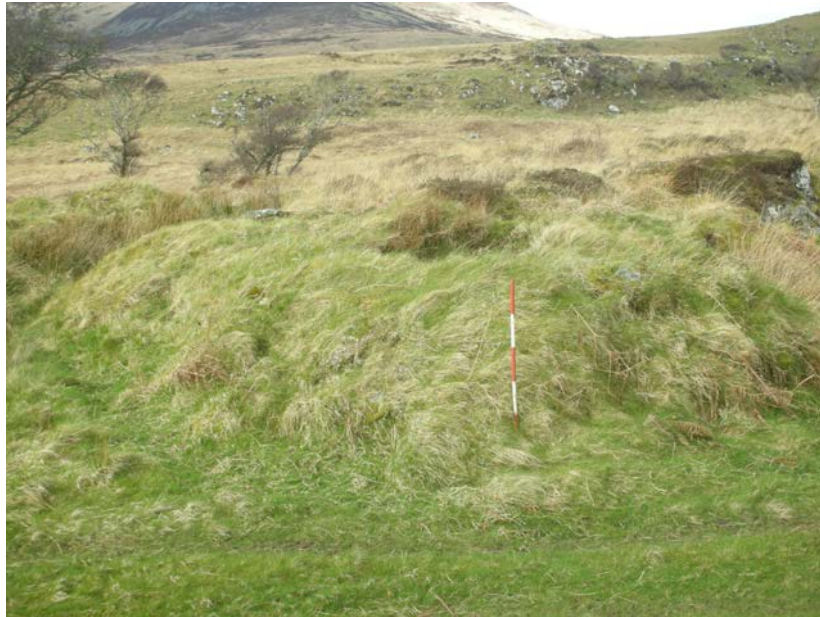
Site 16, Structure 1

Possible recessed platform or small enclosure with turf and stone walls sides. Measures 7m by 6m internally with walls standing up to 0.4m in height.

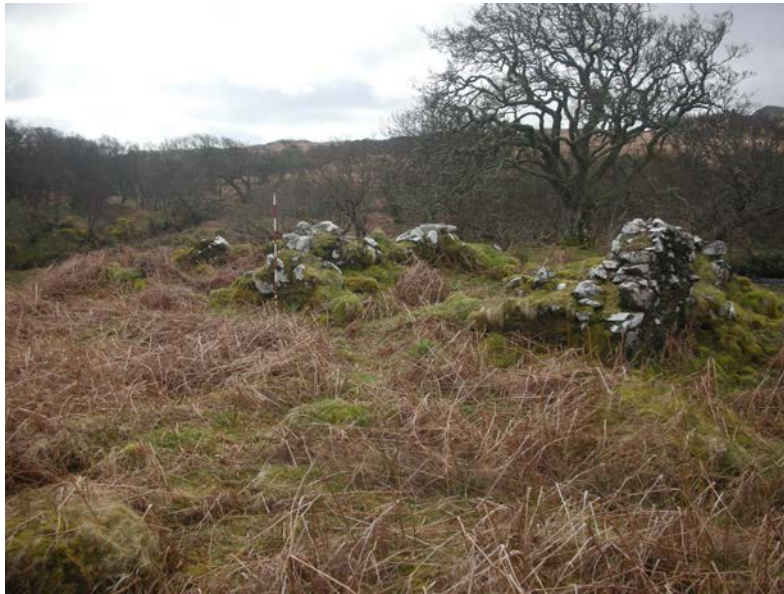
Creagfinn, Structure 1

Rectangular NW/SE oriented rubble built structure and measures 18m long and 6m wide externally with walls 0.60m wide and standing up to 1.7m in height. The building is divided into three parts with opposing entrances in the two northernmost divisions. Traces of an attached enclosed area 10m wide lies on the western side of the structure. Two twinning pens have been constructed within the northern room. The northern wall is best preserved and suggests a gable ended building.

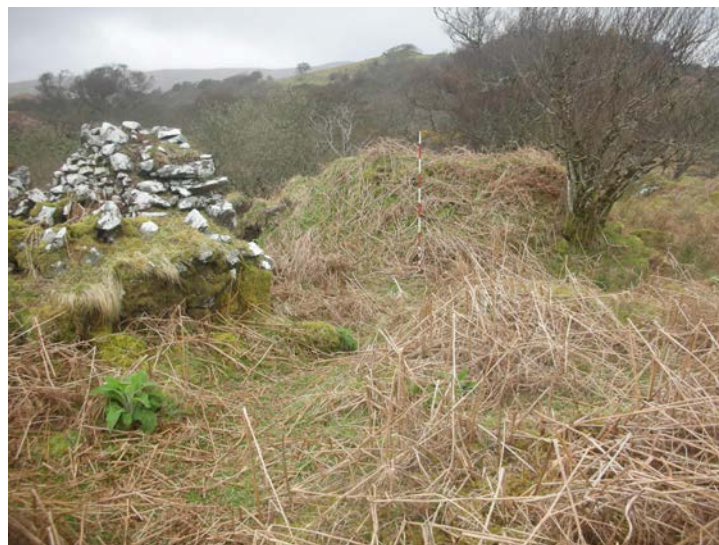
This kiln structure is sub circular in shape measuring 5.5 by 5m and stands to a height up to 2.40m above present ground level. The walls measured up to 1.40m thick around a central chamber, which was likely accessed on the SW side.

Creagfinn, Structure 2, Kiln lying NE of Structure 1
