DUN FHINN

Ardtalla Estate, Kildalton, Islay

Survey and Excavation

Data Structure Report

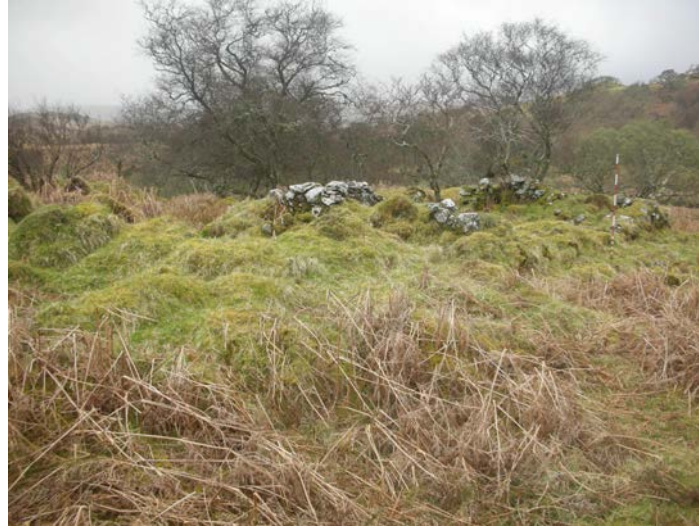
Creagfinn, Structure 3

Rectangular NW/SE oriented rubble built structure measuring 17.7m in length by and 6m wide externally with walls 0.70m wide standing in 0.70m in height. The building is divided into three parts with two entrances on the NE side. A twinning pen has been constructed in the corner of the southern room.

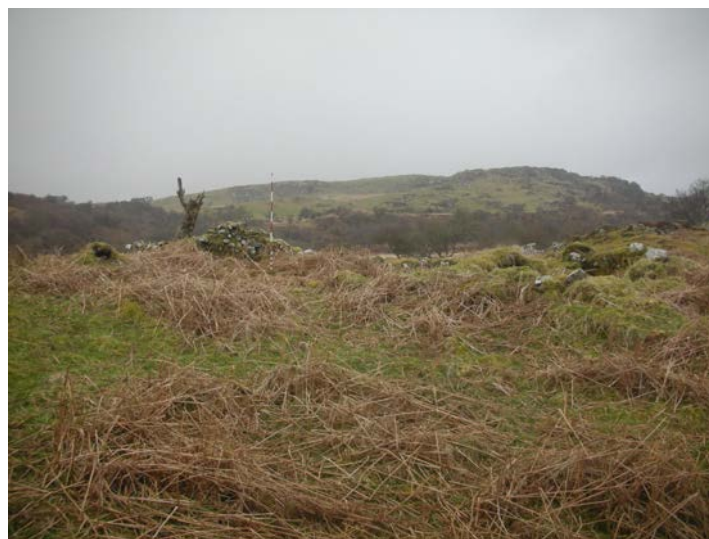
Creagfinn, Structure 4

This building in its original form may have been T shaped. At the W end are the footings of a SW/NE oriented rectangular building measuring 9.8m by 5.20m externally with walls standing 0.50m high. Over this has been built a smaller structure measuring 5.4m by 3.30m externally with walls up to 1.50m in height. This smaller structure is divided into two parts or rooms the northern most with a distinctly curving N wall. To the SE of these is what was likely an attached rectangular range which is oriented NW/SE, measuring 16m long by 6.1m wide externally and divided into three parts.

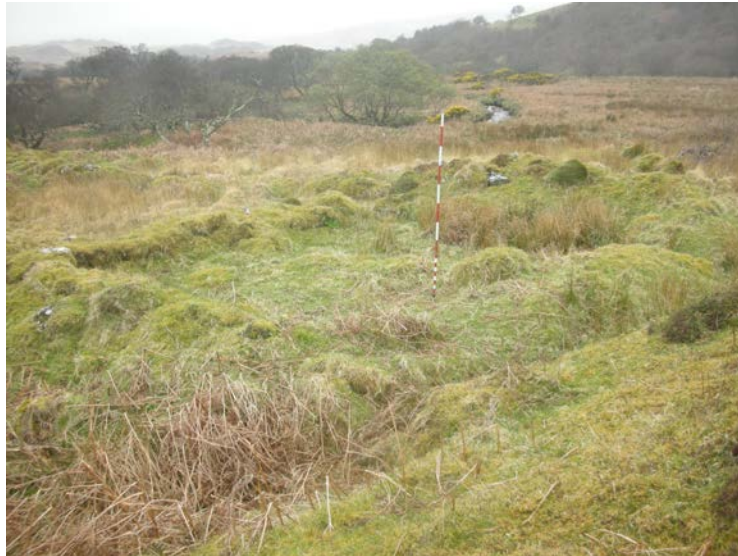
Creagfinn, Structure 5

Rectangular NW/SE oriented rubble built structure measuring long 11.30 long by 6.50m wide with walls 0.70m wide and standing up to 0.80m in height. The building is divided into two parts with opposed entrances in the northern room.

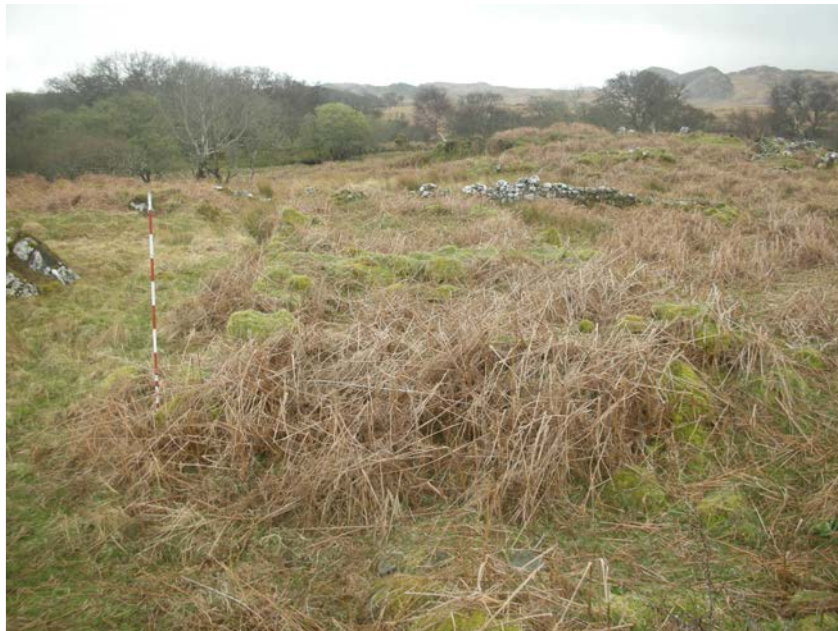
Creagfinn, Structure 6

Rectangular SW/NE oriented rubble built structure measuring 15m long and wide 5.50m wide with walls 0.70m wide and standing in up to 0.60m height. The building is divided into two parts with opposing entrances in the southern room and a single entrance in the SE wall of the northern room.

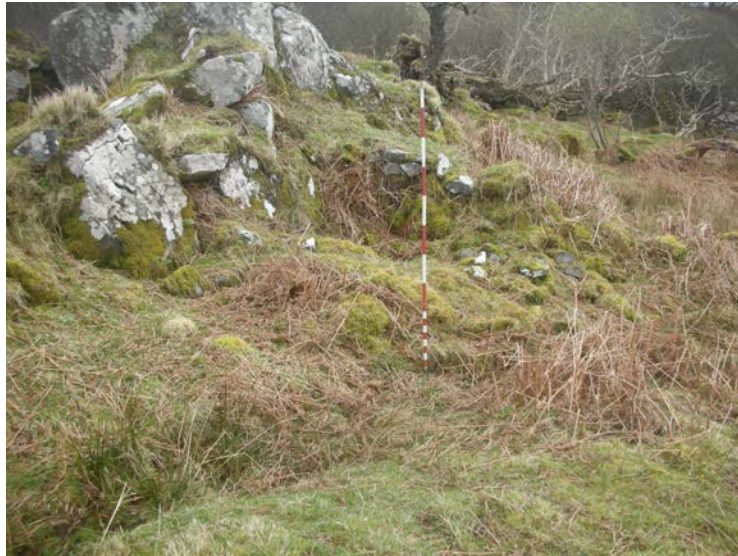
Creagfinn, Structure 7

This kiln structure was constructed against a natural scarp at the north and an enclosure wall on the east. The structure measured 4.0m by 2.70m with walls measuring 0.80m wide and standing up to 1.00m high.

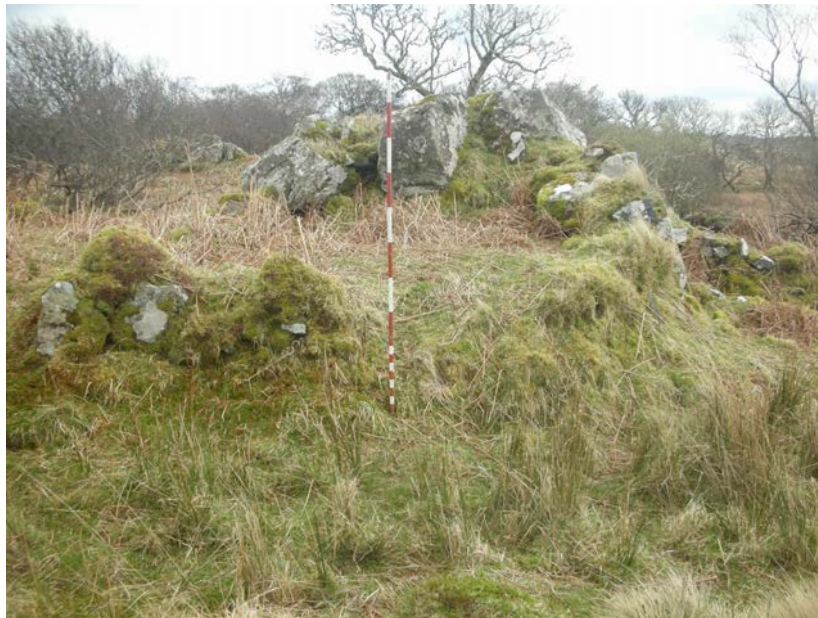
Creagfinn, Structure 8

This could be the remains of an irregular structure or a small enclosure measuring 10m by 8m with walls 0.60m wide and standing up to 0.45m high.

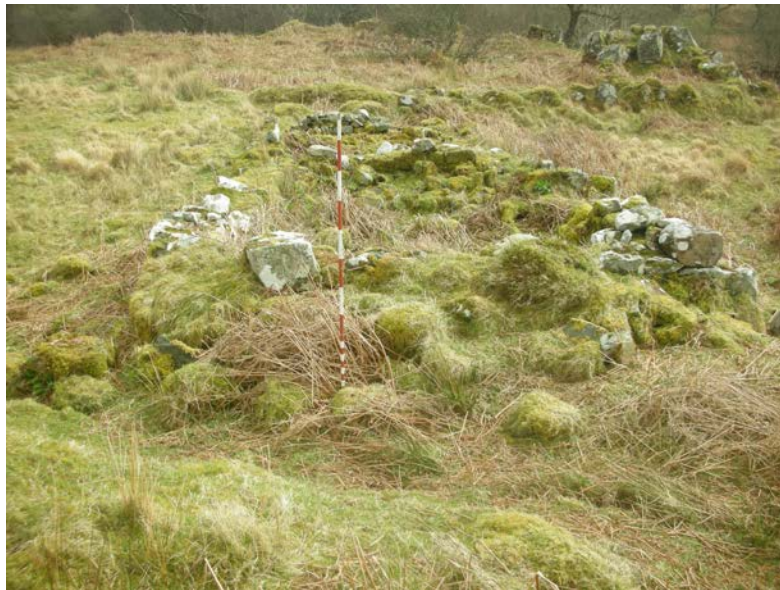
Creagfinn, Structure 9

Rectangular NW/SE oriented rubble built structure measuring 15.60m long and 5.80m wide externally with walls 0.80m wide and standing up to 1.15m in height. The building is divided into three parts (although what may be the remains of a later wall suggest a fourth division).

Two entrances on the south side of the building give access to the eastern and western rooms, while a now blocked entrance on the north side gives access to the central room or bay.

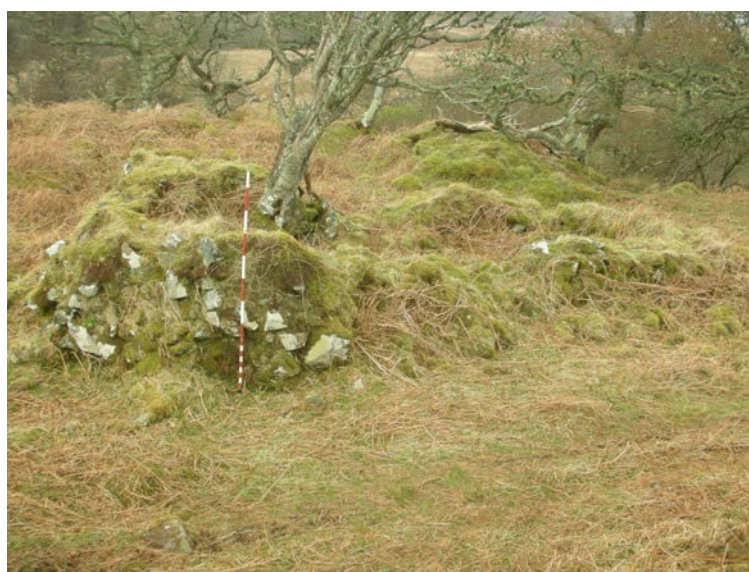
Ballore, Structure 1

Structure 1. NR 45500 52116

Oval E/W oriented rubble built structure with rounded ends measuring 7.80m long by 4.9m wide externally with walls standing up to 1.70m in height. The building has two entrances on either long side and is divided into two parts.

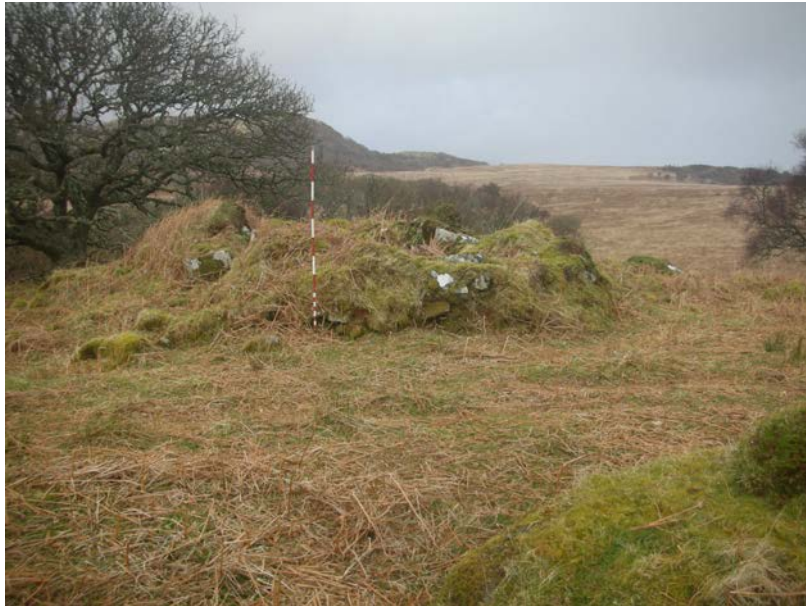
Ballore, Structure 2

Structure 2. NR 45521 52123

Oval SW/NE oriented rubble built structure with rounded ends measuring 8.70m long by 5.0m wide externally with walls standing up to 1.60m in height. The building has an entrance on the SE side.

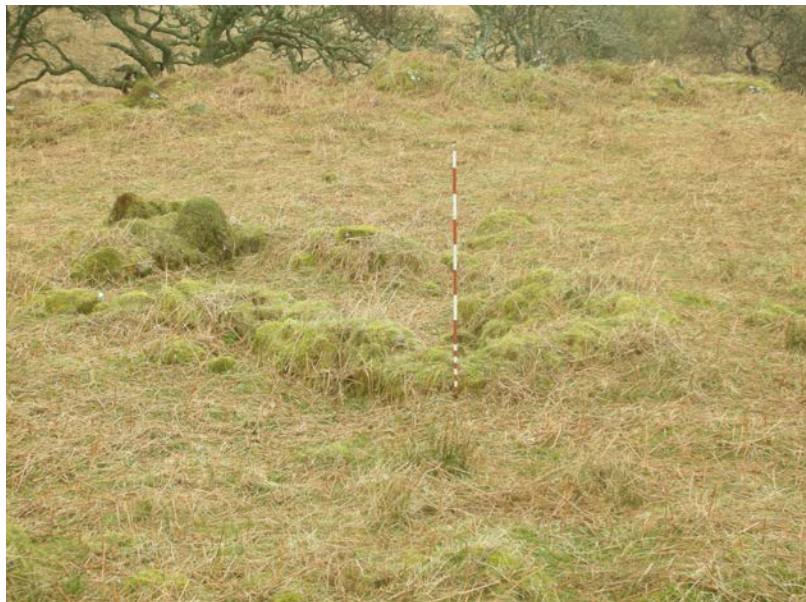
Ballore, Structure 3

Structure 3. NR 45529 52108

Badly disturbed remains of an oval SW/NE oriented rubble built structure with rounded ends measuring 9.5m long and 3.20m wide externally with walls standing 0.60m in height. The building is with an entrance on the SE side.

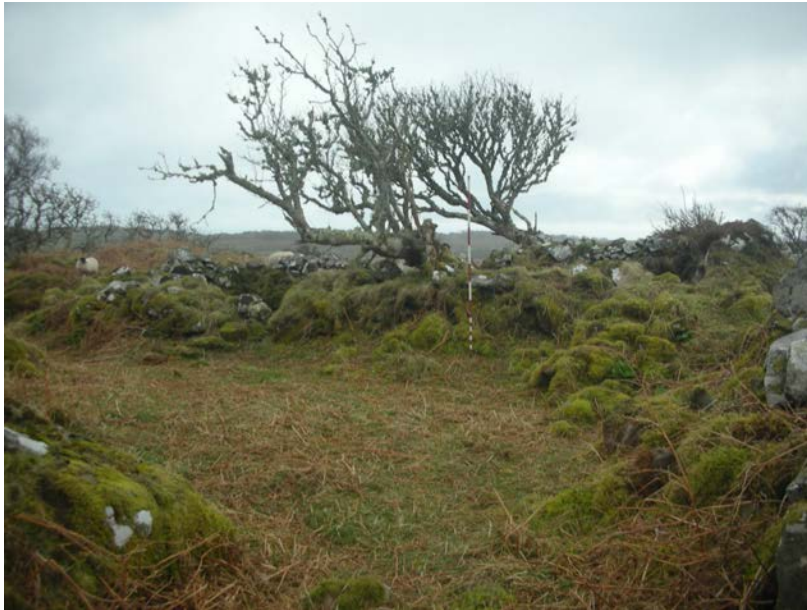
Ballore, Structure 4

Structure 4. NR 45556 52084

Oval E/W oriented rubble built structure with rounded ends measuring 12.4m long and 6.7m wide externally with walls standing up to 1.90m in height. The building is divided into two parts by a later? cross-wall and has opposed entrances on the long sides.

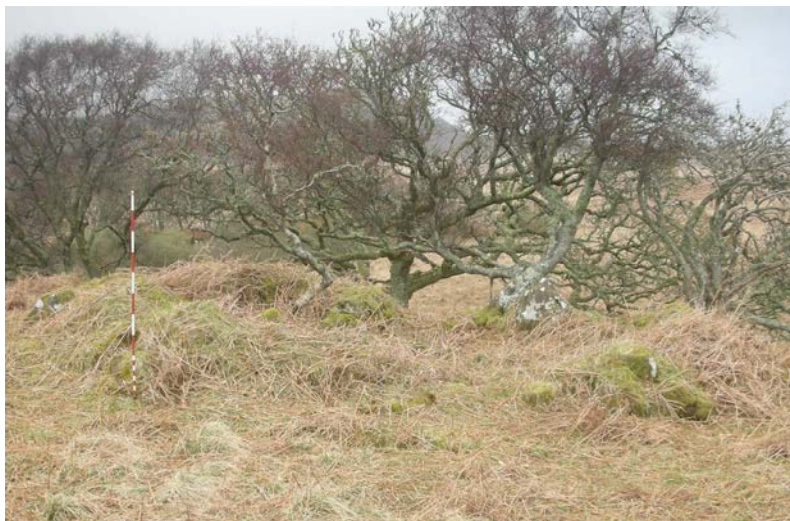
Ballore, Structure 5

Structure 5. NR 45532 52106

Oval SW/NE oriented rubble built structure with rounded ends measuring 9.0m long by 5.0m wide externally with walls standing up to 1.10m in height. The building has an entrance on the SE side.

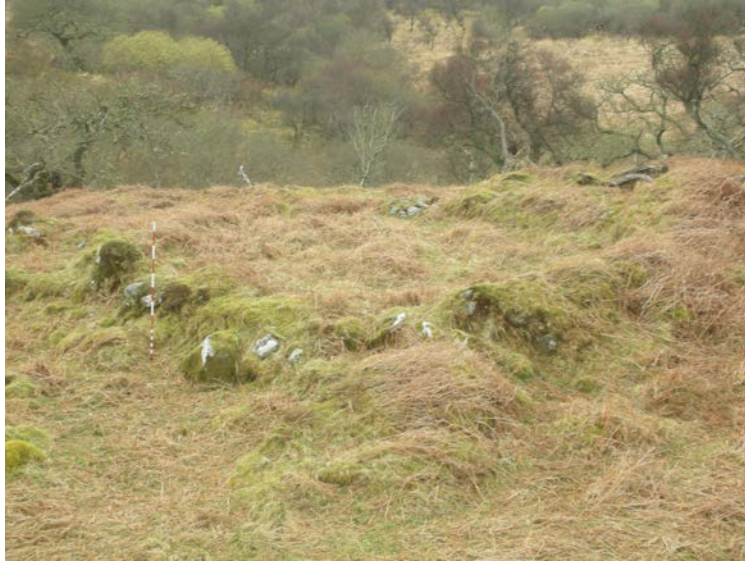
Ballore, Enclosure 1

Enclosure 1. NR 45489 52119

Oval turf and stone enclosure measuring 10.5m by 8.4m externally within walls up to 1.1m wide and standing to a height of 0.8m

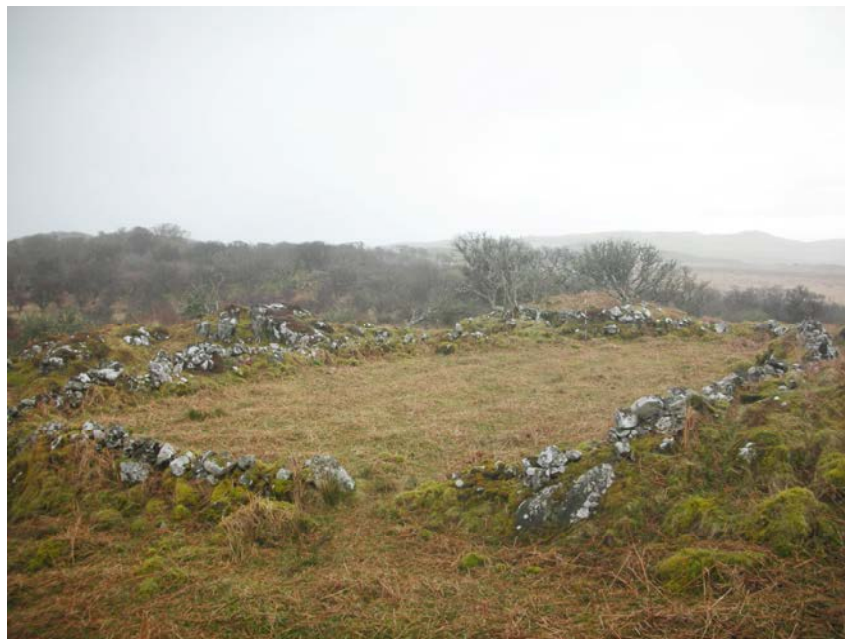
Ballore, Enclosure 2

Enclosure 2. NR 45545 52086

Irregularly shaped stone and turf enclosure attached to the end of Structure 4 with evidence of internal rig and furrow cultivation.

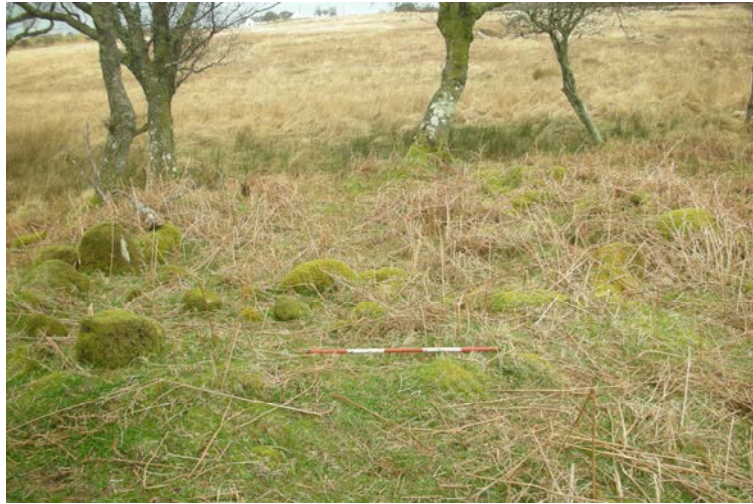
Site 19, Structure

Structure NR 45838 52149

Very dilapidated footings of an oval structure, measuring c7-8m by 6m externally. The possible structure sits within an area of improved ground.
